Receiver's Rehabilitation Plan

123 Main St
Springfield, MA 01151
99-CV-999
Nov 12, 2015

428 Belmont Ave, Springfield, MA 01108

Summary

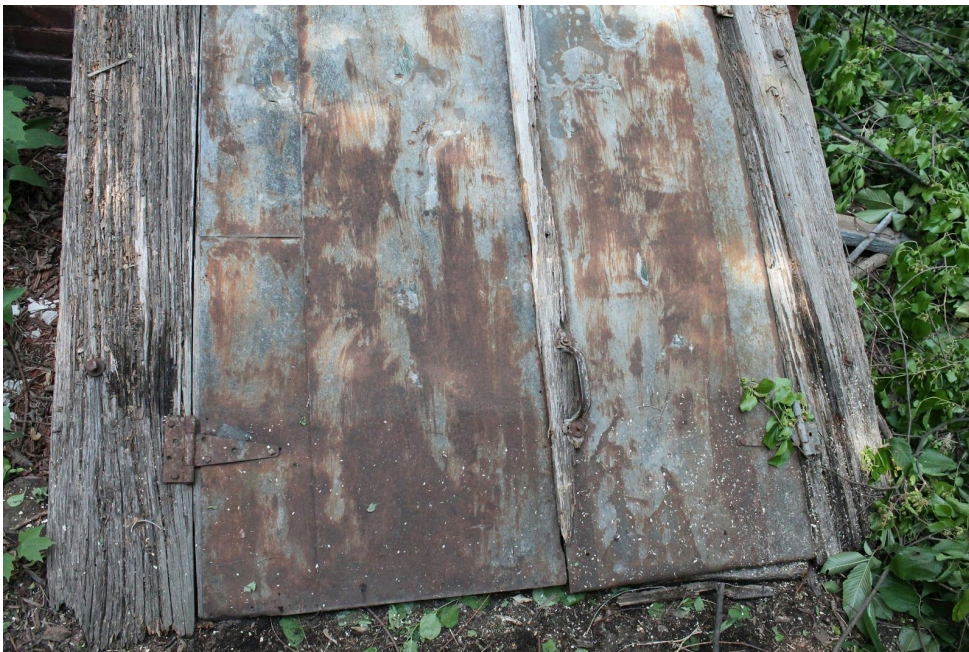
Exterior: See deteriorated bulkhead

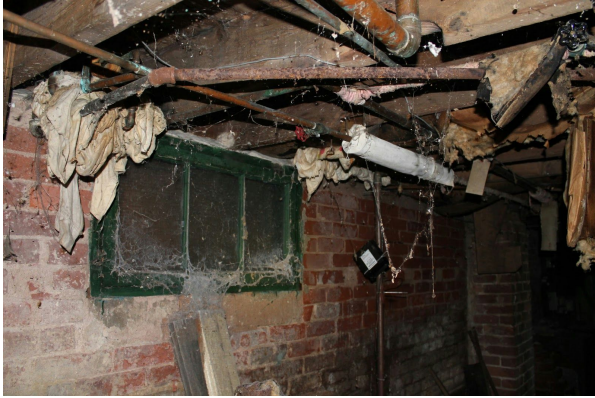
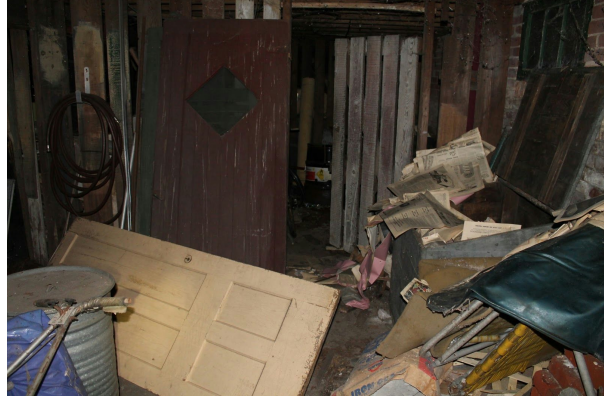
Basement: See debris, tires , and faulty plumbing

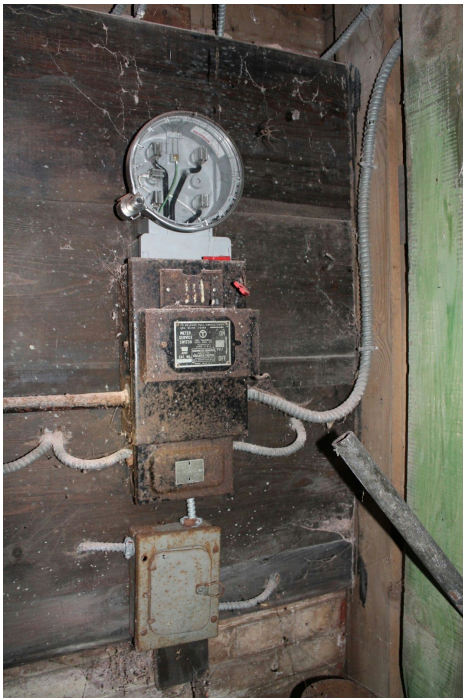
The main service to the property is in very poor condition. The existing service panels are fuse boxes and also in Poor condition. The interior of the house, from sections visible, has substantial water damage to the existing wiring. The moisture, coupled with the poor maintenance, has created several electrical hazards on the property.

Electrical: See fuses and wiring hazards

We propose to run new service, install a 4 meter box on the exterior of the property, install new circuit breaker panels for all units, and rewire the existing apartments appropriately. We also propose to add exterior security lighting for the property. Total cost estimate - \$1,000 (labor and materials)
