NARRATIVE APPRAISAL REPORT

FORMER ELIAS BROOKINGS SCHOOL
367 HANCOCK STREET
SPRINGFIELD, MASSACHUSETTS

APRIL 11, 2014

RE: Narrative Appraisal Report:
Former Elias Brookings School
367 Hancock Street
Springfield, MA
Crowley & Associates File #16299

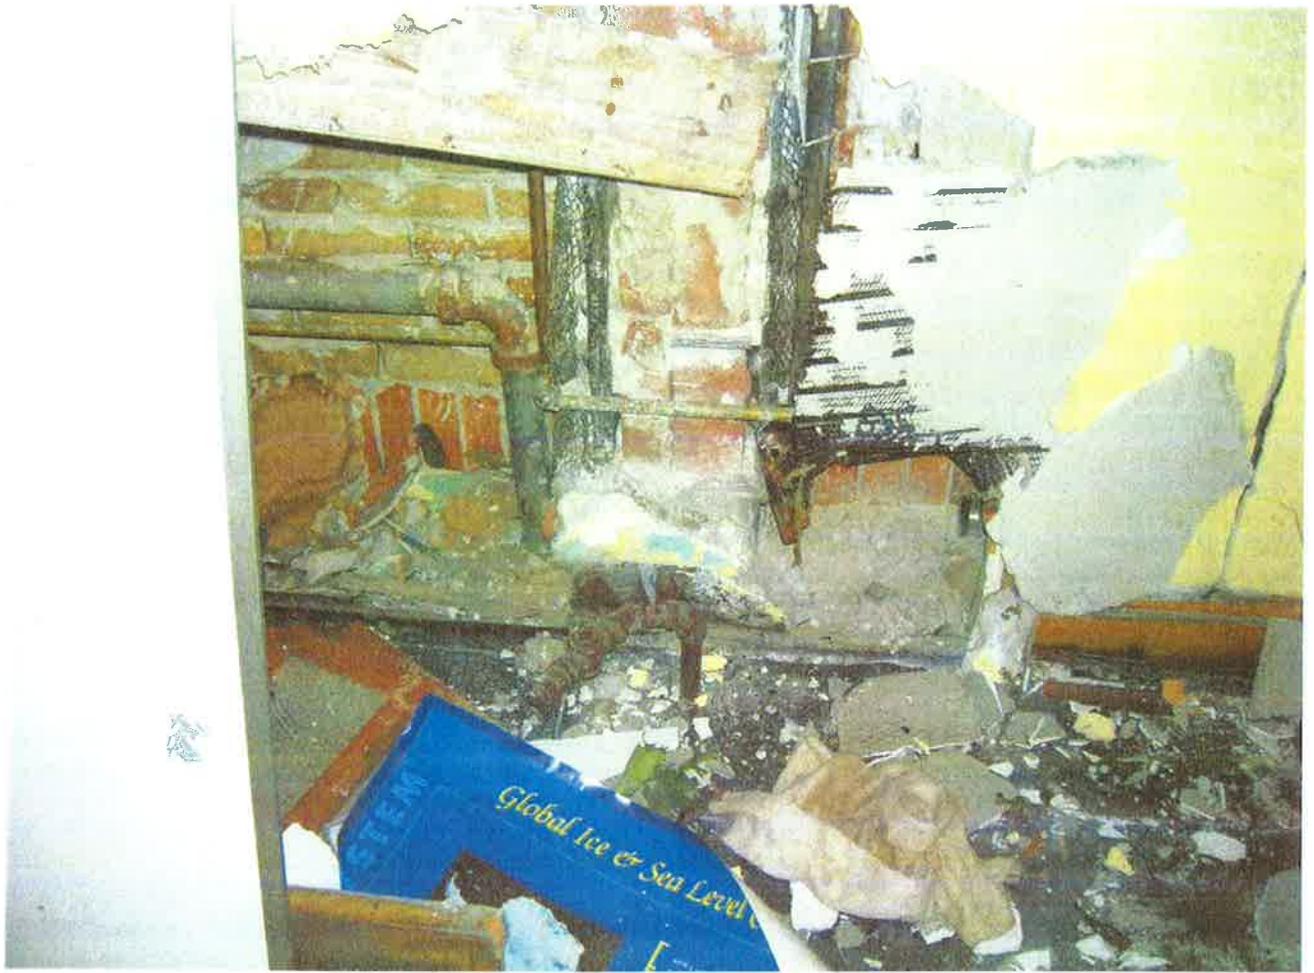
Figure 1 Piping risers in wall at damaged wall area

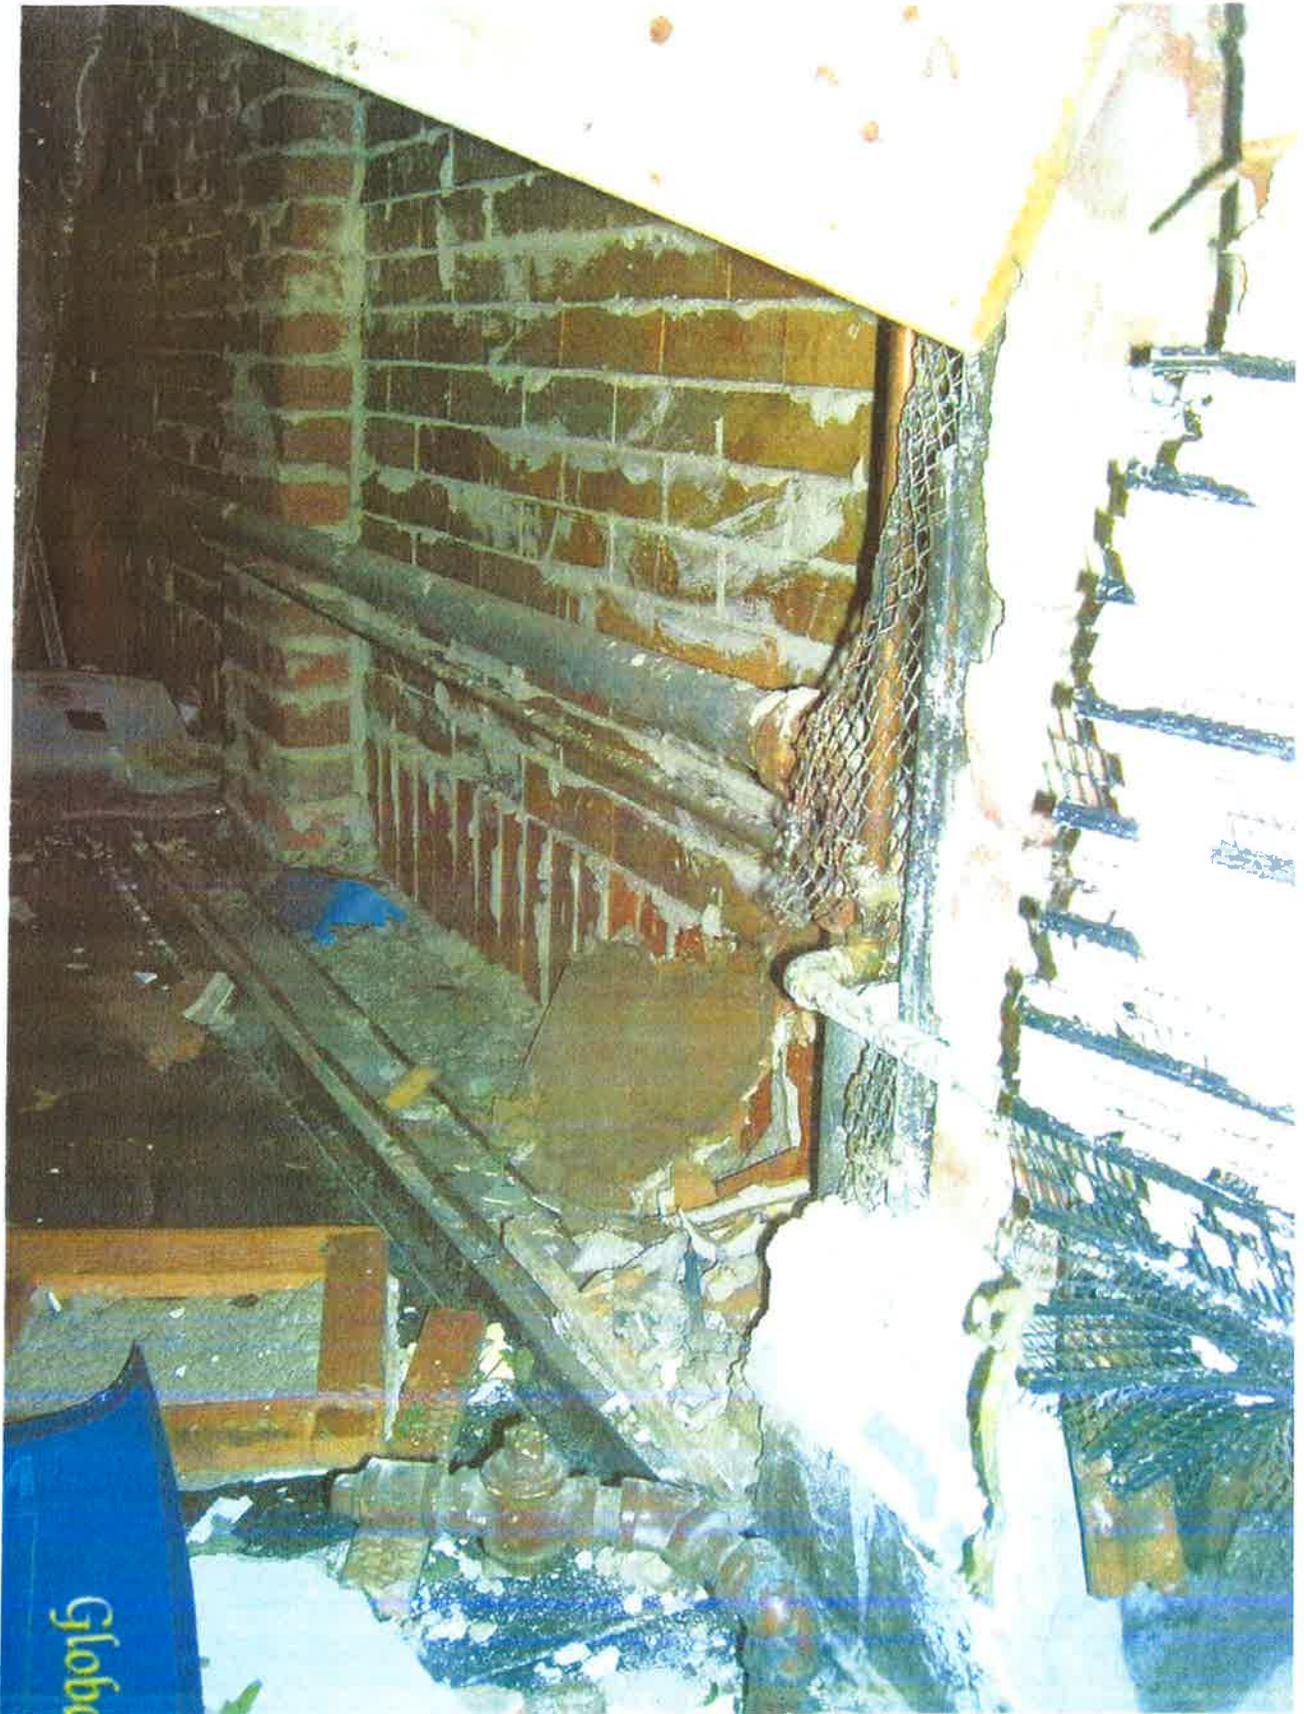
Figure 2 Horizontal piping in damaged wall

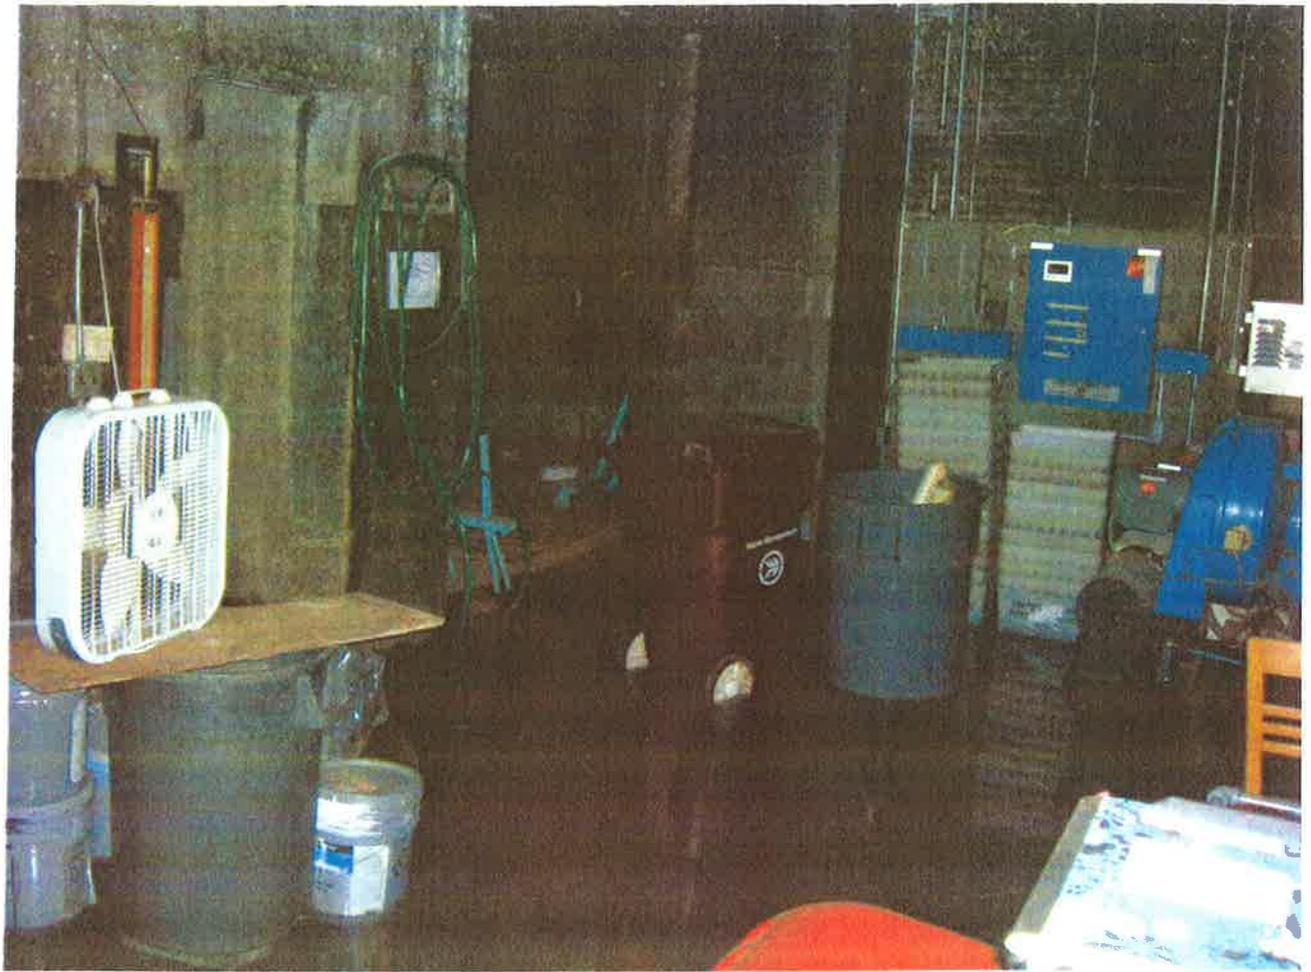
Figure 3 Basement flooding

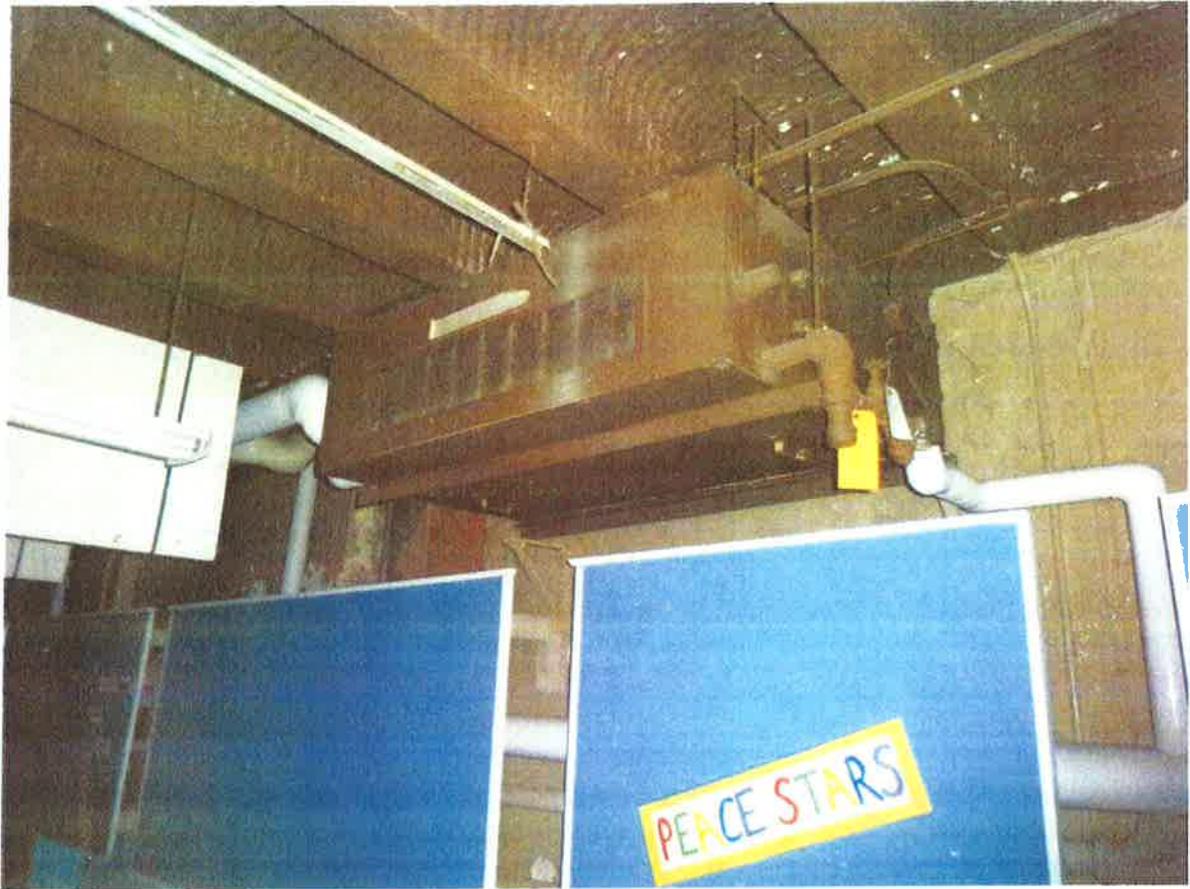
Figure 4: Lower level Unit Ventilator

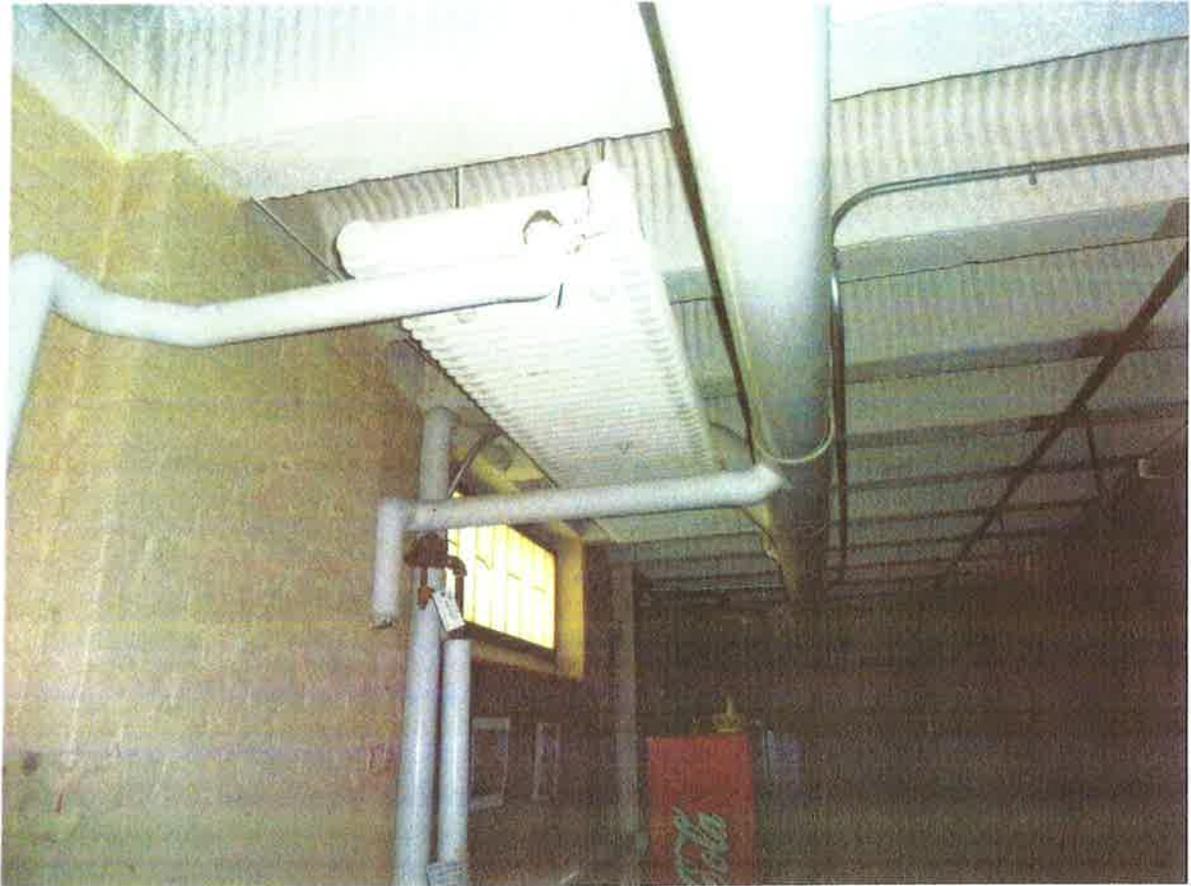
Figure 5: Lower level steam radiator

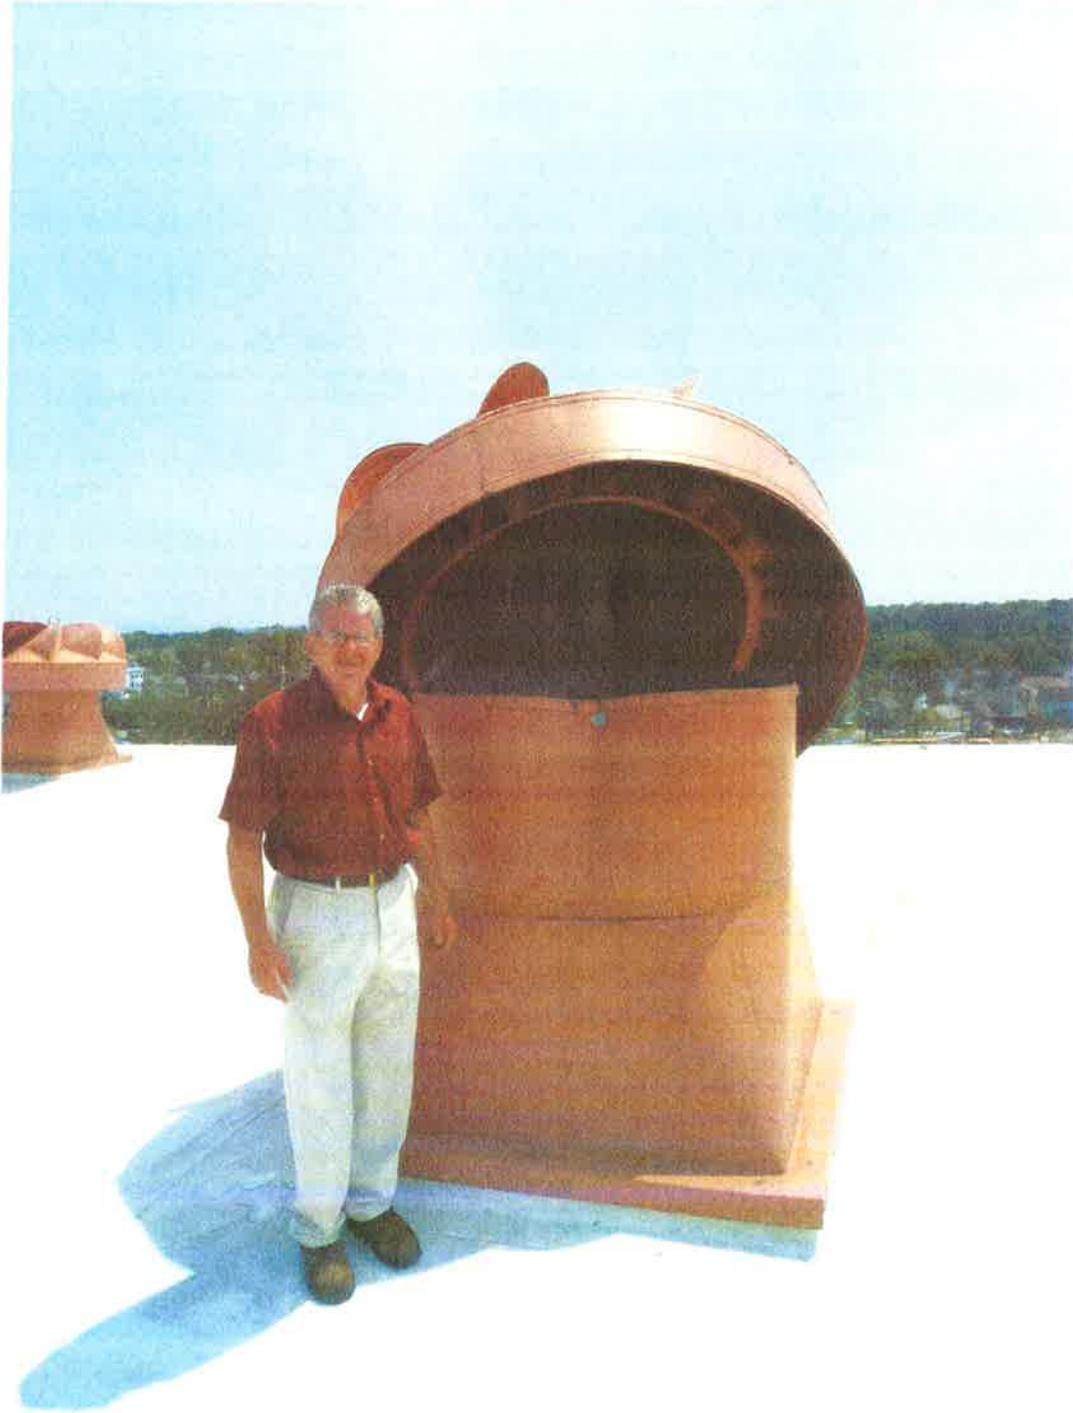
Figure 6: Damaged Roof Vent on roof

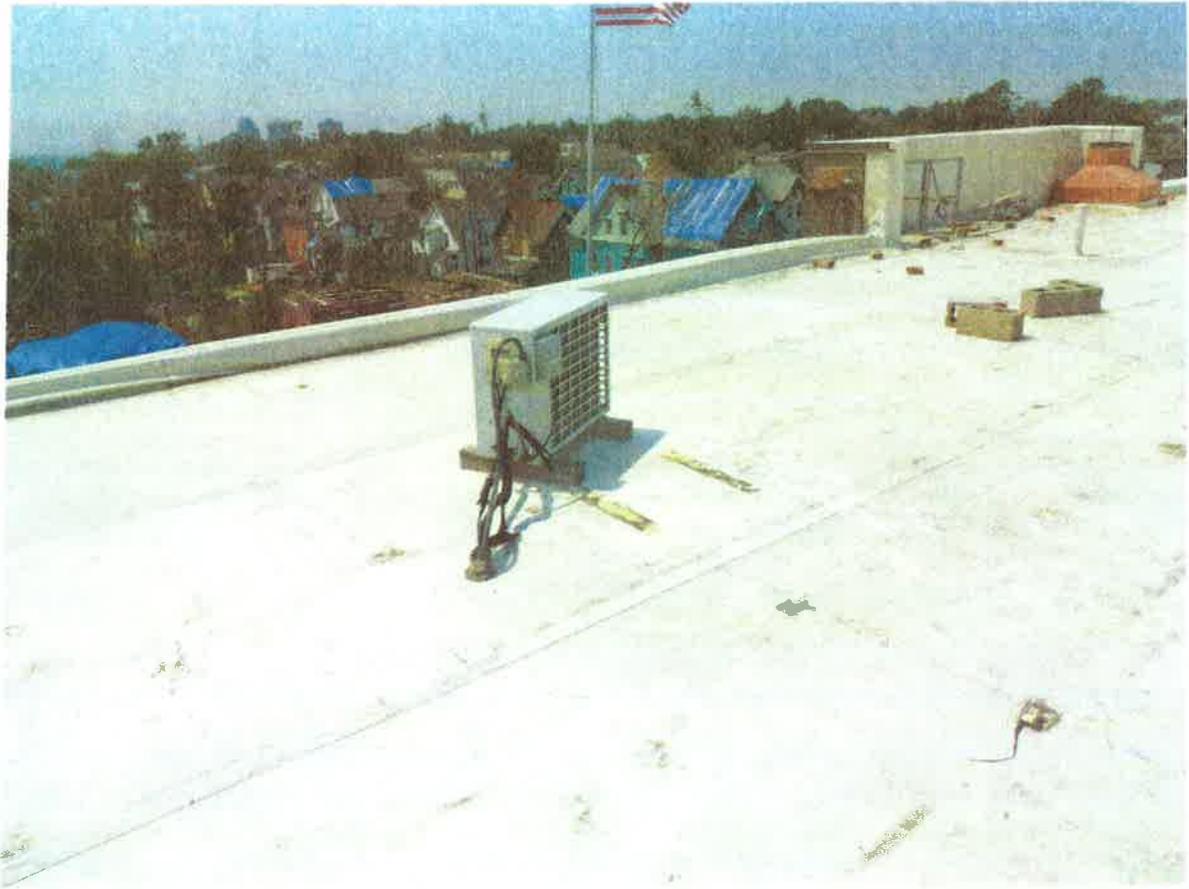
Figure 7: Shifted Condensing Unit on roof

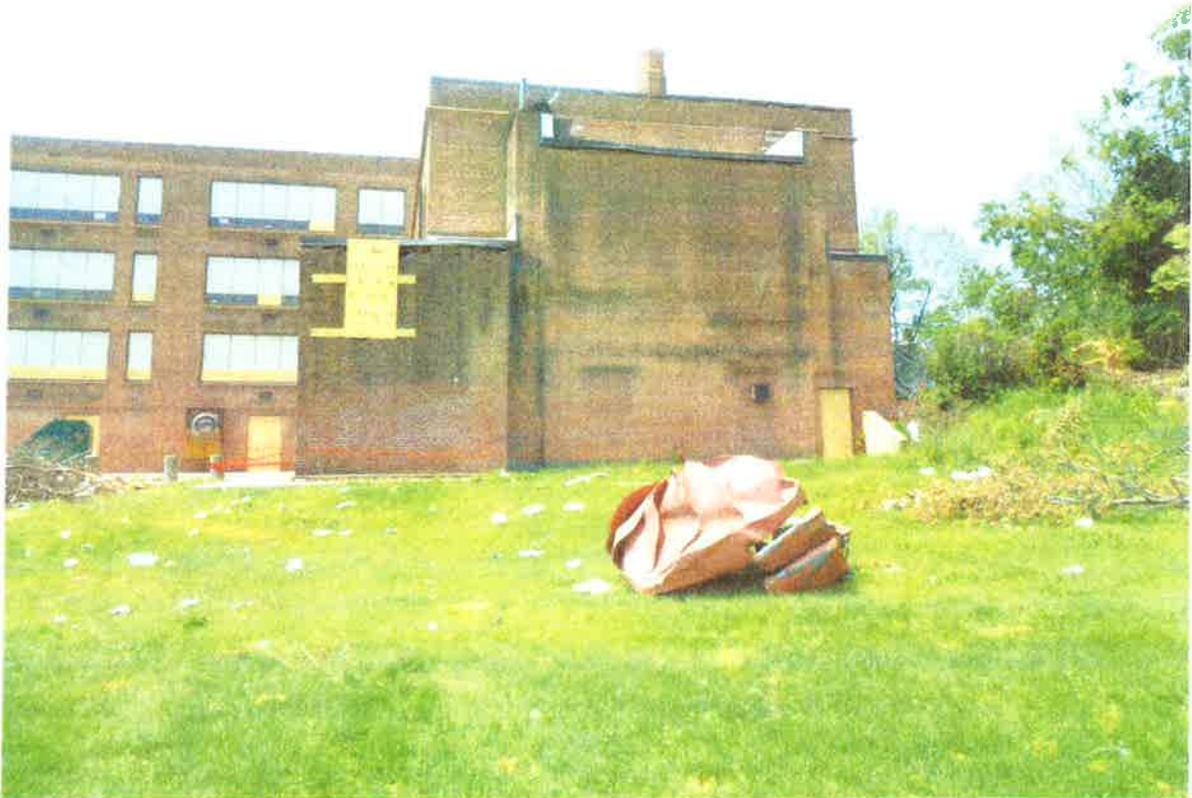
Figure 8: Roof Vent in adjacent field

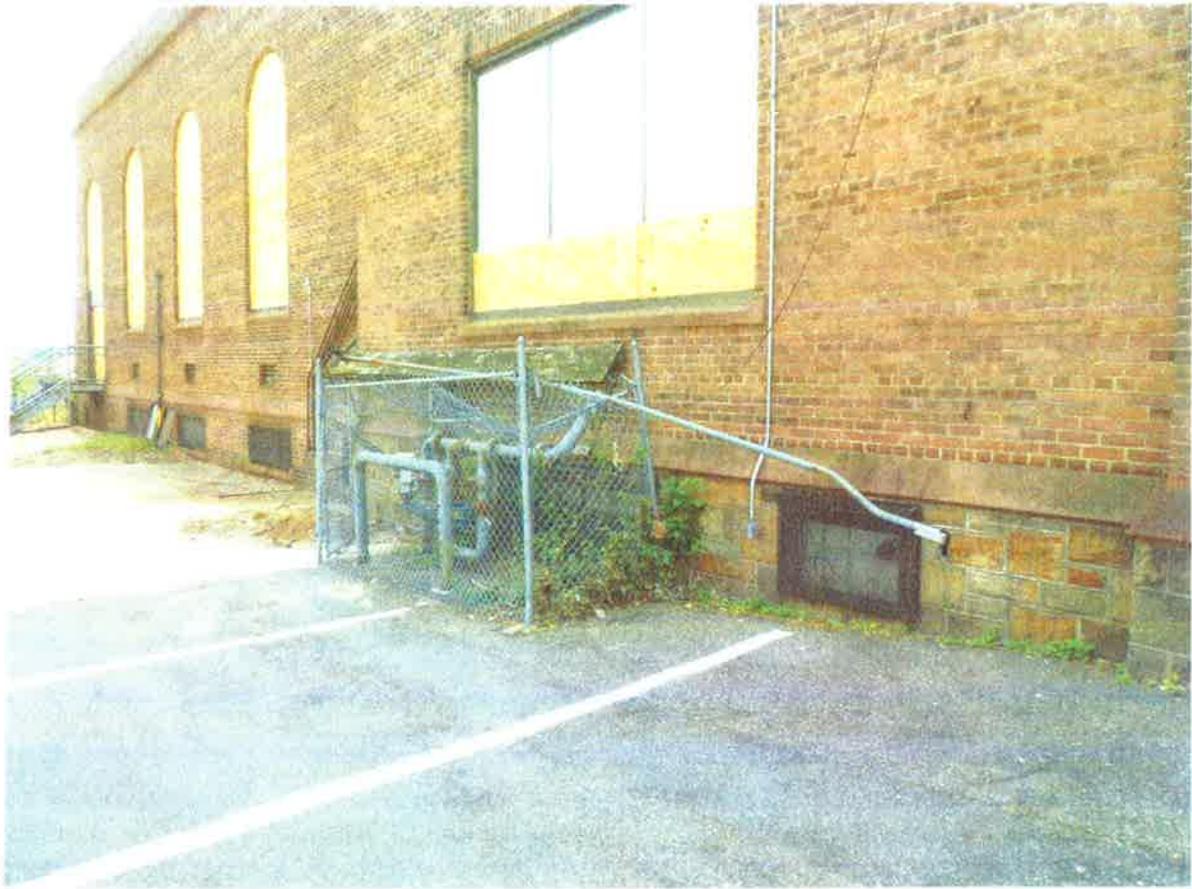
Figure 9: Gas service with Telephone Service disconnection from wall

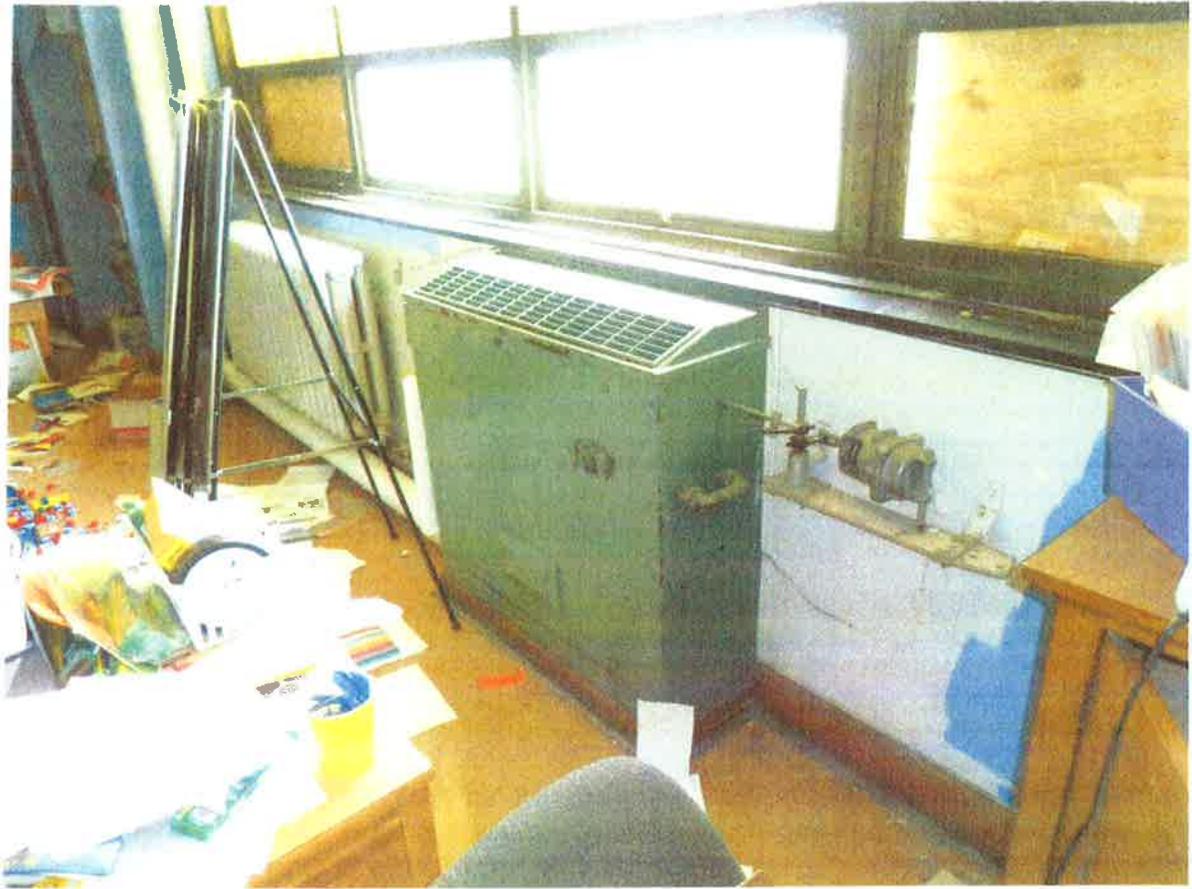
Figure 10: Exterior wall exposed cast iron radiator and Induction Unit serving classroom

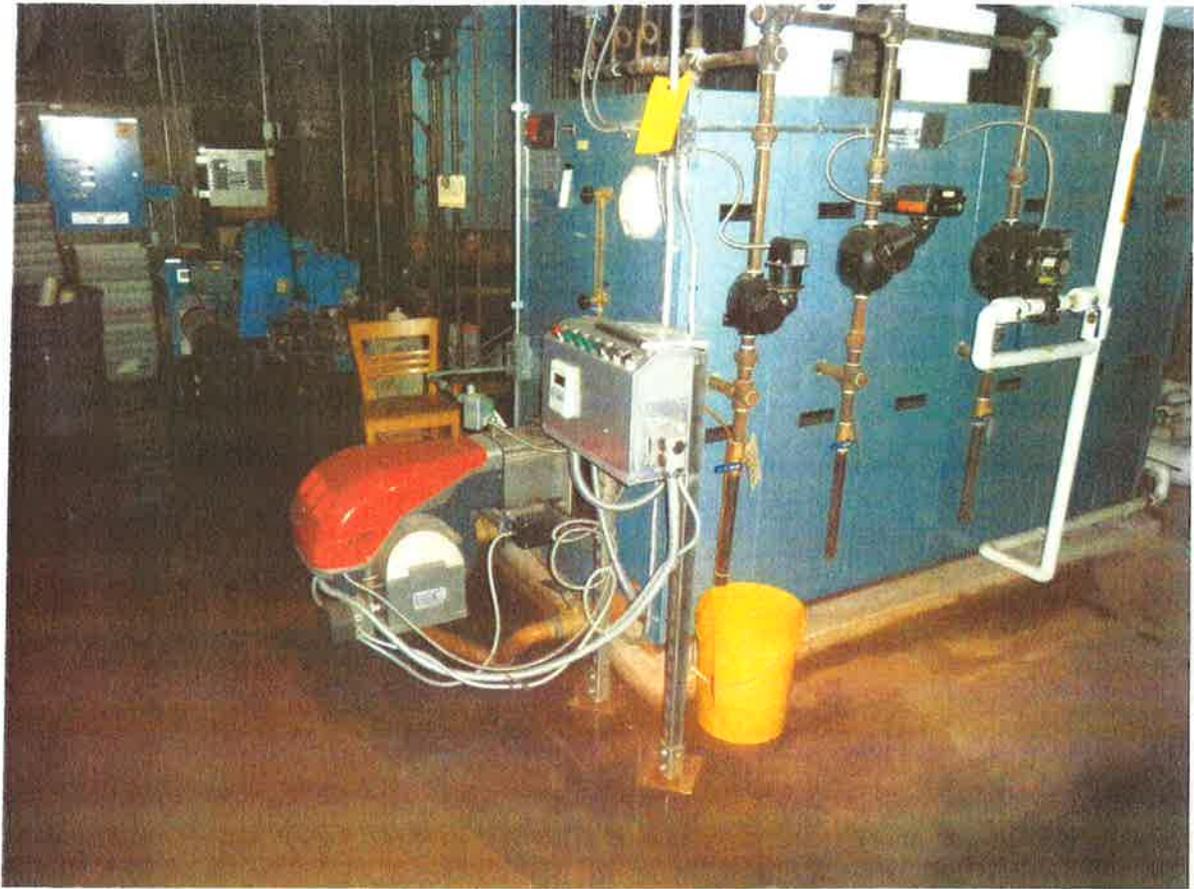
Figure 11: New Boiler/Burner in Flooded Basement

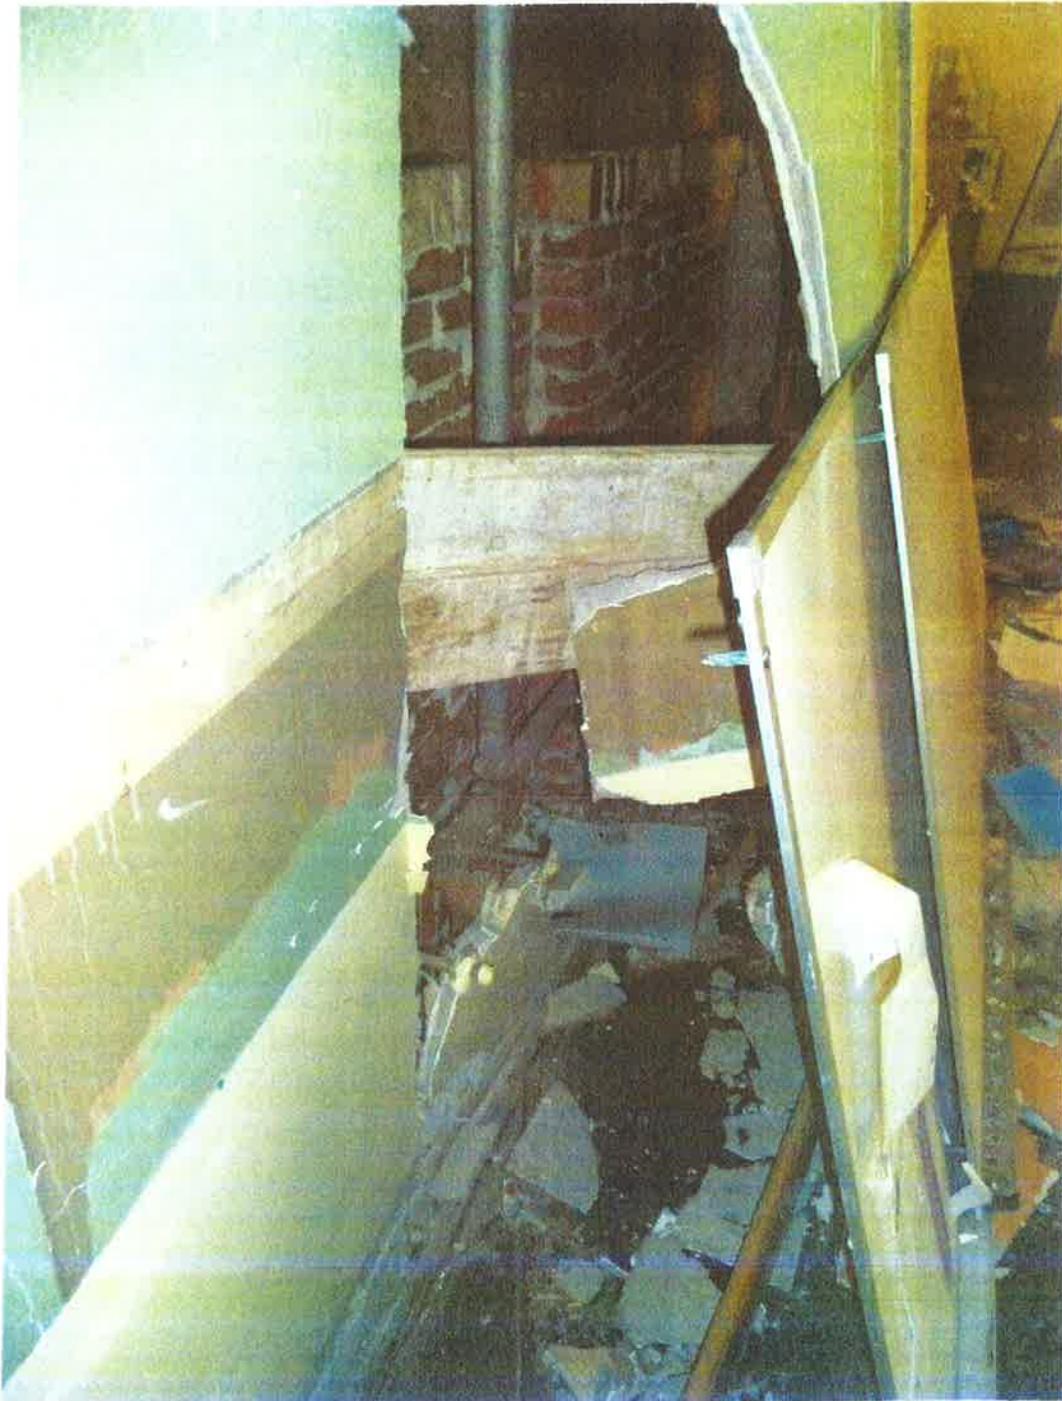
Figure 12: Collapsed Interior Wall with Pipes exposed

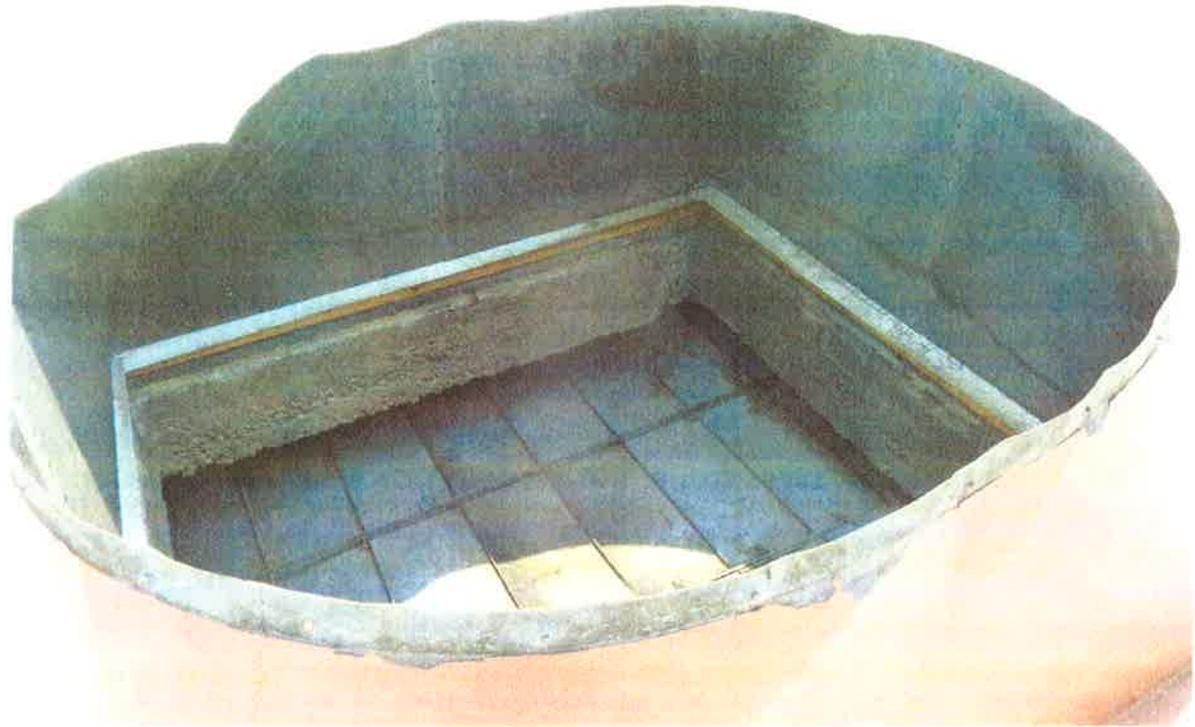
Figure 13: Torn off Roof Vent with opening through roof and exposed damper

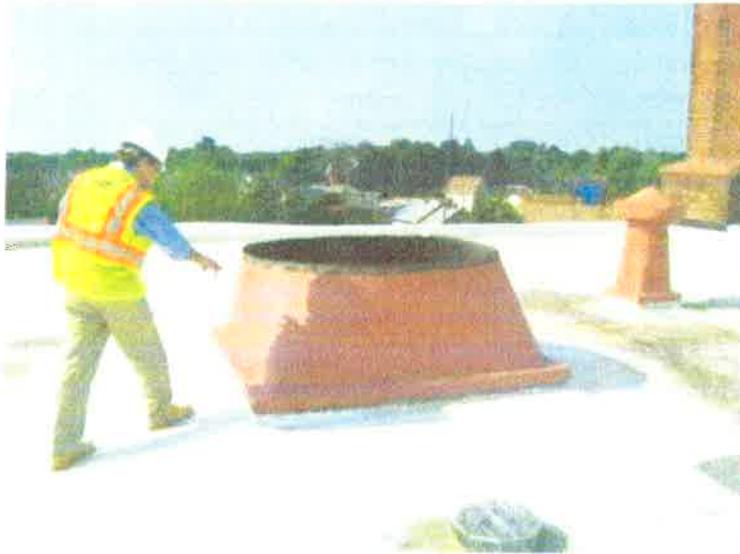
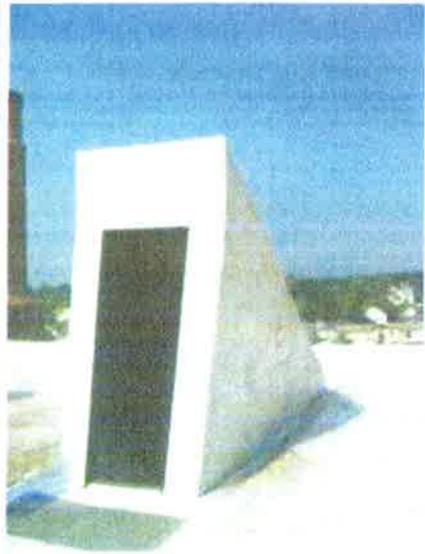
Three large sheet- metal ventilator covers were also blown off by the winds. The City's facilities department has temporarily replaced all but one of them by the time of the study team's visit. The roof access penthouse was also severely displaced by the high winds so that it is no longer plumb, it is now a parallelogram.

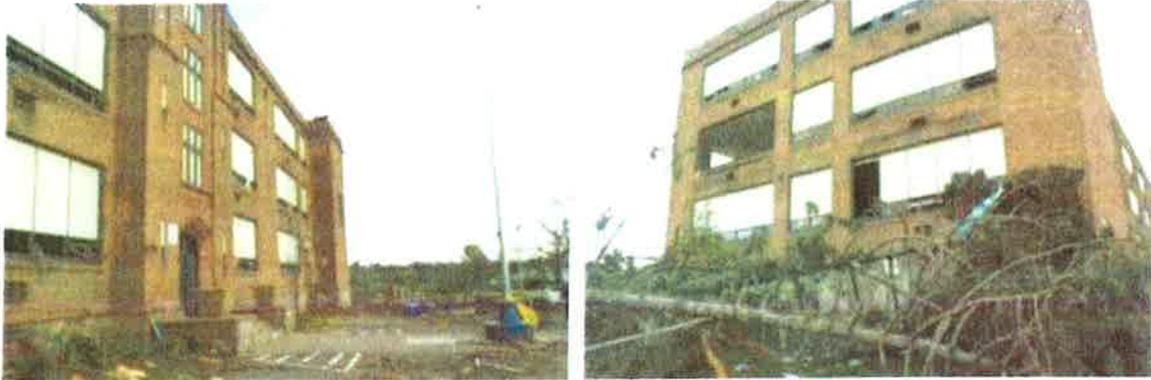
Most all of the operable windows (lower sections) on the west and south facades were blown out, although the upper fiberglass panels remained in place. At the southwest corner two entire window frames, approximately (6' x 15') were blown out. At the window frames that remained in place, several had damage to the aluminum frames, including deformations that opened up joints to the exterior.

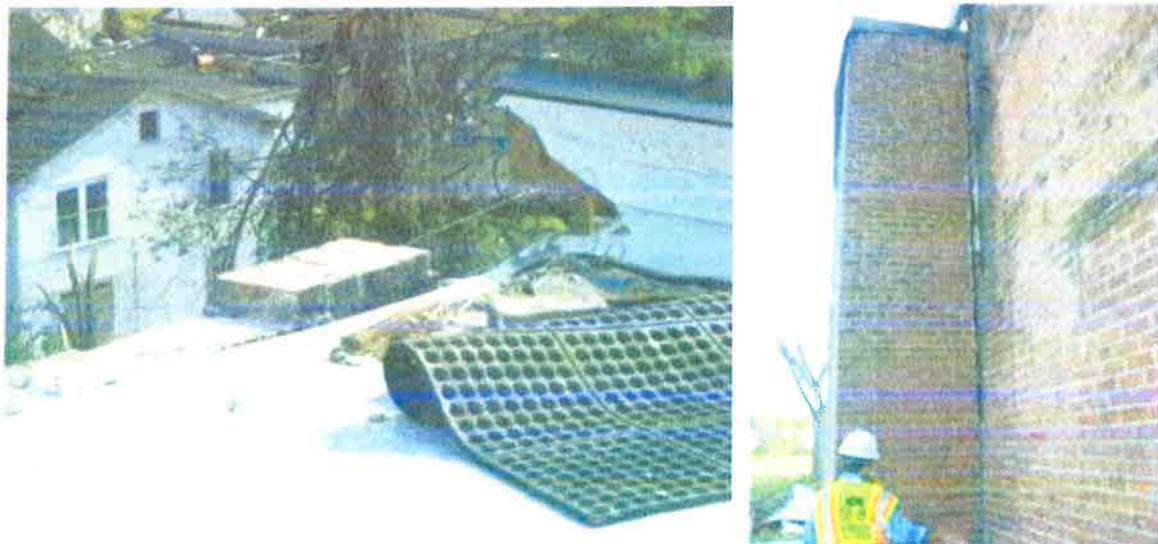
The brick parapets were blown off entirely at the south end of the main building and the lower portions of gym building had large sections of brick removed. These lower structures looked to be disconnected (not toothed-in) to the main gym structure and have been displaced.

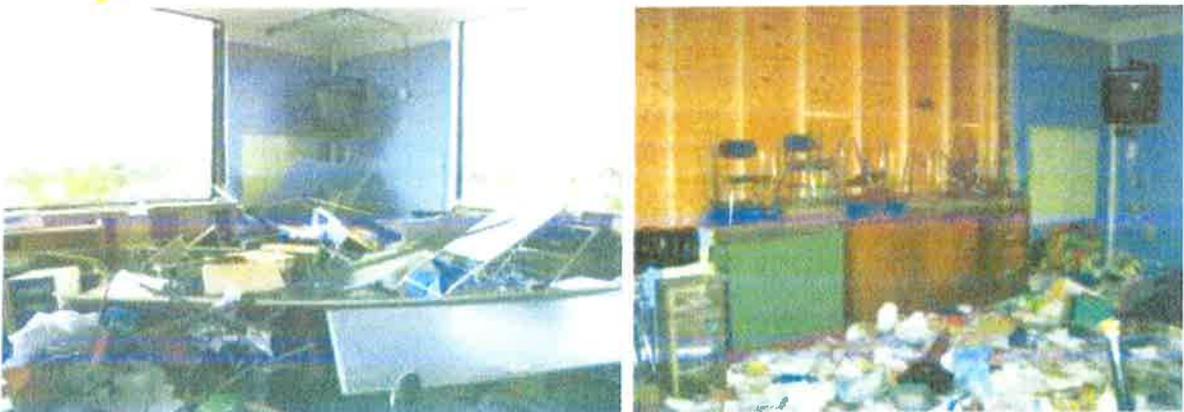
The large classroom at the southern end of the second floor suffered extensive interior damage as this was the classroom that had two corner windows entirely blown out.

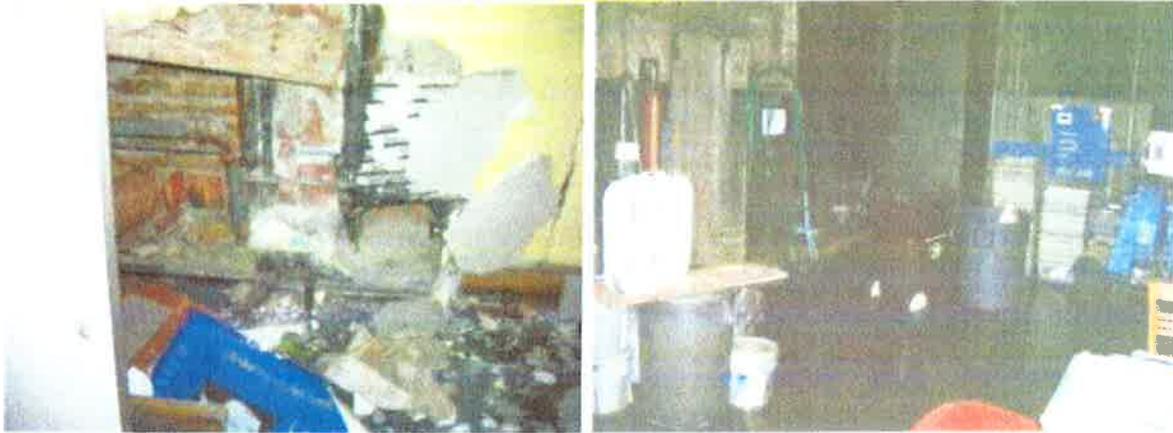
The Plumbing systems in the building seem to have suffered minor damages from the tornado. There may be some damage caused to systems that were part of the collapsed corridors, although no leaks were observed or sewer gas smells perceived. Some additional testing is required to confirm the integrity of these systems.

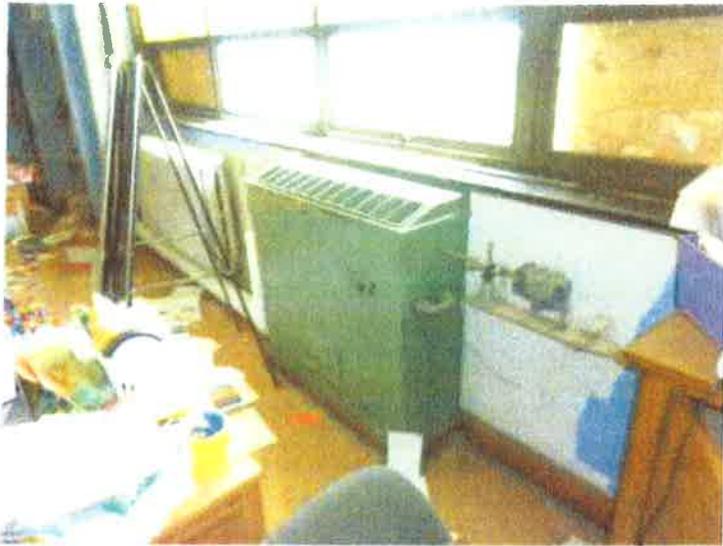
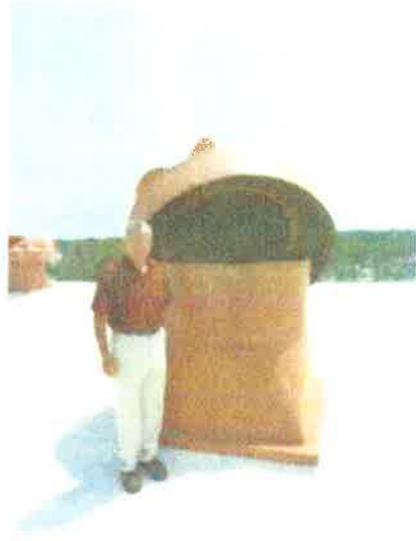
The existing steam radiator piping and pneumatic lines that serve unit ventilators may have been damaged by collapsed windows and corridor walls. Additional testing is needed to confirm the integrity of this system.

The rooftop ventilators, although re-installed, are damaged and probably not salvageable. Also rooftop condensing units appear to have been displaced and are probably damaged.

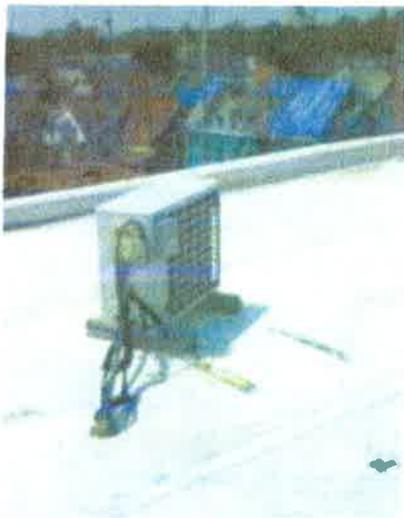
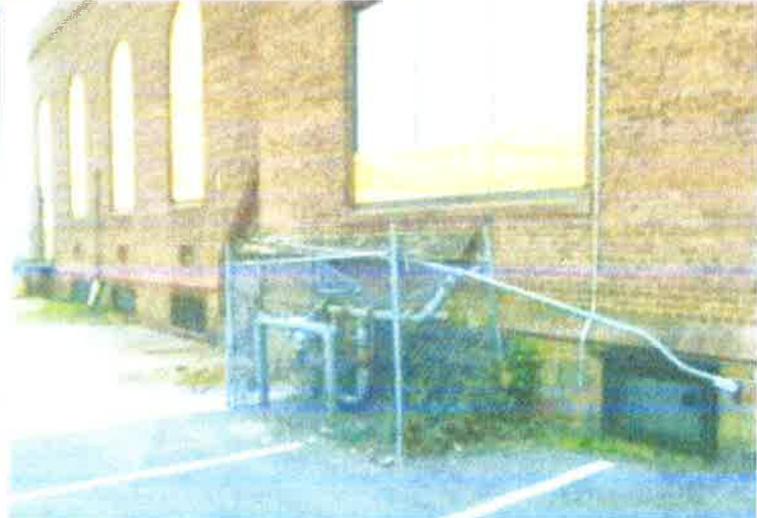
The storm damage left the power, lighting and fire alarm systems with what appears to be minimal damage. Some interior walls are buckled or settled resulting in exposed electrical systems in the respective walls. The extent of this damage requires further investigation or testing of the affected systems. Other damage extends to electrically-connected mechanical components that were forcefully dislodged or removed from the roof.
