NARRATIVE APPRAISAL REPORT

FORMER ELIAS BROOKINGS SCHOOL
367 HANCOCK STREET
SPRINGFIELD, MASSACHUSETTS

APRIL 11, 2014

RE: Narrative Appraisal Report:
Former Elias Brookings School
367 Hancock Street
Springfield, MA
Crowley & Associates File #16299

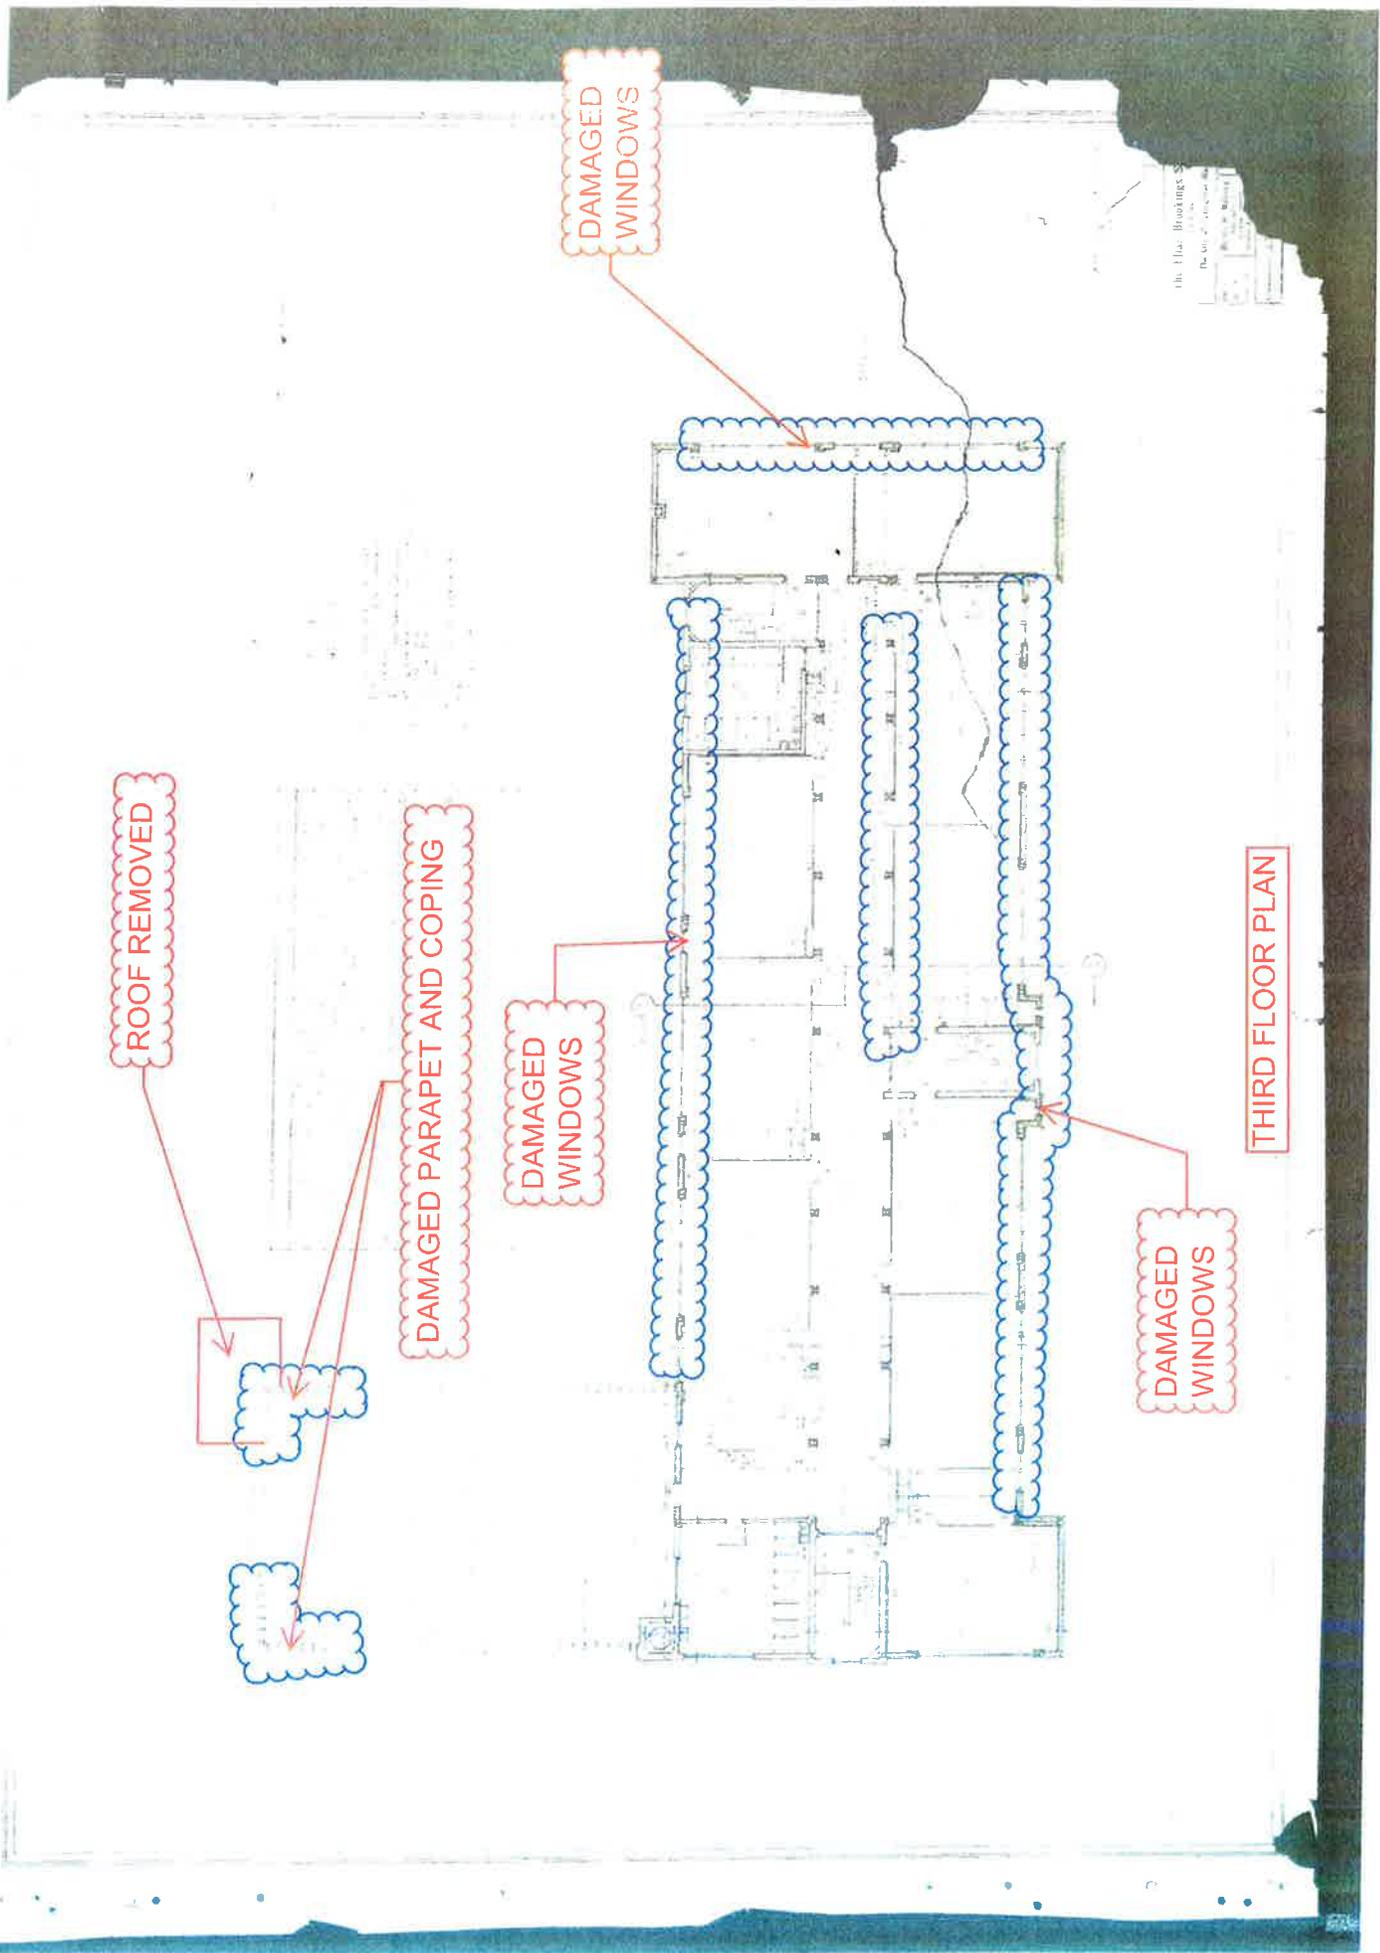
THIRD FLOOR PLAN

DAMAGED PARAPETS AND METAL COPINGS

DISPLACED PENTHOUSE STRUCTURE

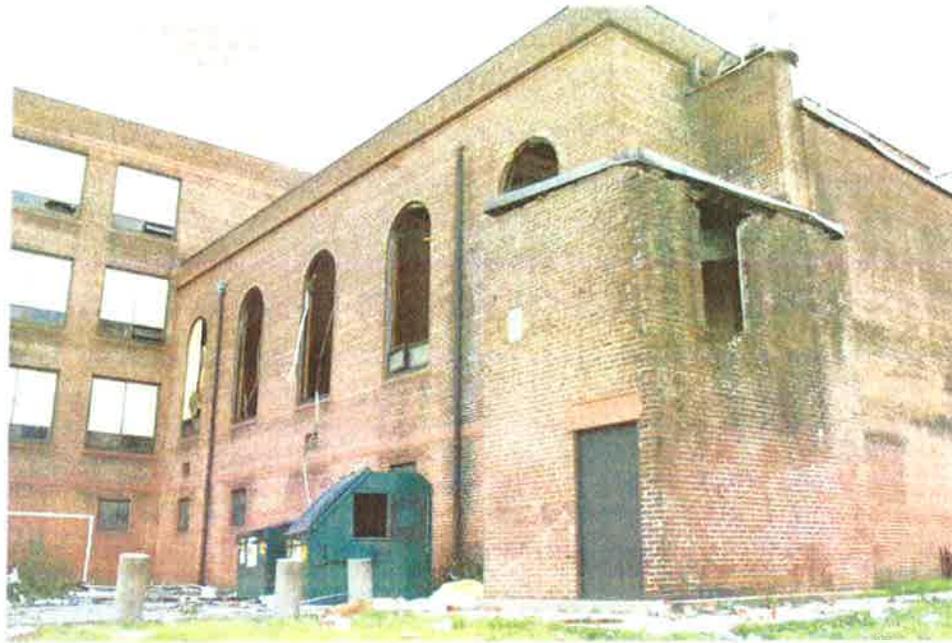
Blown out gymnasium windows and damaged single story addition.

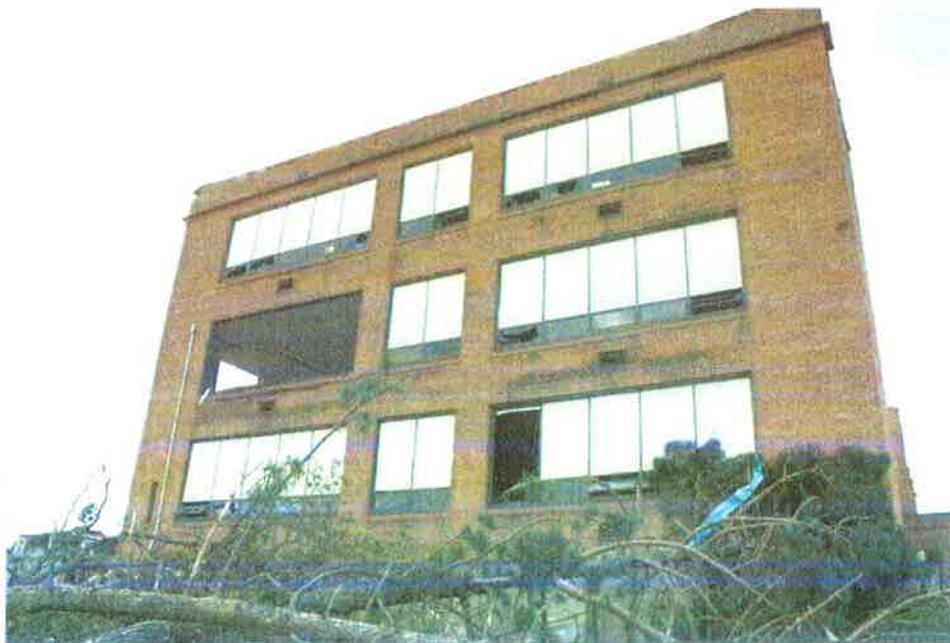
South elevation blown out window damage.

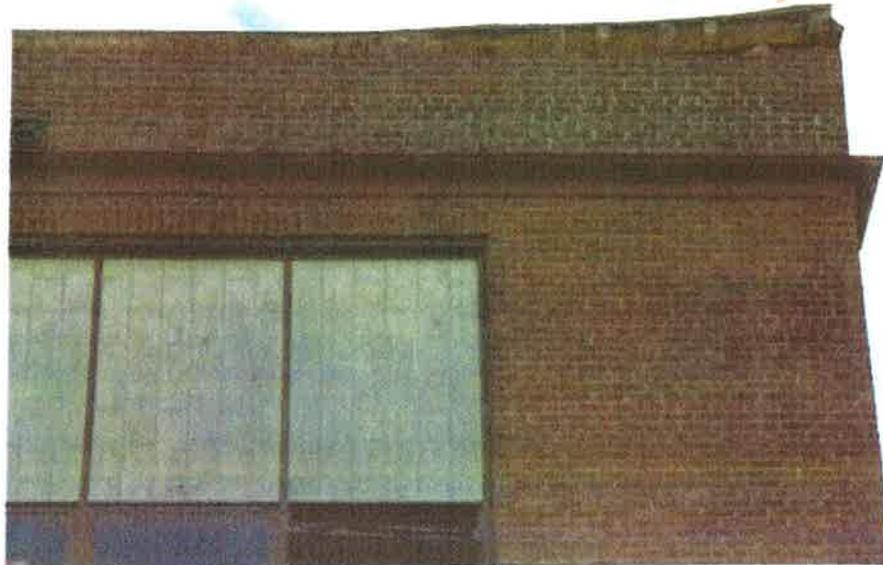
Typical roof coping damage.

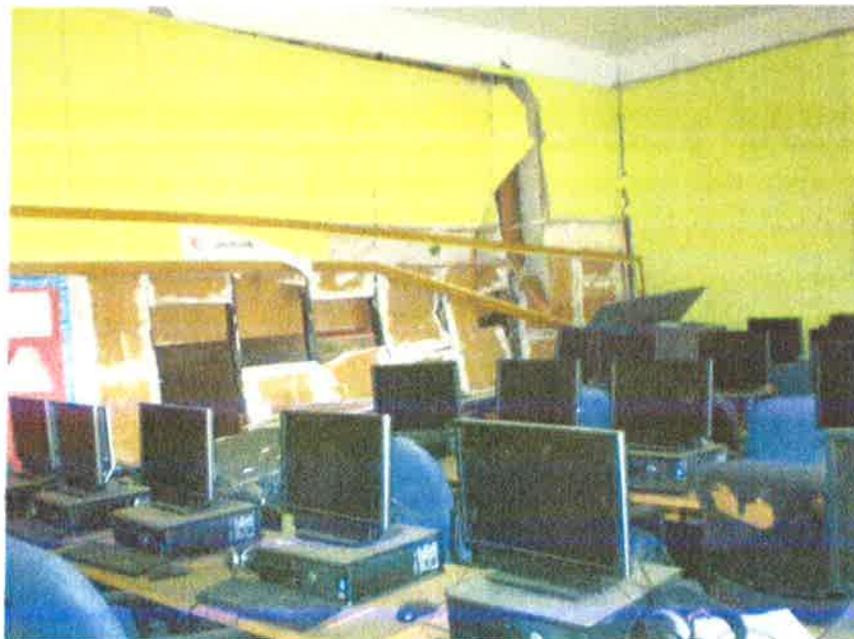
Blown out interior corridor wall.

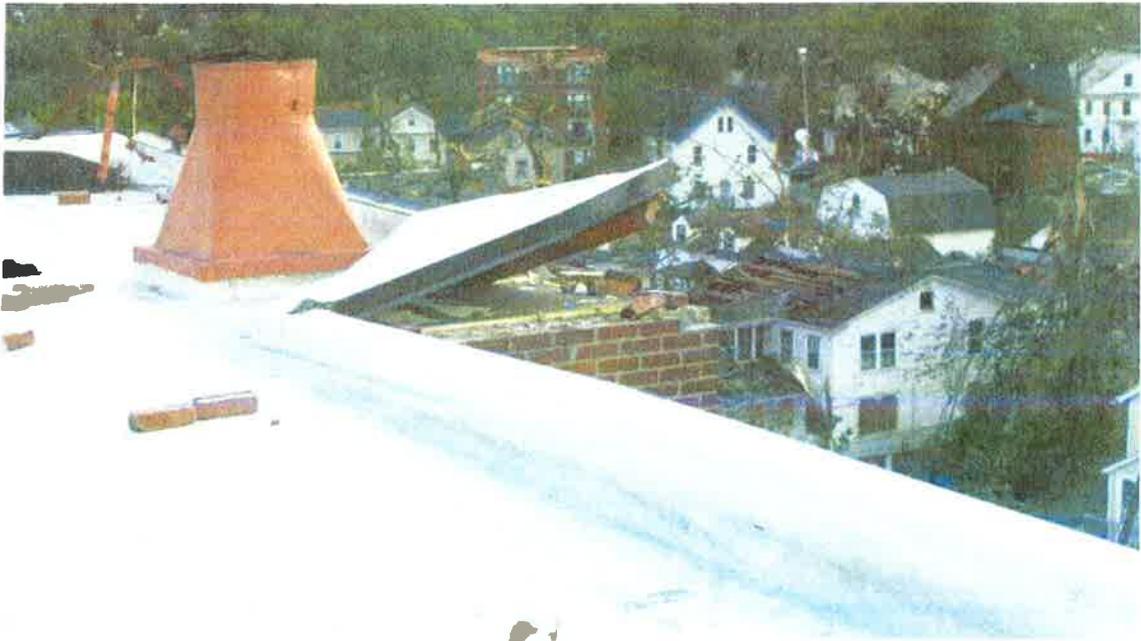
Damaged roof coping and top of masonry wall damage.

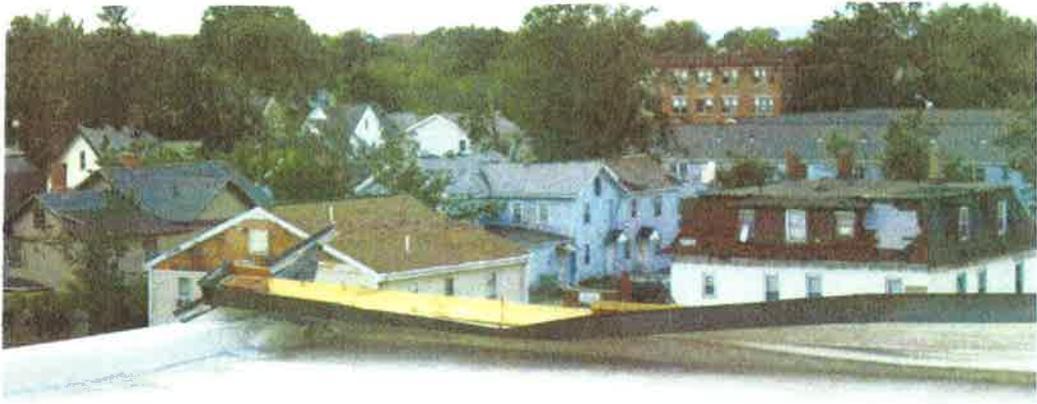
Damaged roof coping.

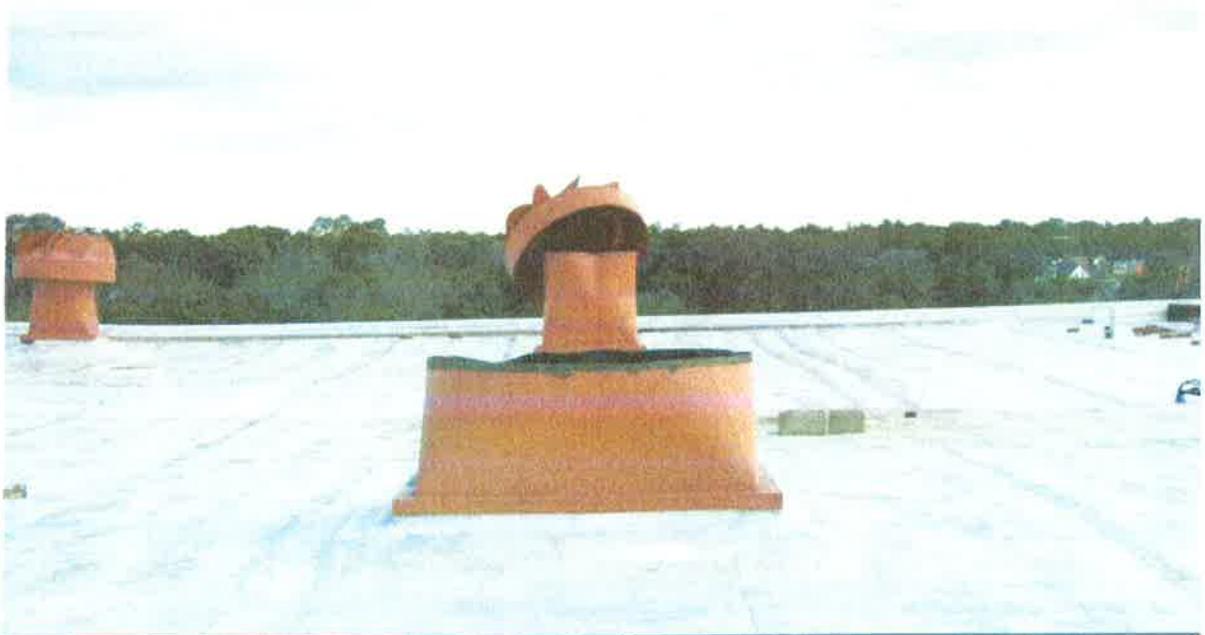
Damaged roof fans and detached/ballooned roof membrane.

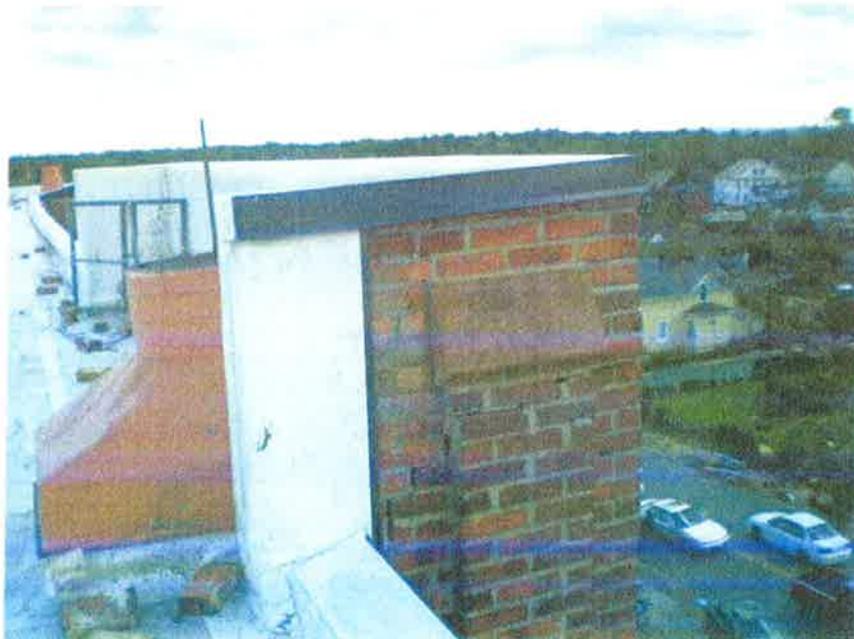
Damaged and parapet and blown off roof fan.
