Emergency Damage Assessment

Elias Brookings School

Springfield, Mass

June 22, 2011

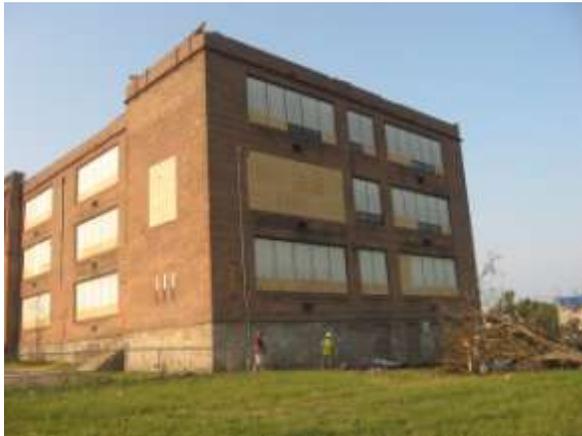
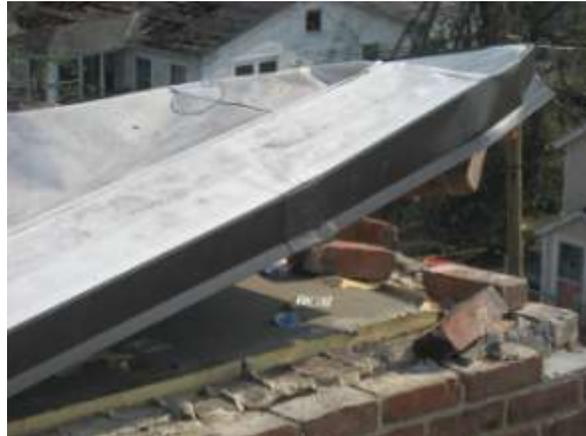
The most significant damage to the Brookings School is to the exterior envelope- roof, parapet and windows, and to certain interior corridor walls.

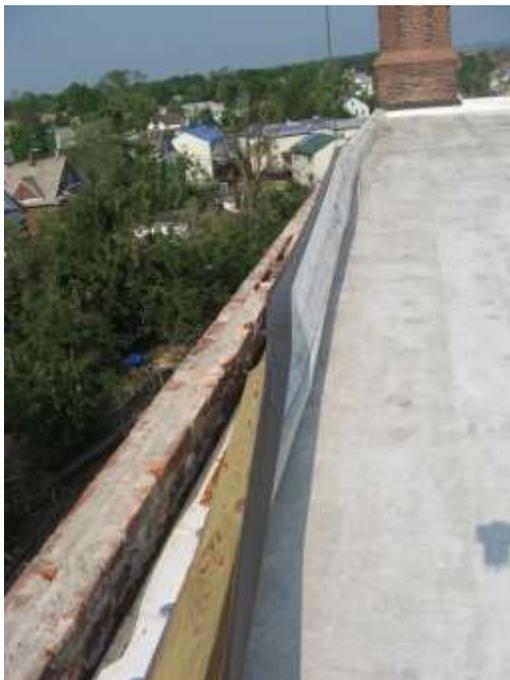
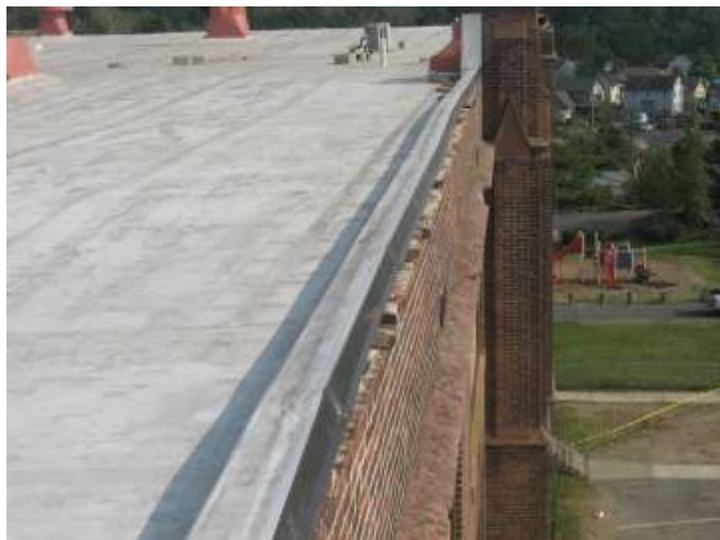
Extensive areas of the roof parapet have been dislodged and removed by the tornado with much of the brick falling to the ground below. In areas where the parapet remains, much of the metal coping and blocking has been damaged, often loosening the top courses of brick.

- Stabilize and repair the roof parapet
- Demolish and rebuild the rooftop stair penthouse
- Repair the membrane roof
- Stabilize (or demolish) the east stair enclosure at the gym
- Make all window openings weathertight
- Remove interior debris
- Test the integrity of the plumbing, HVAC and Electrical systems as per the engineers' recommendations

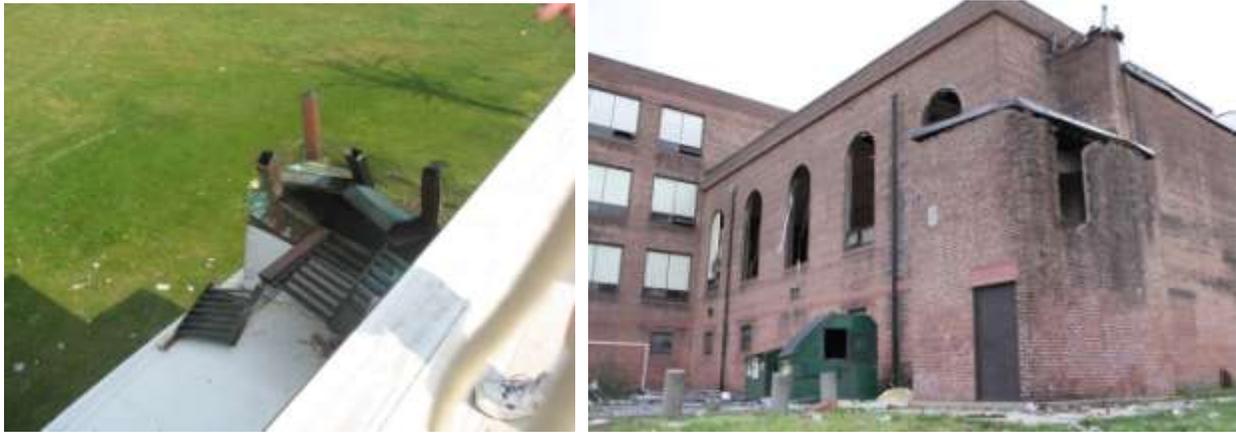
Near the gymnasium, the roofs of a stairwell and ventilation shaft were completely blown off; in one case taking most of the brick wall with it.

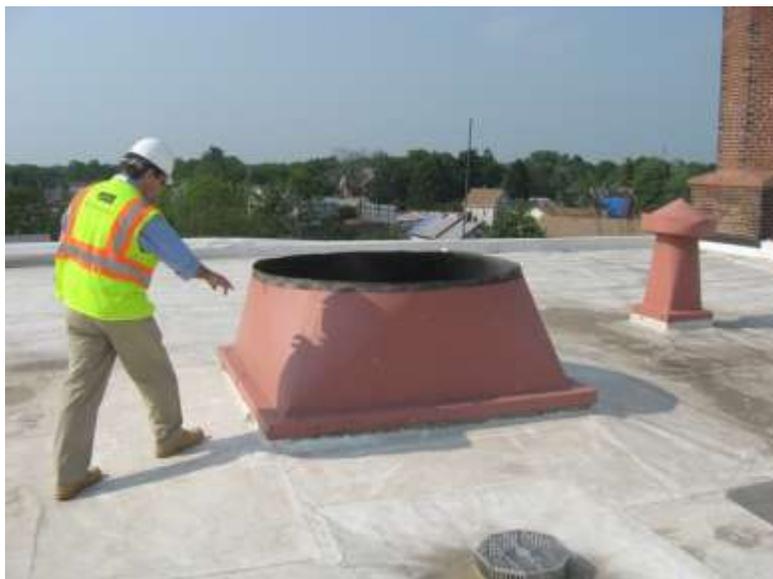
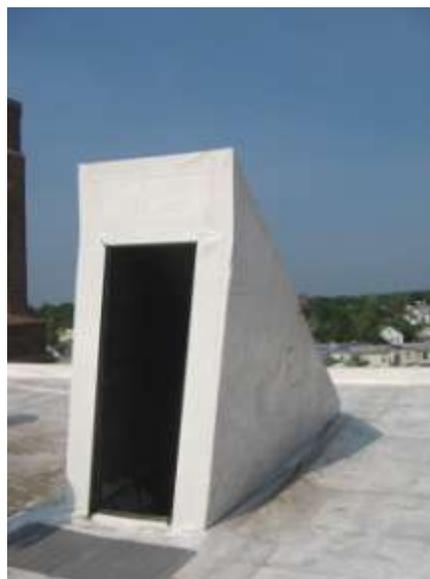
Three large sheet- metal ventilator covers were also blown off by the winds. The City's facilities department has temporarily replaced all but one of them by the time of the study team's visit. The roof access penthouse was also severely displaced by the high winds so that it is no longer plumb, it is now a parallelogram.

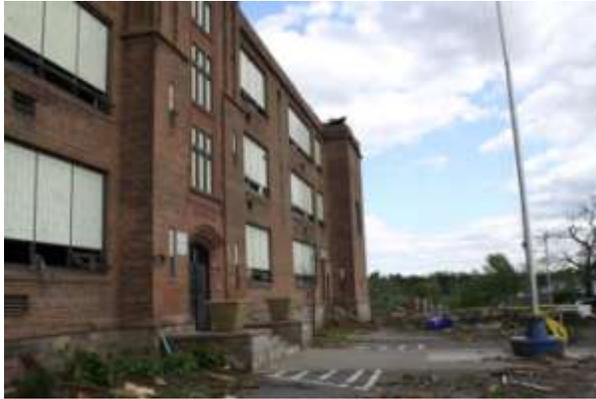
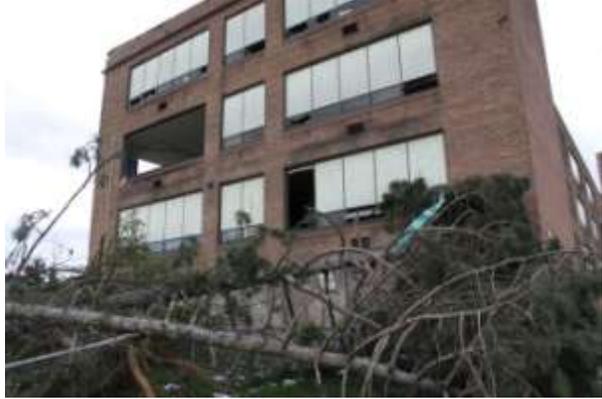
Building envelope:
Most all of the operable windows (lower sections) on the west and south facades were blown out, although the upper fiberglass panels remained in place. At the southwest corner two entire window frames, approximately (6' x 15') were blown out. At the window frames that remained in place, several had damage to the aluminum frames, including deformations that opened up joints to the exterior.

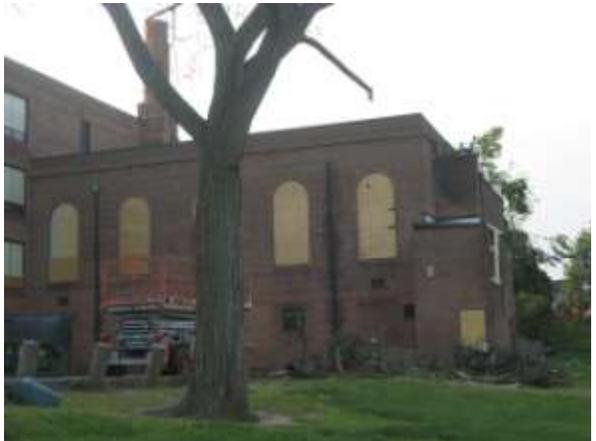
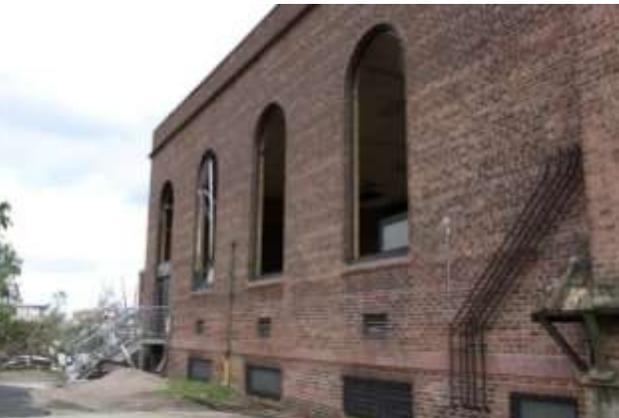
At the gymnasium, virtually all of the fiberglass arched windows and frames were blown out.

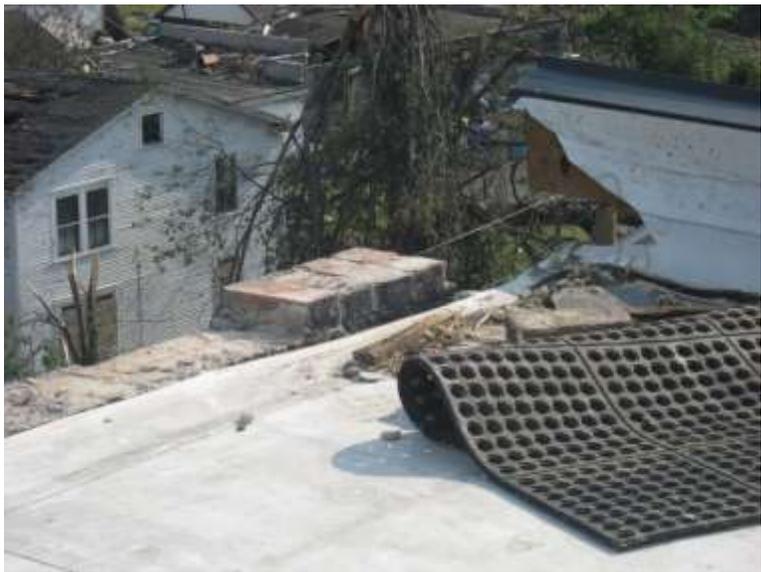
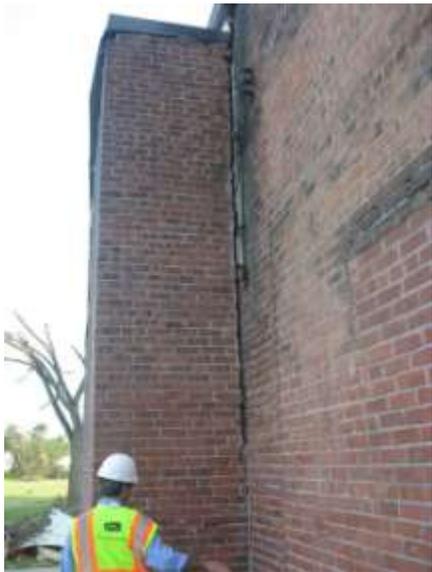
The brick parapets were blown off entirely at the south end of the main building and the lower portions of gym building had large sections of brick removed. These lower structures looked to be disconnected (not toothed-in) to the main gym structure and have been displaced.

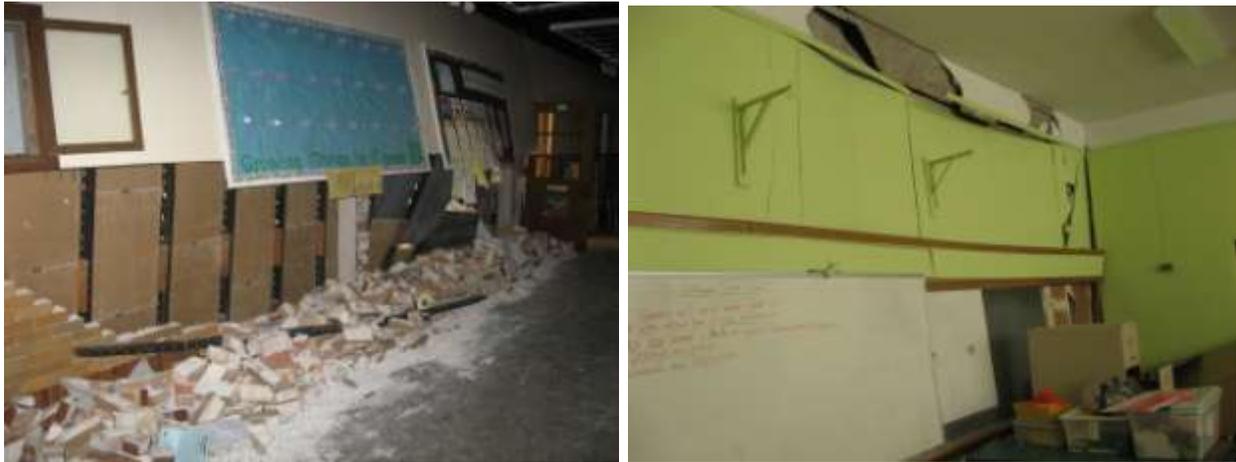
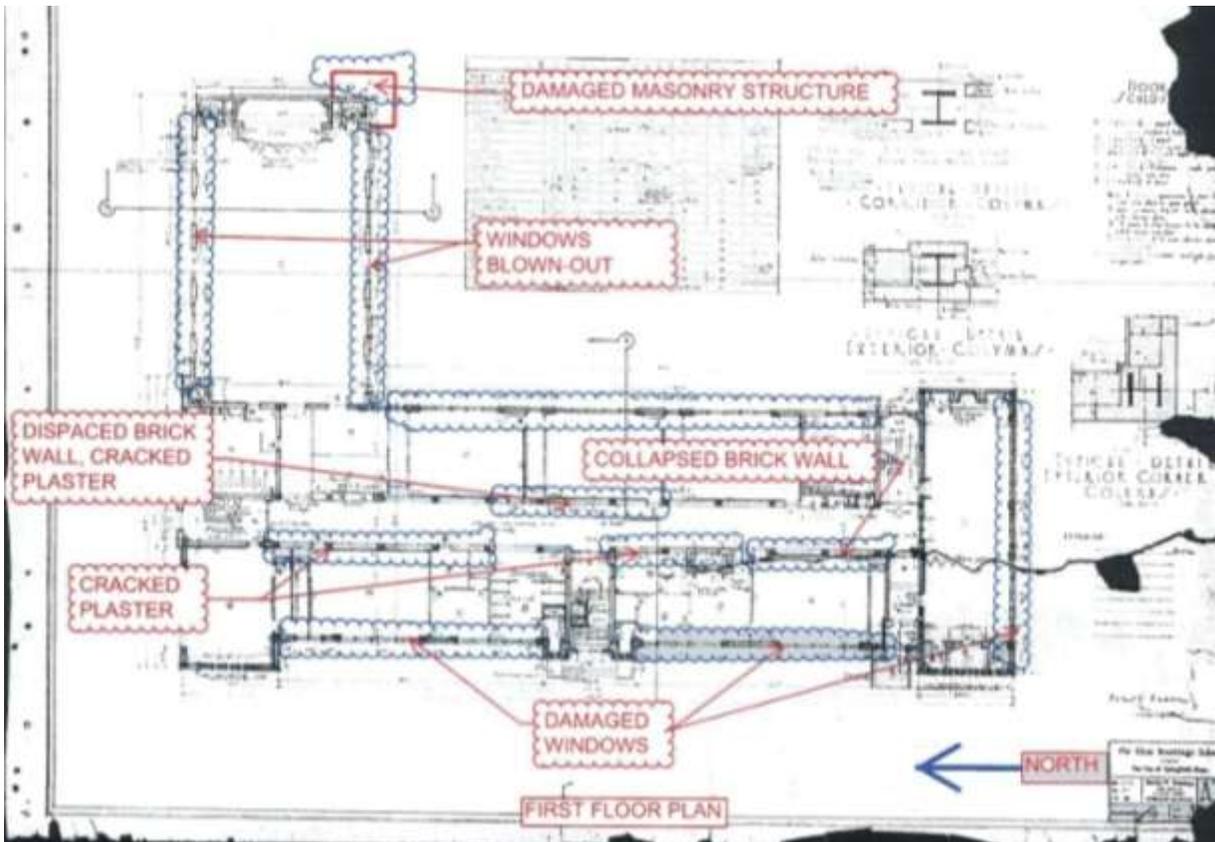
The primary damage to the interior is to the corridor walls which were displaced and in some locations, blown over. Portions of the brick walls had collapsed entirely on two floors along the southern end of the classroom corridor. In most all of the remaining East facing classrooms the interior plaster walls had cracked along a line at the top of the masonry corridor walls.

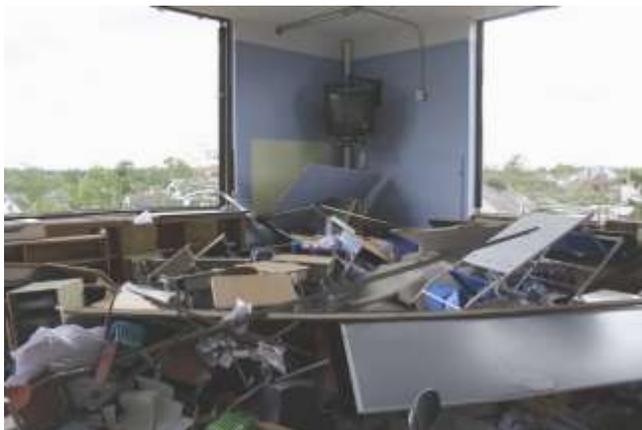
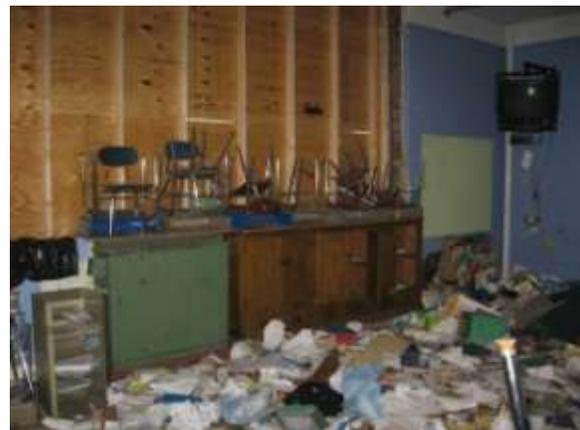
The large classroom at the southern end of the second floor suffered extensive interior damage as this was the classroom that had two corner windows entirely blown out.

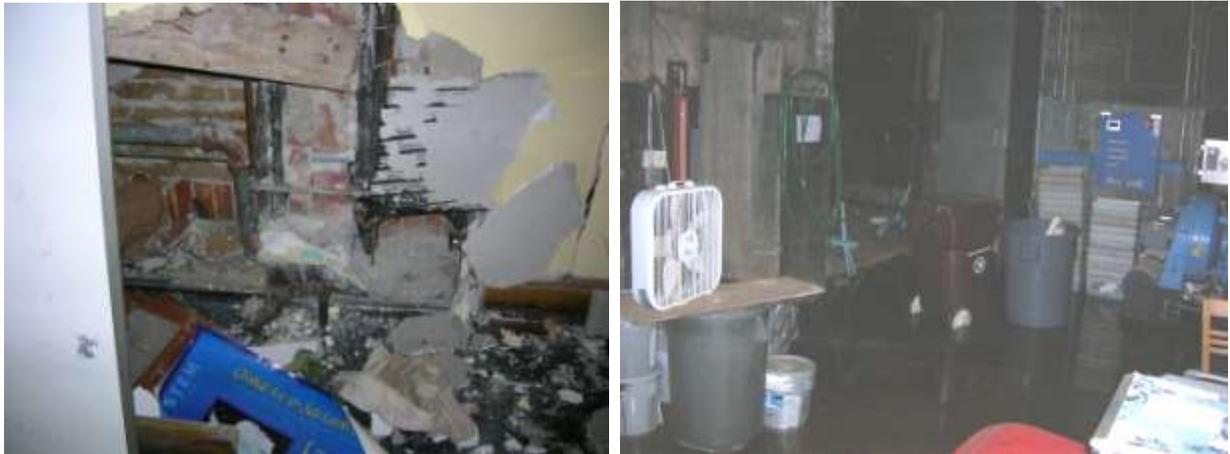
The Plumbing systems in the building seem to have suffered minor damages from the tornado. There may be some damage caused to systems that were part of the collapsed corridors, although no leaks were observed or sewer gas smells perceived. Some additional testing is required to confirm the integrity of these systems.

Since power was lost to the building during the storm, certain systems could not be observed to confirm their integrity. The loss of power did cause a failure of the basement sump pump which led to flooding of the basement; about 1"-2" of ground water was standing in the basement at the time of the professional team's visit.

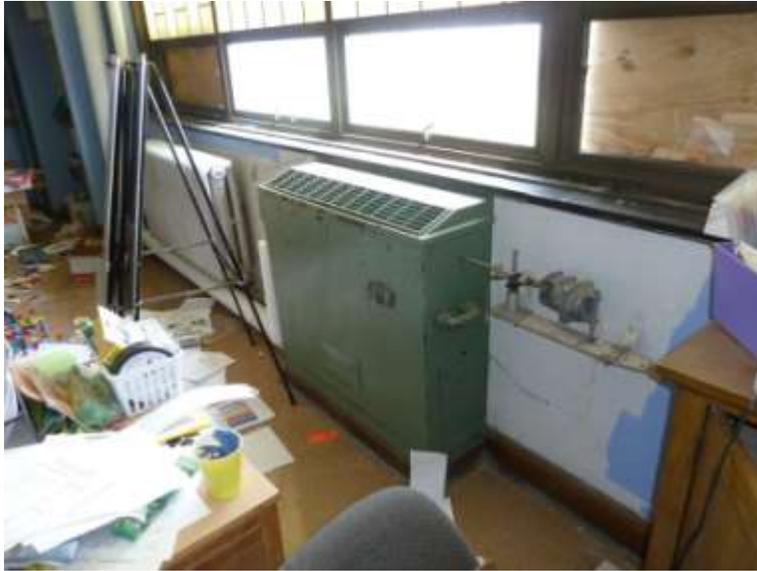
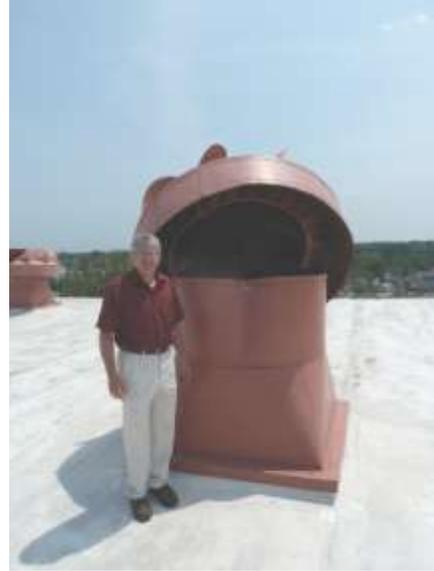
The existing steam radiator piping and pneumatic lines that serve unit ventilators may have been damaged by collapsed windows and corridor walls. Additional testing is needed to confirm the integrity of this system.

The rooftop ventilators, although re-installed, are damaged and probably not salvageable. Also rooftop condensing units appear to have been displaced and are probably damaged.

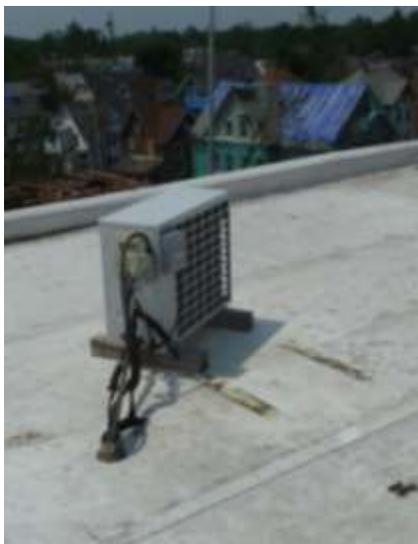
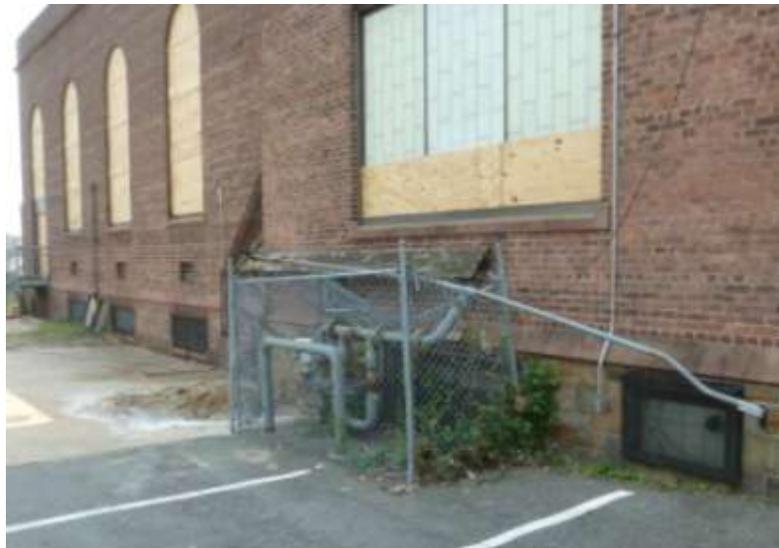
The storm damage left the power, lighting and fire alarm systems with what appears to be minimal damage. Some interior walls are buckled or settled resulting in exposed electrical systems in the respective walls. The extent of this damage requires further investigation or testing of the affected systems. Other damage extends to electrically-connected mechanical components that were forcefully dislodged or removed from the roof.
