### SPRINGFIELD SS4A

STATE ST & SCHOOL ST / SPRING ST

INTERSECTION NO. 1

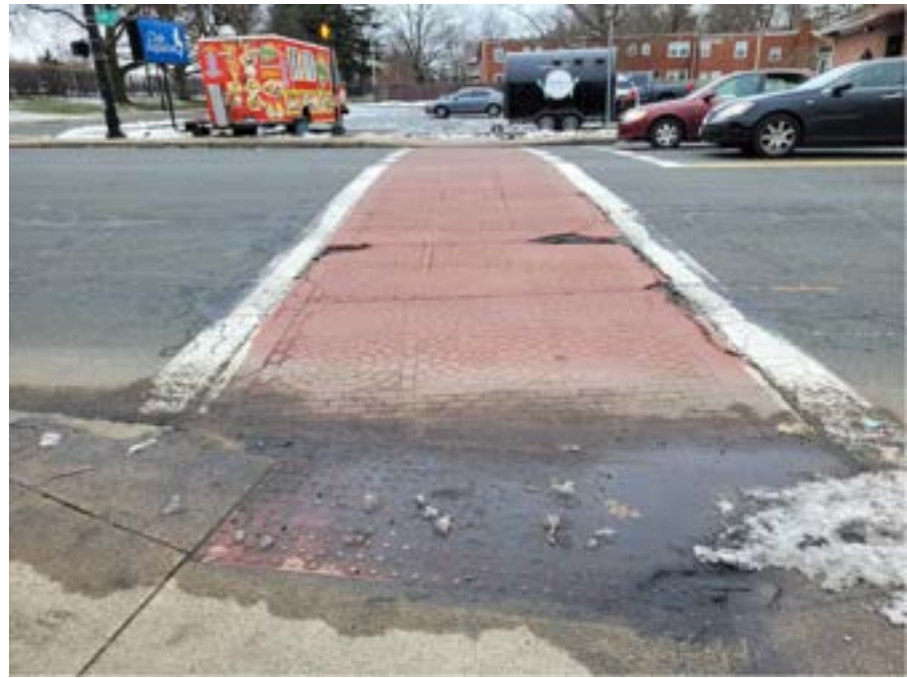
1 STATE STREET CROSSING

1. STATE STREET CROSSWALK (SW) IS FURTHER AWAY FROM INTERSECTION AND VEHICLES PULL BEYOND CROSSWALK.
2. NO BIKE LANES ARE PRESENT, BICYCLISTS SHARE THE ROAD. SIGNS ARE PRESENT FOR SIGNAL REQUESTS.

1. MOVE STATE STREET CROSSWALK CLOSER TO INTERSECTION
2. ADD DIAGONAL CROSSING PAVEMENT MARKINGS
3. INSTALL APS PUSHBUTTONS AT ALL CORNERS, RELOCATE WHERE REQUIRED
4. ADD "NO TURN ON RED" RESTRICTIONS AS NEEDED
5. REDUCE CYCLE LENGTHS ON STATE STREET, WITH MORE FREQUENT PEDESTRIAN CYCLES
6. CONSIDER ADDITION OF BUS SHELTER AT STOPS ON STATE STREET

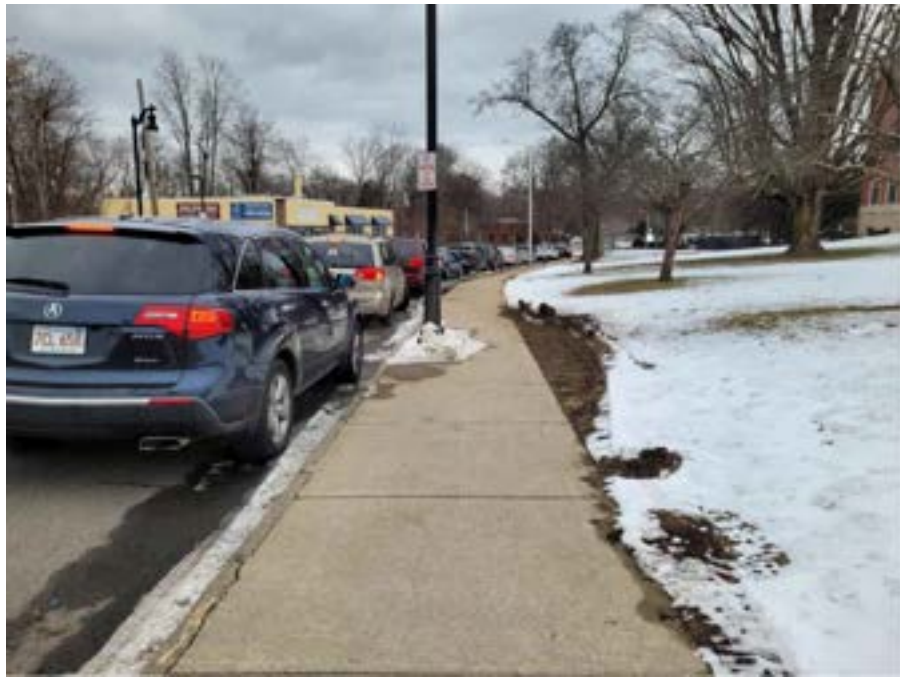
2 GAUCHER STREET SIDEWALK

12. DURING SCHOOL DISMISSAL, PARENTS PARK ON BOTH SIDES OF GAUCHER STREET, LIMITING VISIBILITY OF STUDENTS CROSSING

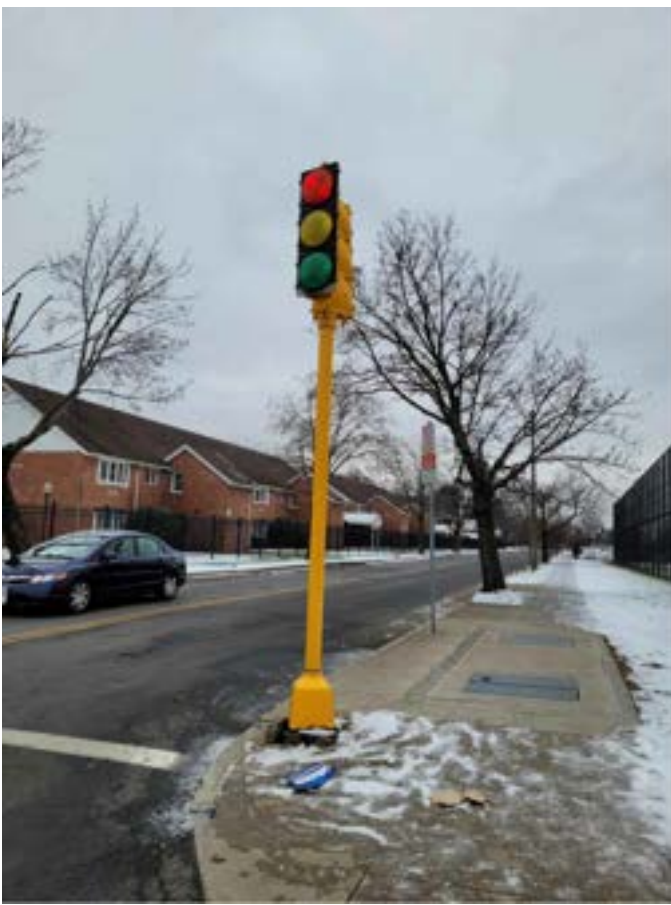
1 UNION STREET TRAFFIC SIGNAL

- 9. SIGNAL EQUIPMENT IS OUTDATED. MISSING SIGNAL VISORS.
- 10. CONTRADICTORY PARKING SIGNS EXIST ON UNION STREET.
- 11. BUS STOPS WERE OBSERVED ON WALNUT STREET.

- 1. POTENTIAL CONVERSION TO ALL-WAY STOP INTERSECTION
- 2. INCREASE CURB RADIUS
- 3. INSTALL INTERSECTION LIGHTING
- 4. IF SIGNAL REMAINS - UPDATE SIGNAL EQUIPMENT AND ADD EXCLUSIVE PEDESTRIAN PHASE

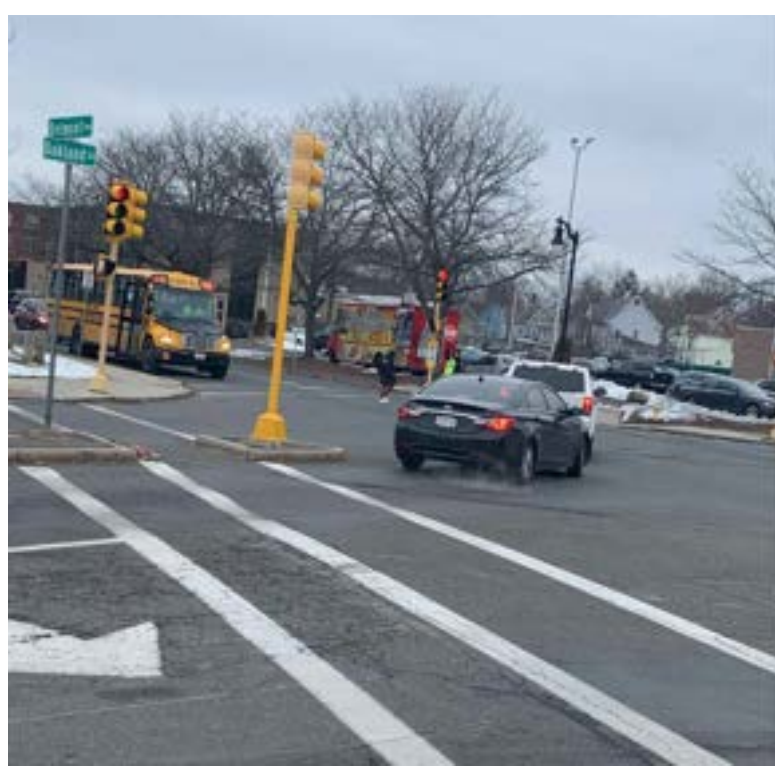
2 INTERSECTION BUS STOP [SEE NOTE 15]

- 3. CROSSWALKS ARE FADED AND SKEWED, INCREASING CROSSING LENGTHS.
- 4. SIDEWALK LEADING TO THE EXISTING BUS STOP IS BROKEN, OF INCONSISTENT MATERIAL, AND NON-COMPLIANT.

- 1. TIGHTEN CORNER RADII AND ADD CURB EXTENSION, REDUCING CROSSING DISTANCES
- 2. NARROW EXISTING LANES AND REMOVE RIGHT-TURN LANE
- 3. INSTALL BUS PULL-OFF AREAS
- 4. INSTALL HIGH-VIS CROSSWALKS AND ADA RAMPS
- 5. INSTALL NEW EQUIPMENT WITH RETROREFLECTIVE BACKPLATES AND PEDESTRIAN COUNTDOWN TIMERS

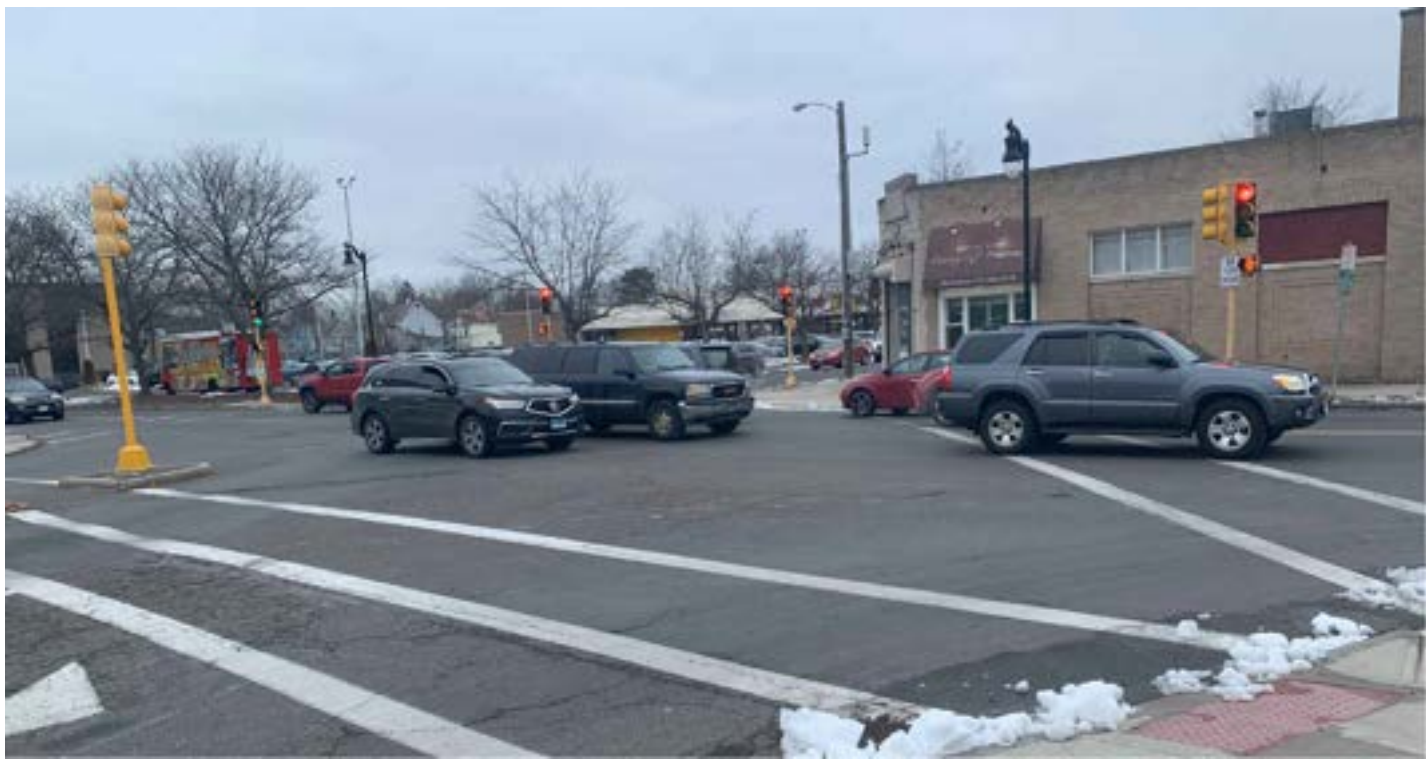
3 BELMONT AVENUE VEHICLE PASSING

- 5. THERE ARE NO BICYCLE ACCOMMODATIONS.
- 6. BELMONT AVENUE HAS LIMITED VISIBILITY DUE TO BUILDING IN NE CORNER.
- 7. THROUGH MOVEMENT VEHICLES WERE OBSERVED TO GO AROUND THOSE WAITING TO MAKE A LEFT TURN, THOUGH THERE IS ONLY ONE LANE.

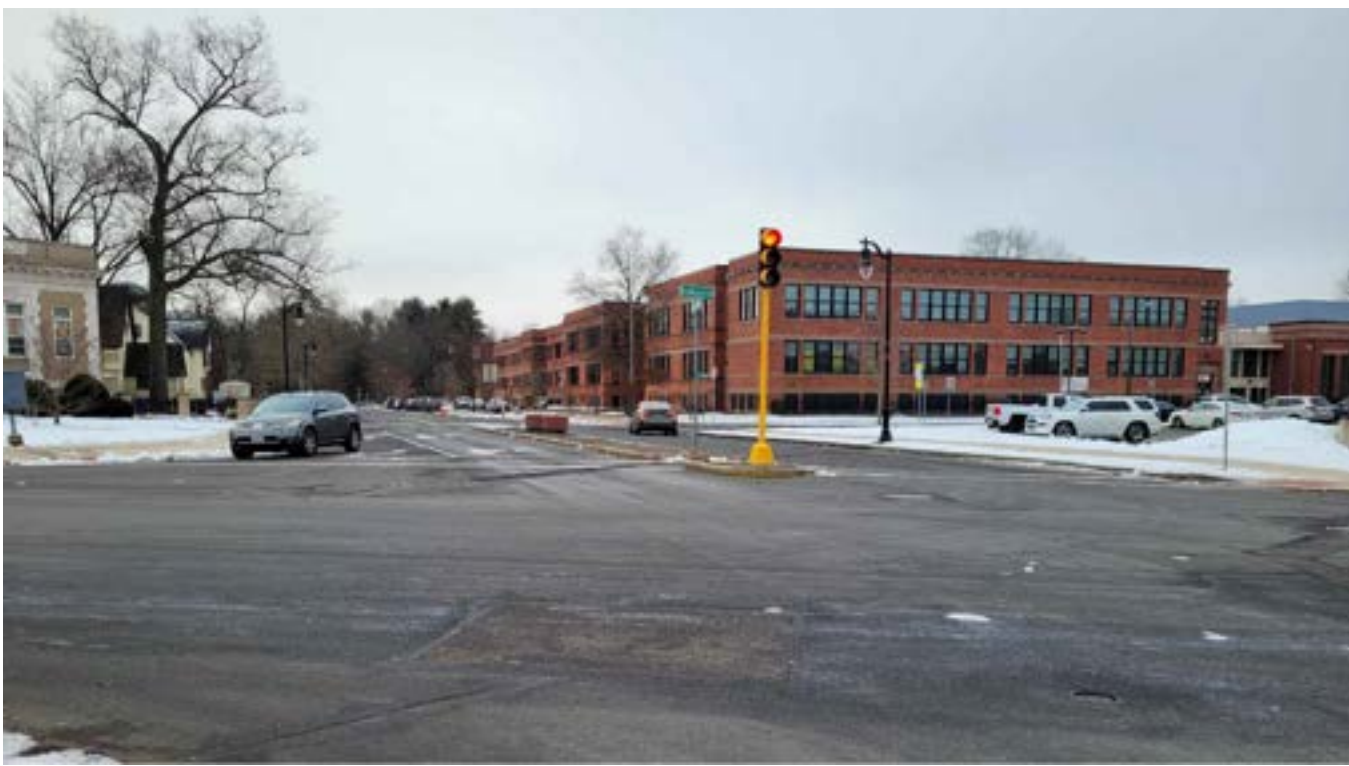
4 OAKLAND STREET REFUGE ISLAND [SEE NOTE 3]

- 1. THERE IS A DEDICATED PEDESTRIAN PHASE, BUT NO COUNTDOWN TIMERS.
- 2. THERE IS A MEDIAN ON OAKLAND STREET, BUT THE REFUGE ISLAND IS NOT ADA COMPLIANT, AND THERE IS NO PUSH BUTTON ON THE REFUGE ISLAND.

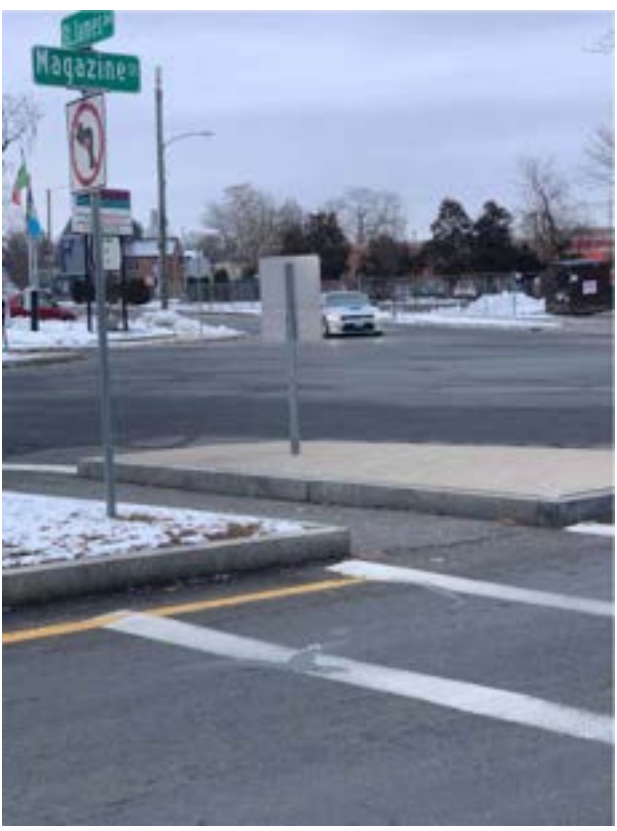
2 MAGAZINE STREET REFUGE ISLAND

- 1. PEDESTRIANS CROSS ST JAMES AVE, THOUGH NO PEDESTRIAN CROSSWALKS EXIST. THE NEAREST CROSSING IS AT STATE STREET.
- 2. THE SIGN ON THE MAGAZINE STREET MEDIAN LIMITS VISIBILITY OF VEHICLES APPROACHING FROM BAY STREET.
