Witman Properties Inc

121 Main St, Holyoke Ma 01040

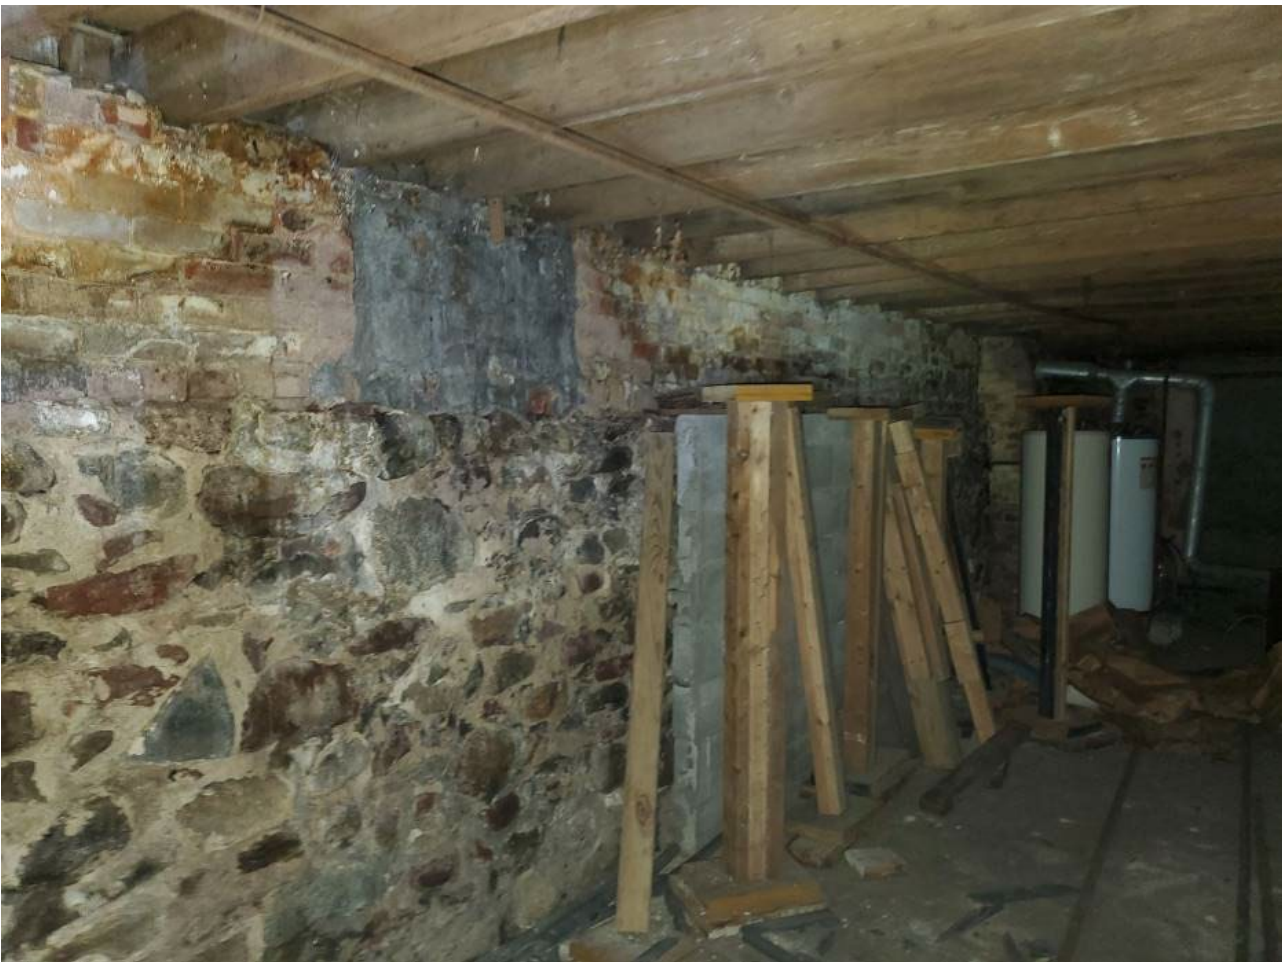
This photo shows fieldstone foundation with brick on top. An earlier repair can also be seen where cement blocks were added for additional support.

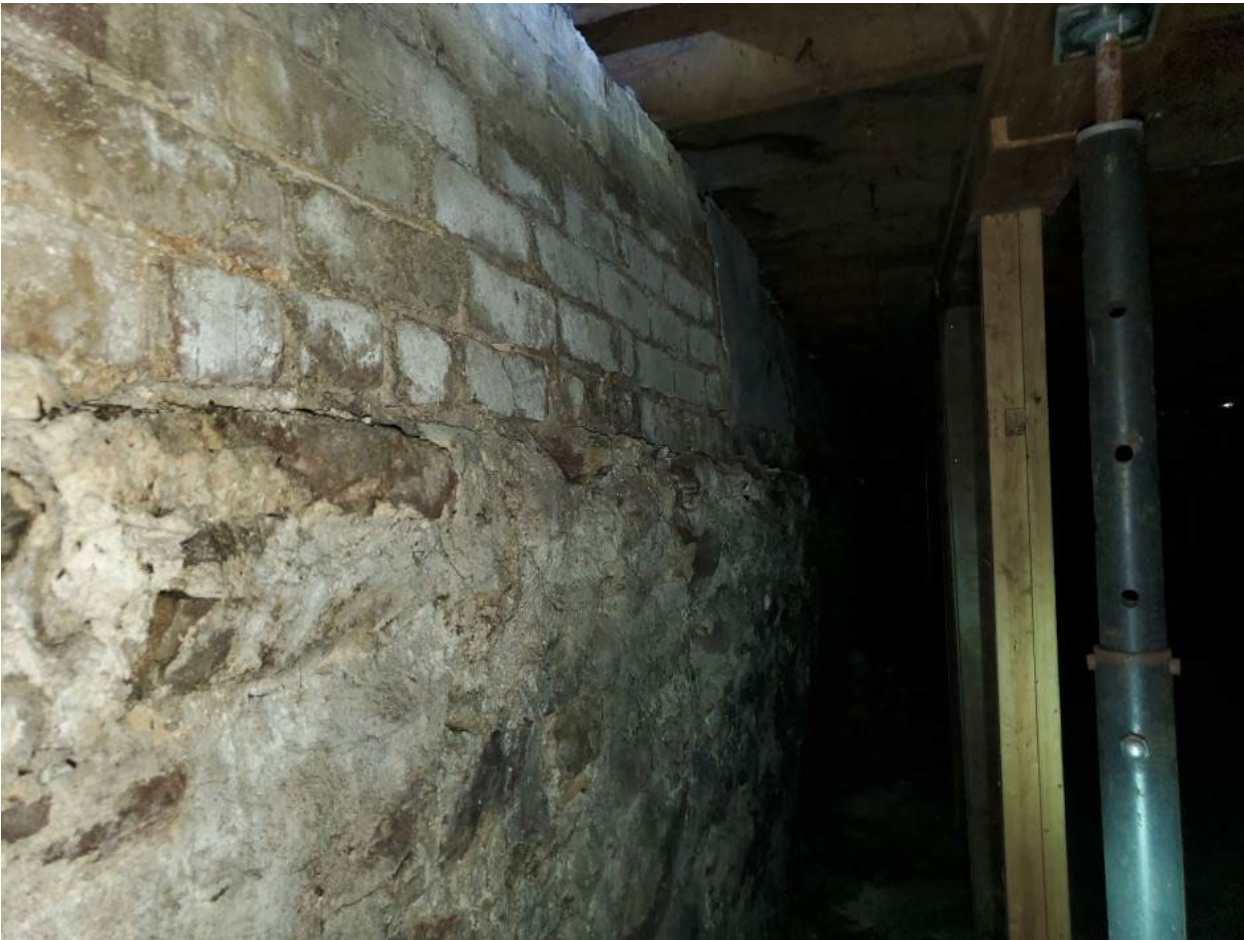
This photo shows the side of the foundation along the driveway that is bowing into the basement.

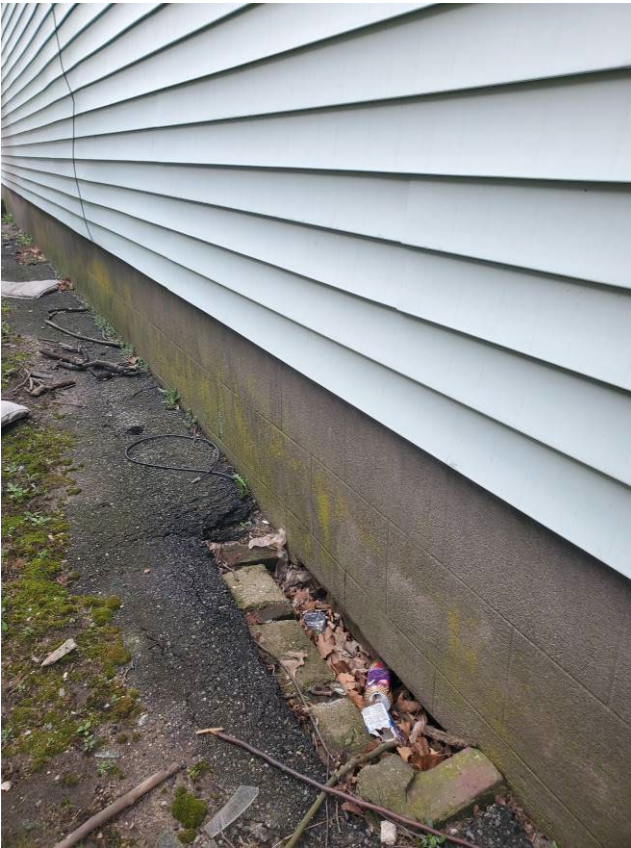
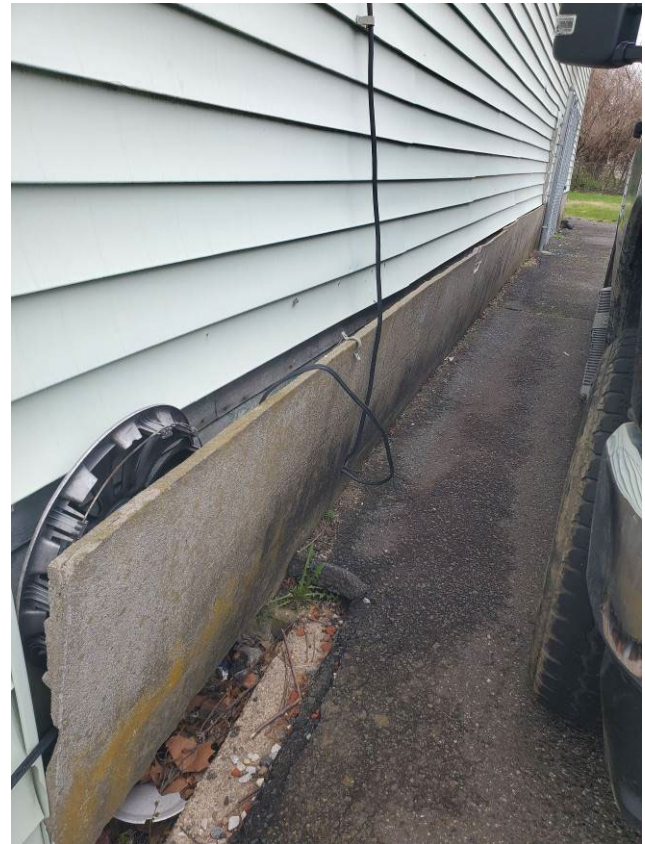
These two photos show the lower masonry façade which is installed over the original clapboard siding.

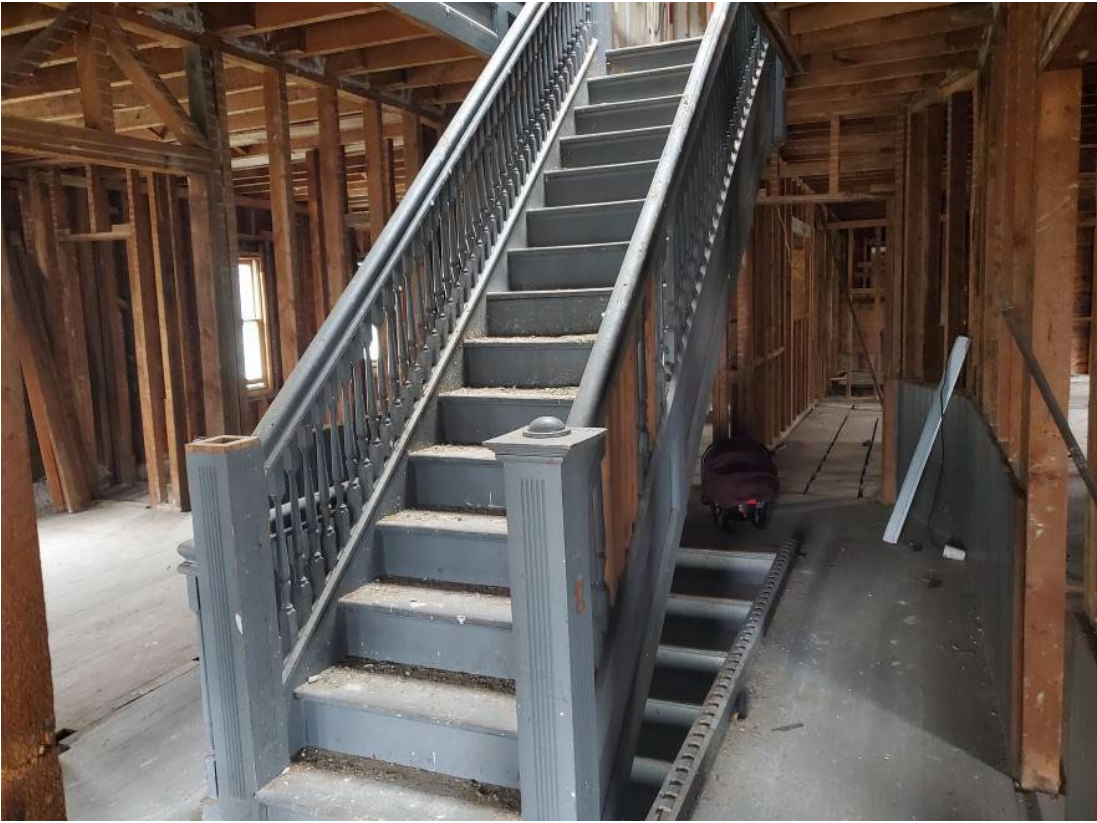
Central staircase from 2nd to 3rd floors.

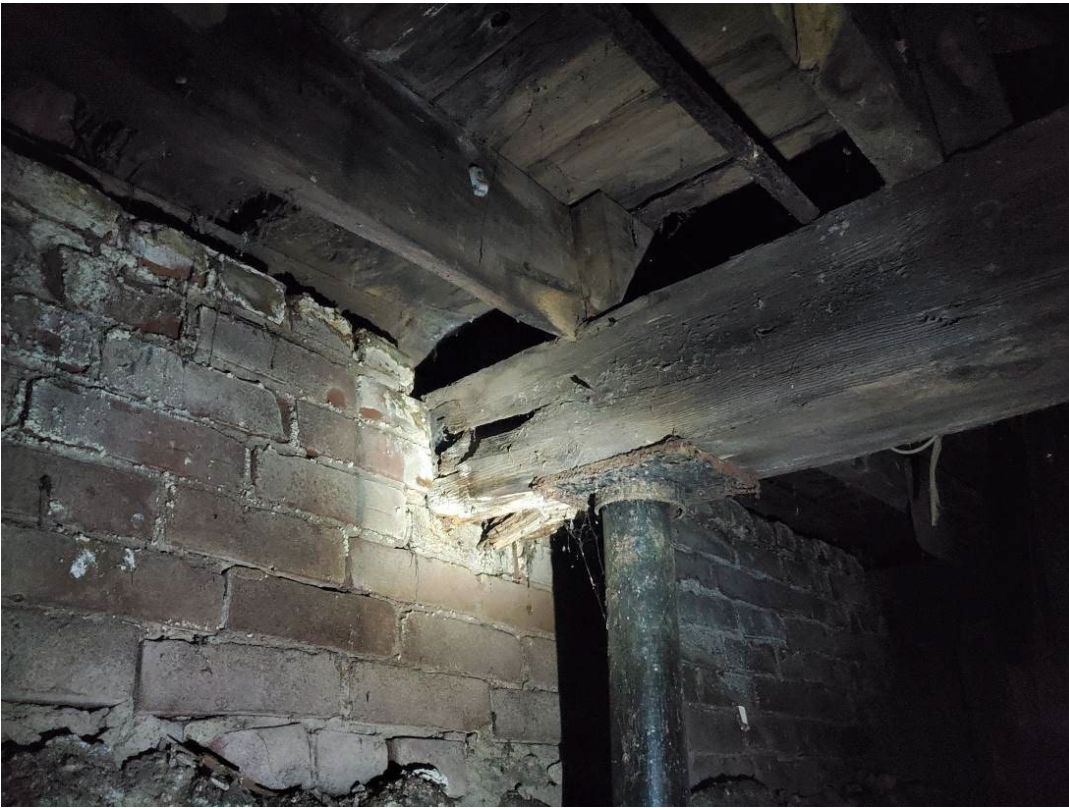
Example of deterioration in wooden structural members where they are in contact with masonry surfaces.

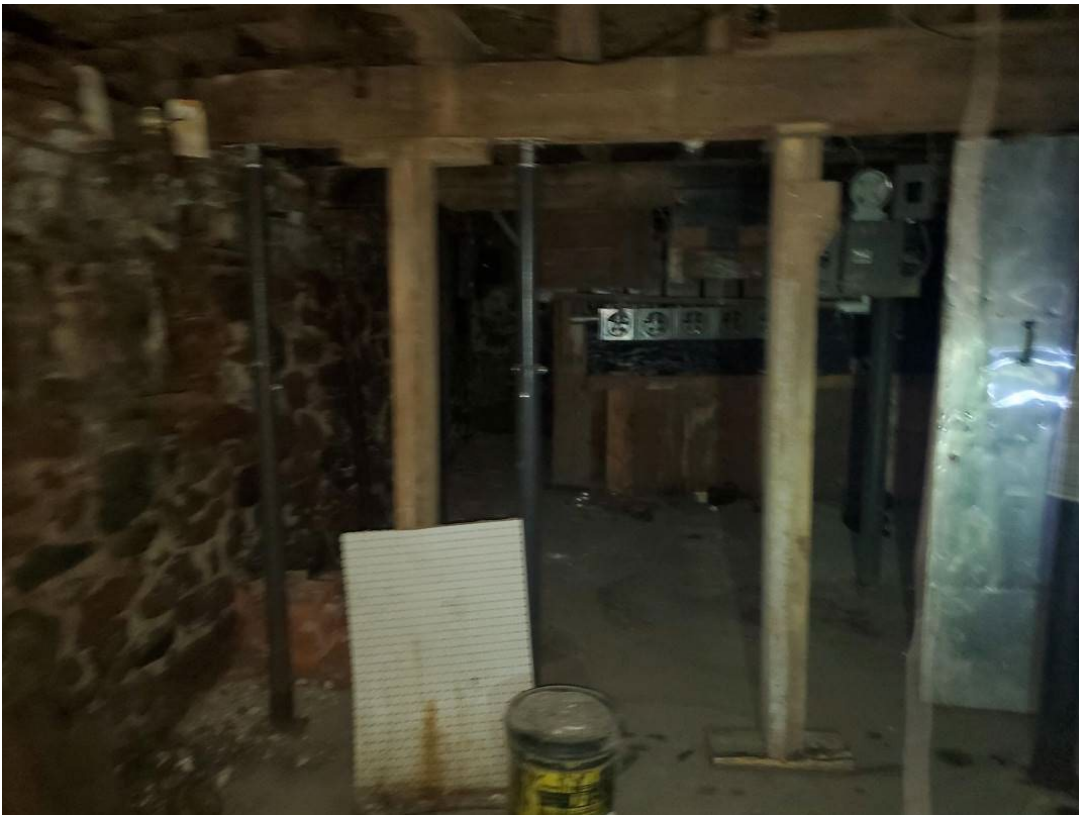
Example of temporary and wooden supports being used as opposed to cement filled steel columns.

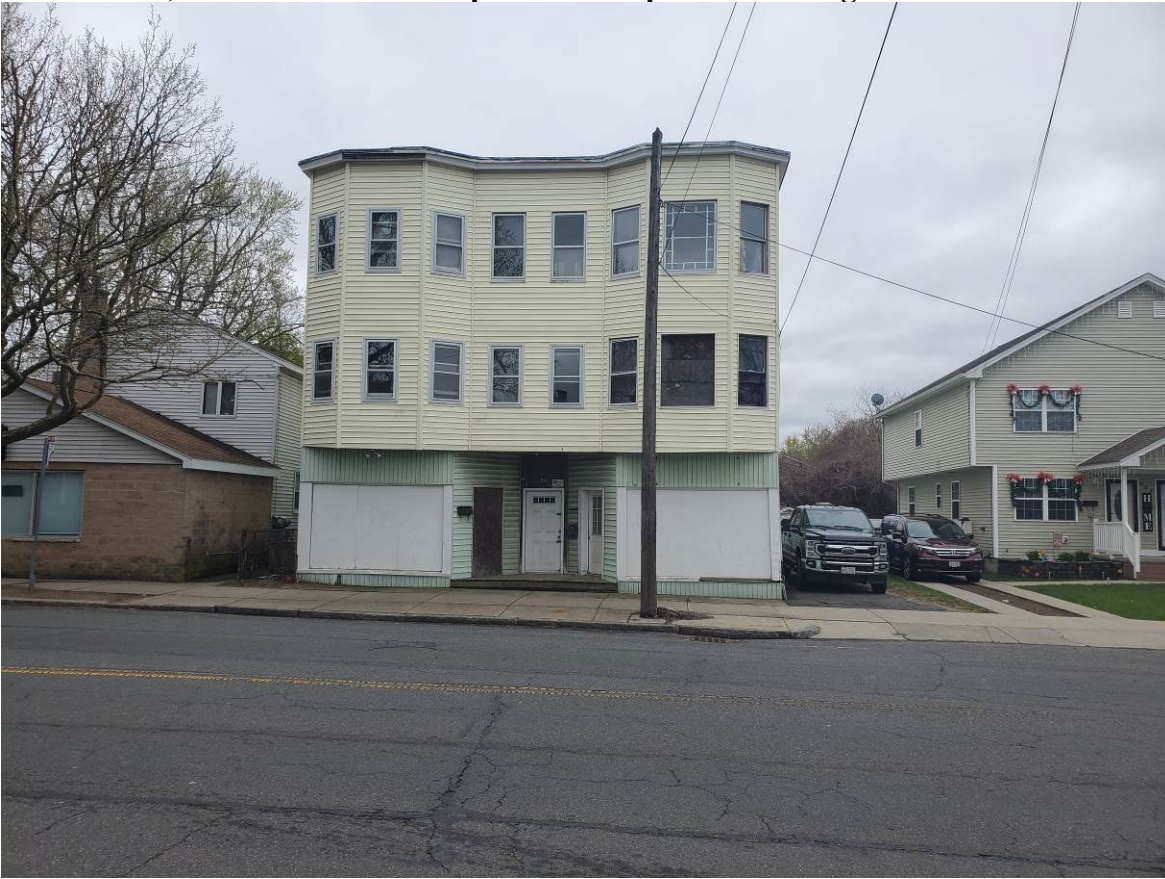
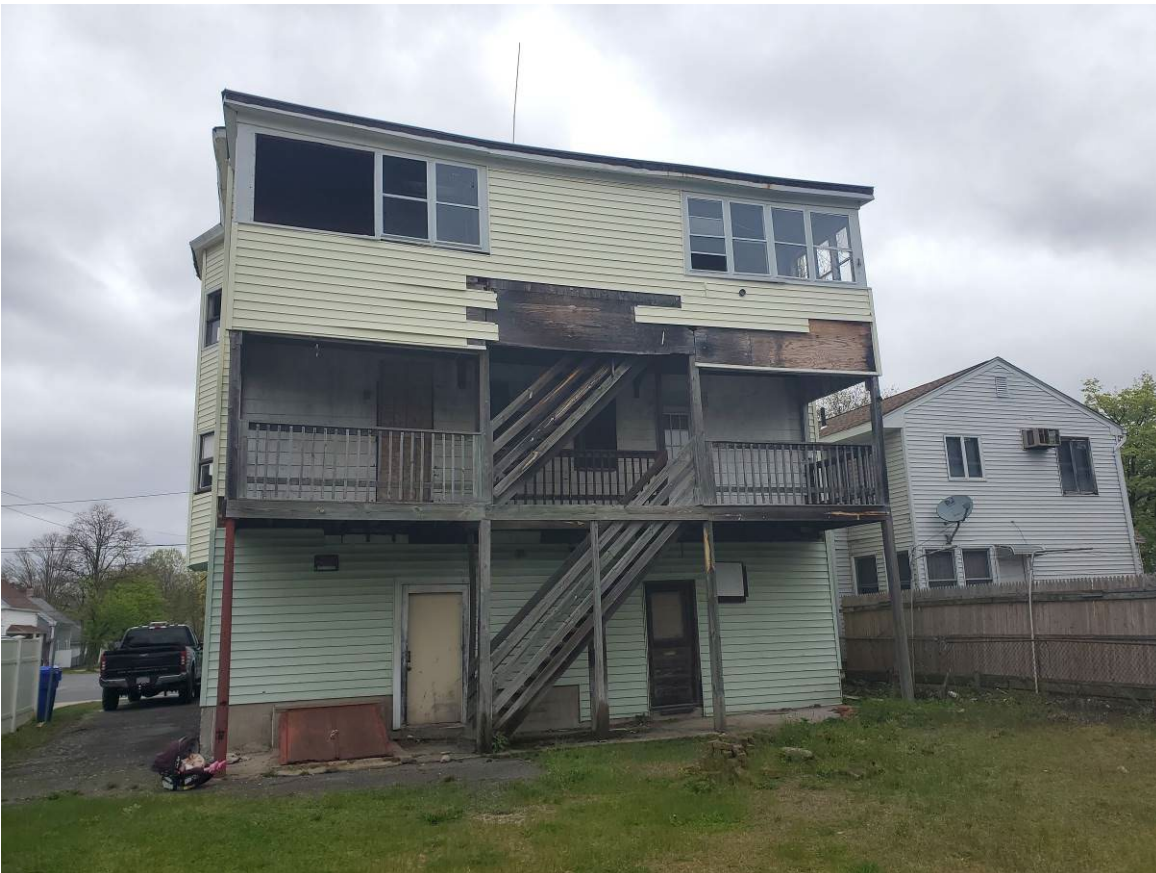
241 Main St, Indian Orchard – Representative photos showing close-up of siding.

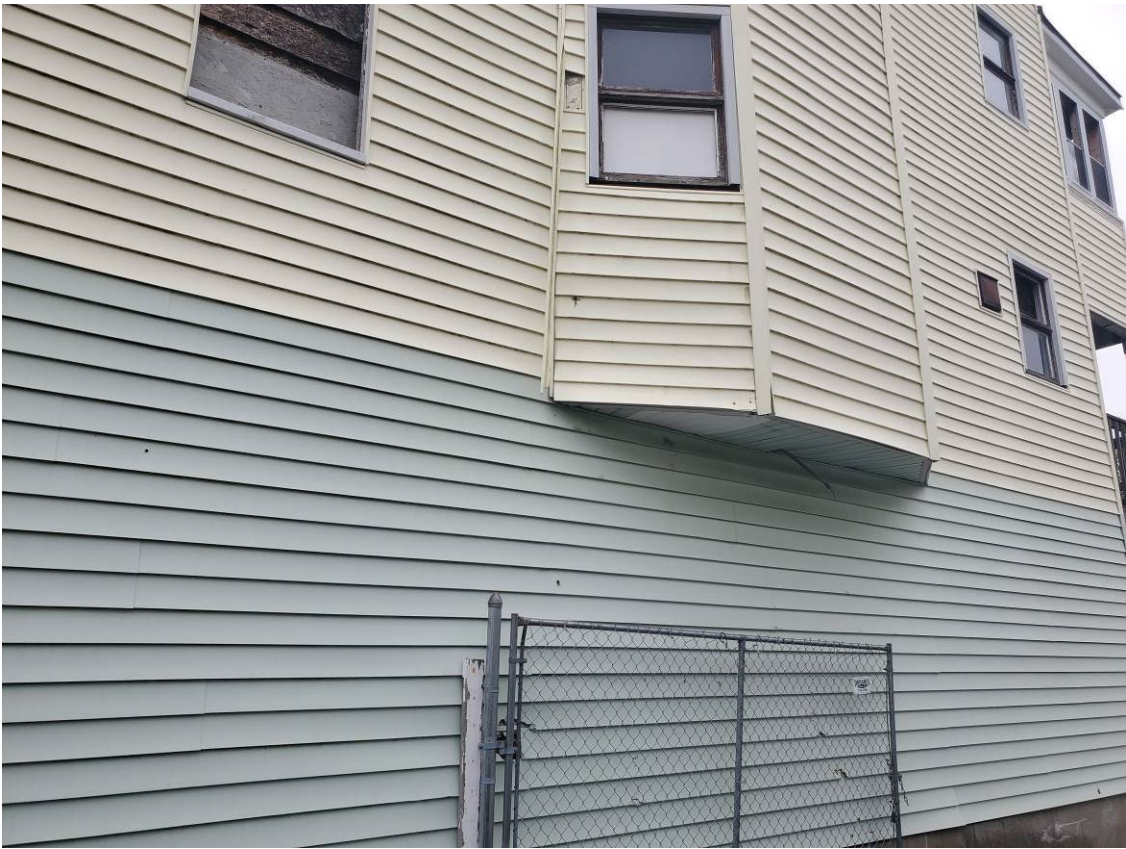
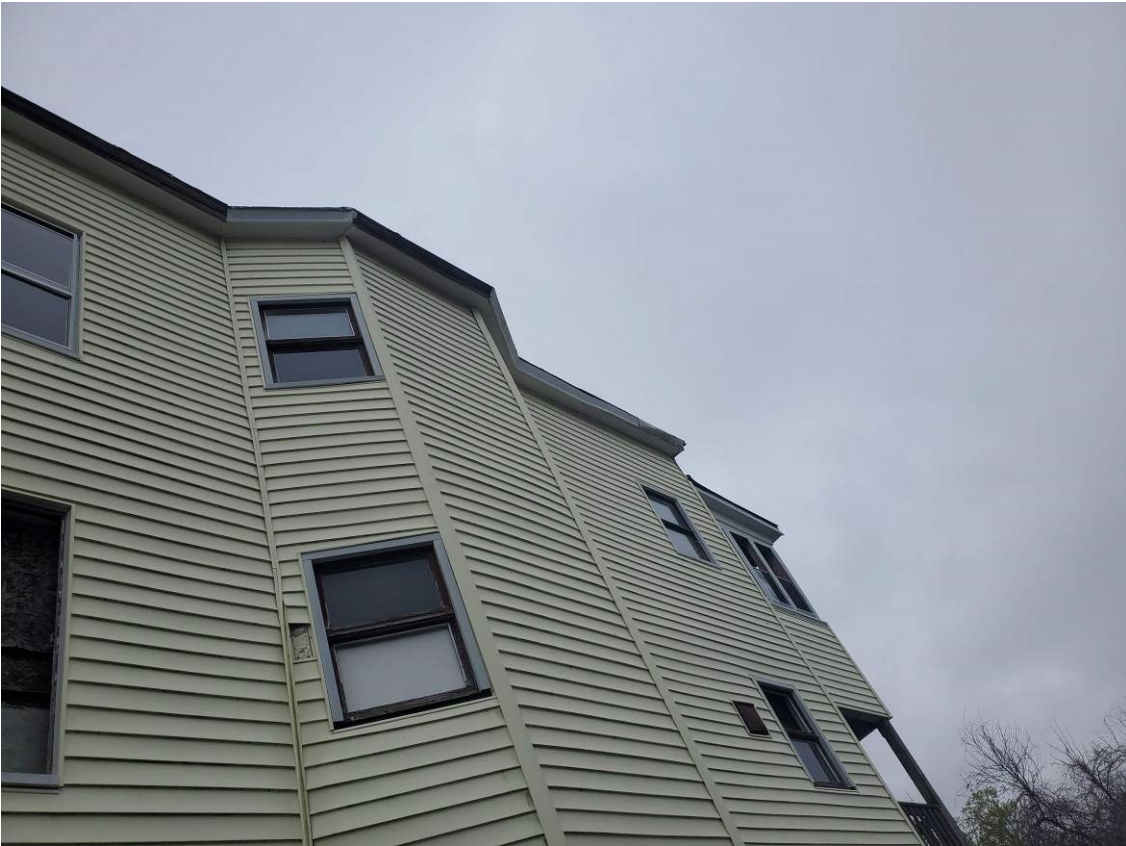
241 Main St, Indian Orchard – Representative photos showing the condition of the rear porch & stair.

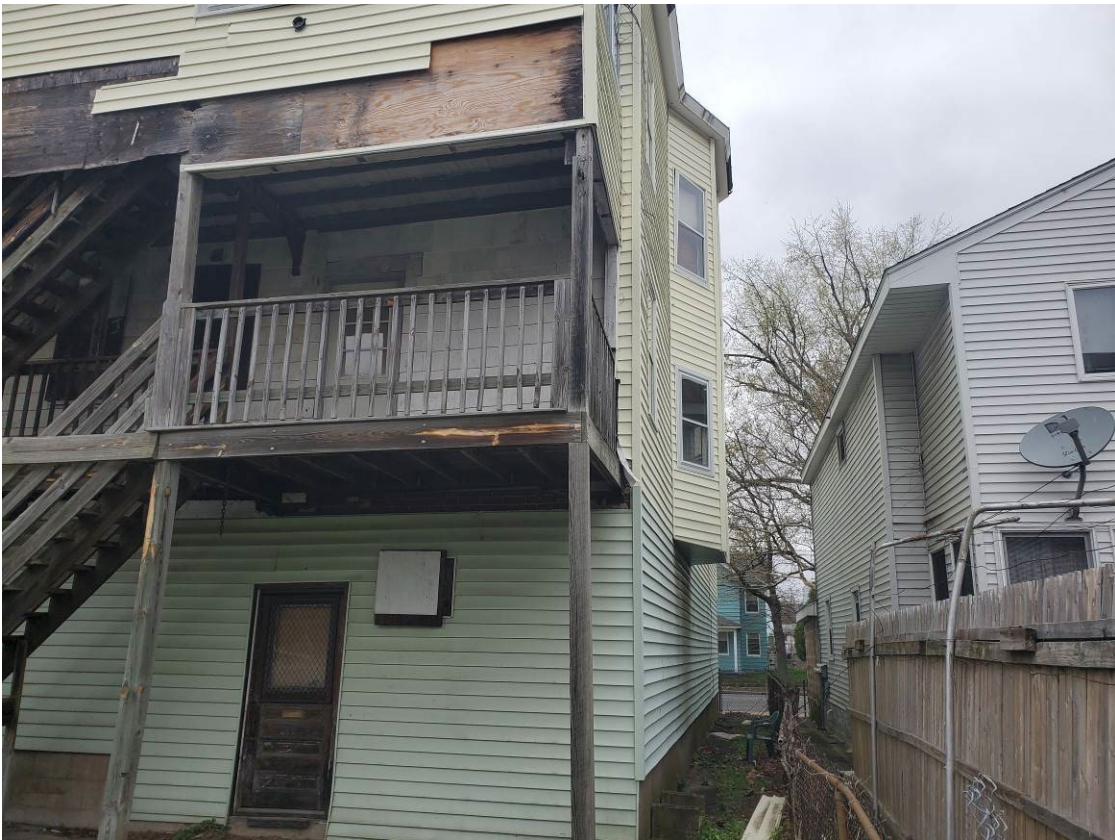
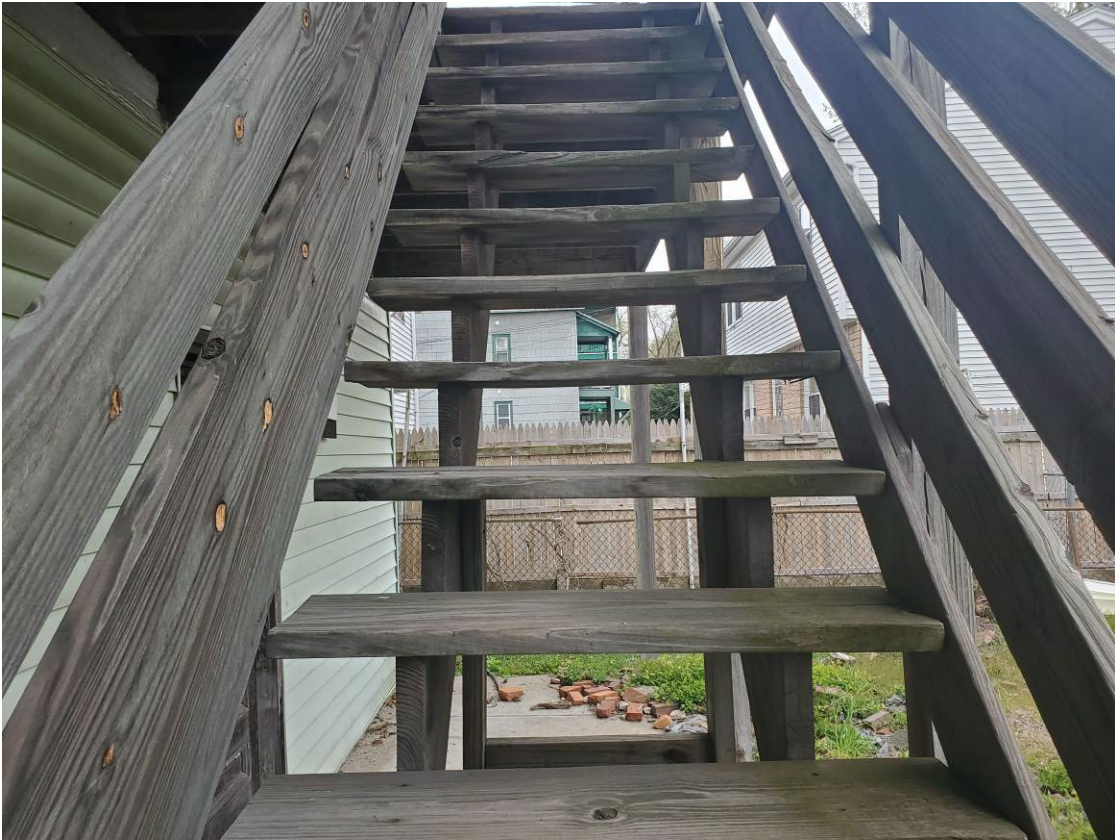
241 Main St, Indian Orchard – Photos showing the open hatchway from the 3rd floor to the roof (top) and the rot that has been caused below (bottom).

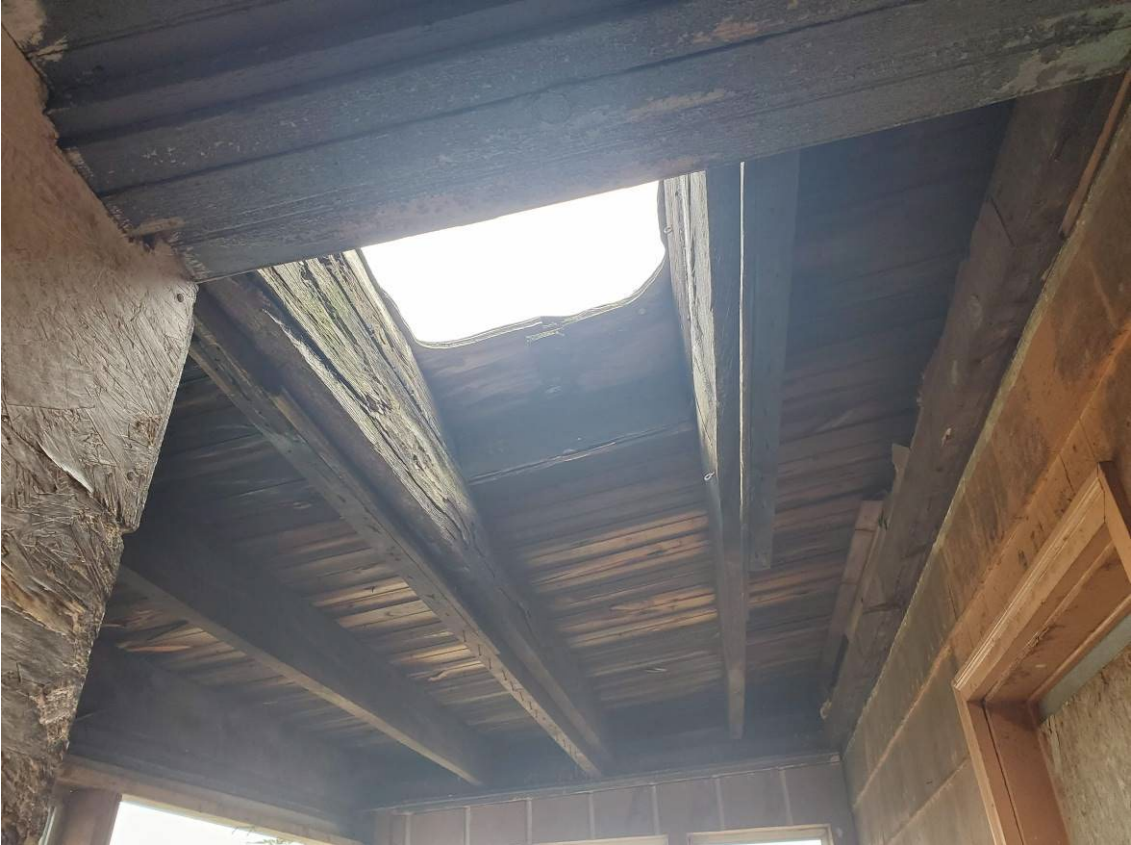
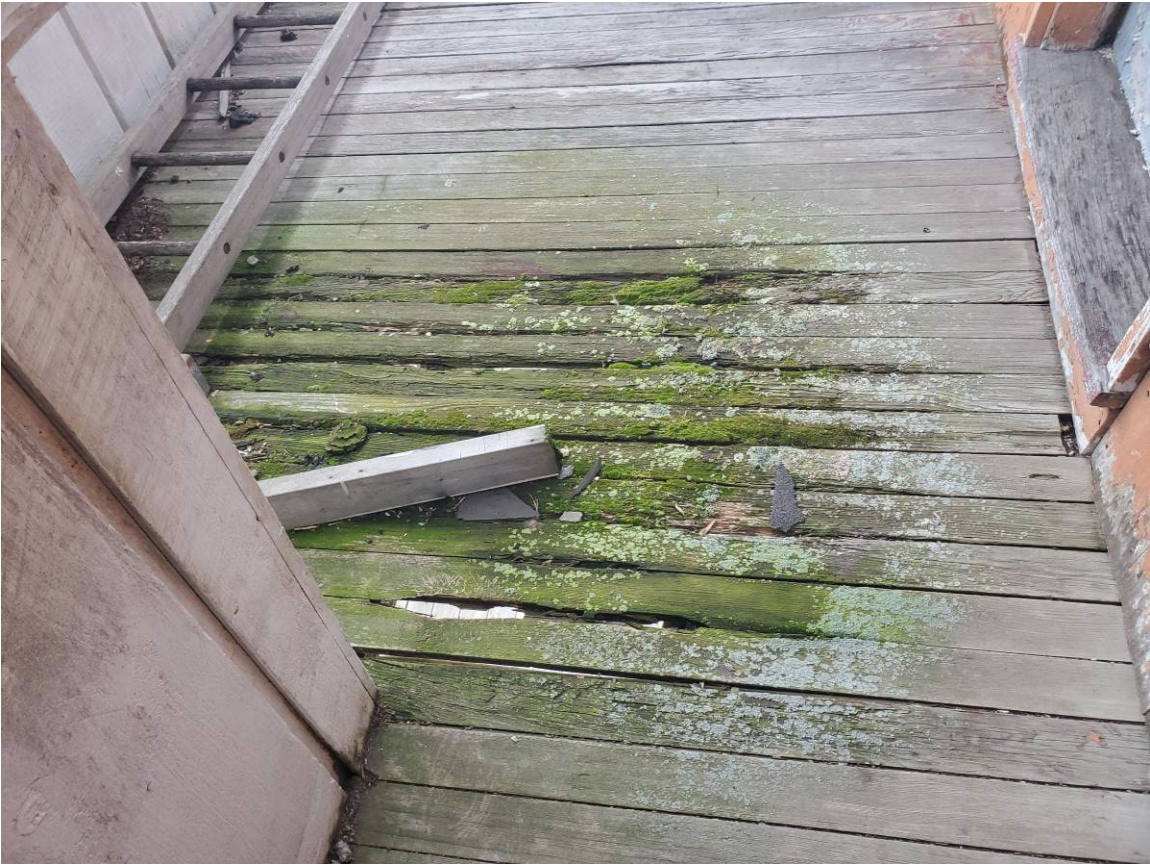
241 Main St, Indian Orchard – Representative photos showing the general condition and varying types of construction used on the rear porch.

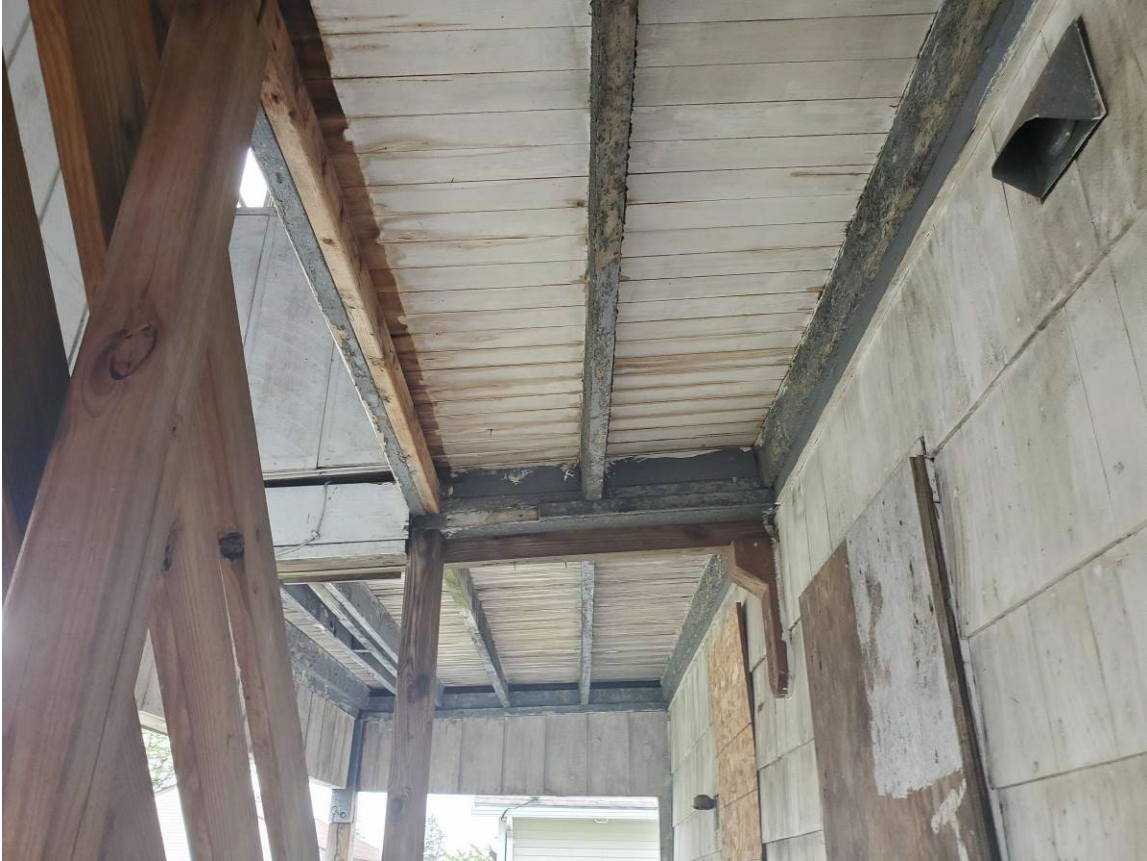
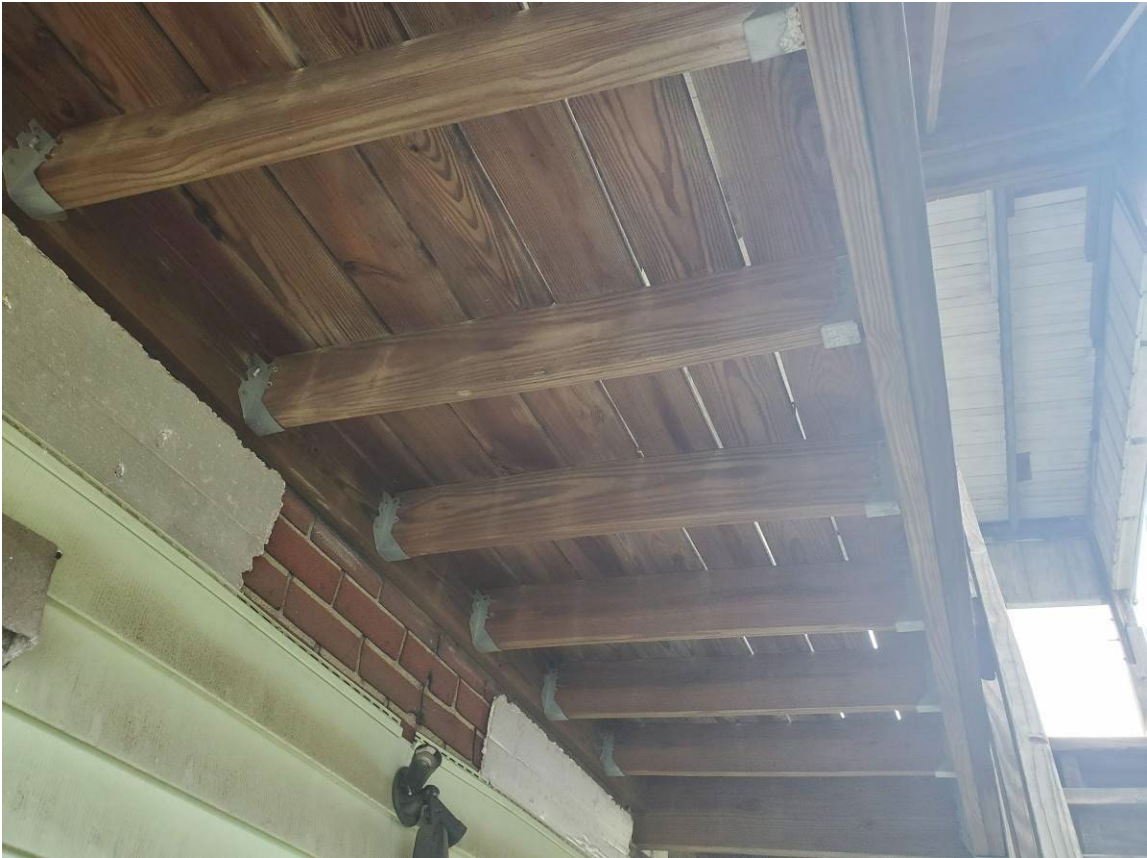
241 Main St, Indian Orchard – Representative photos showing conditions in the 2nd floor left unit of the building.

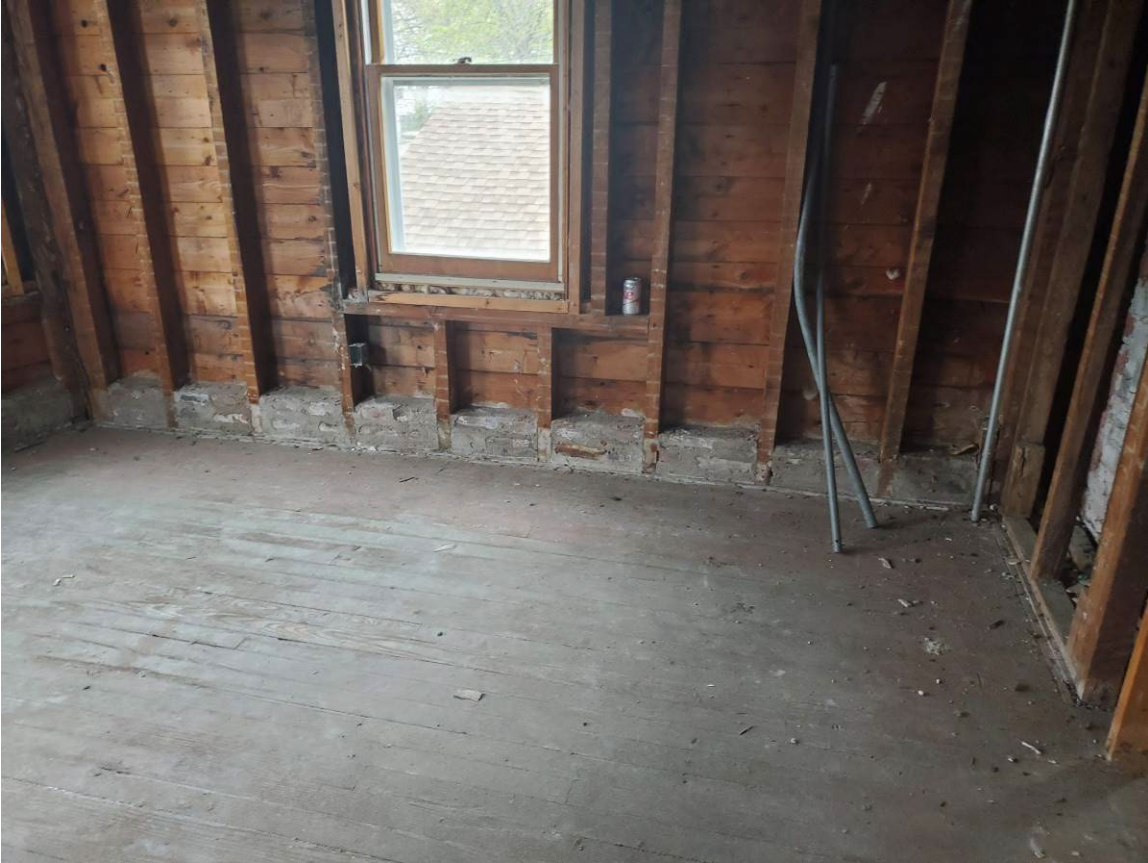
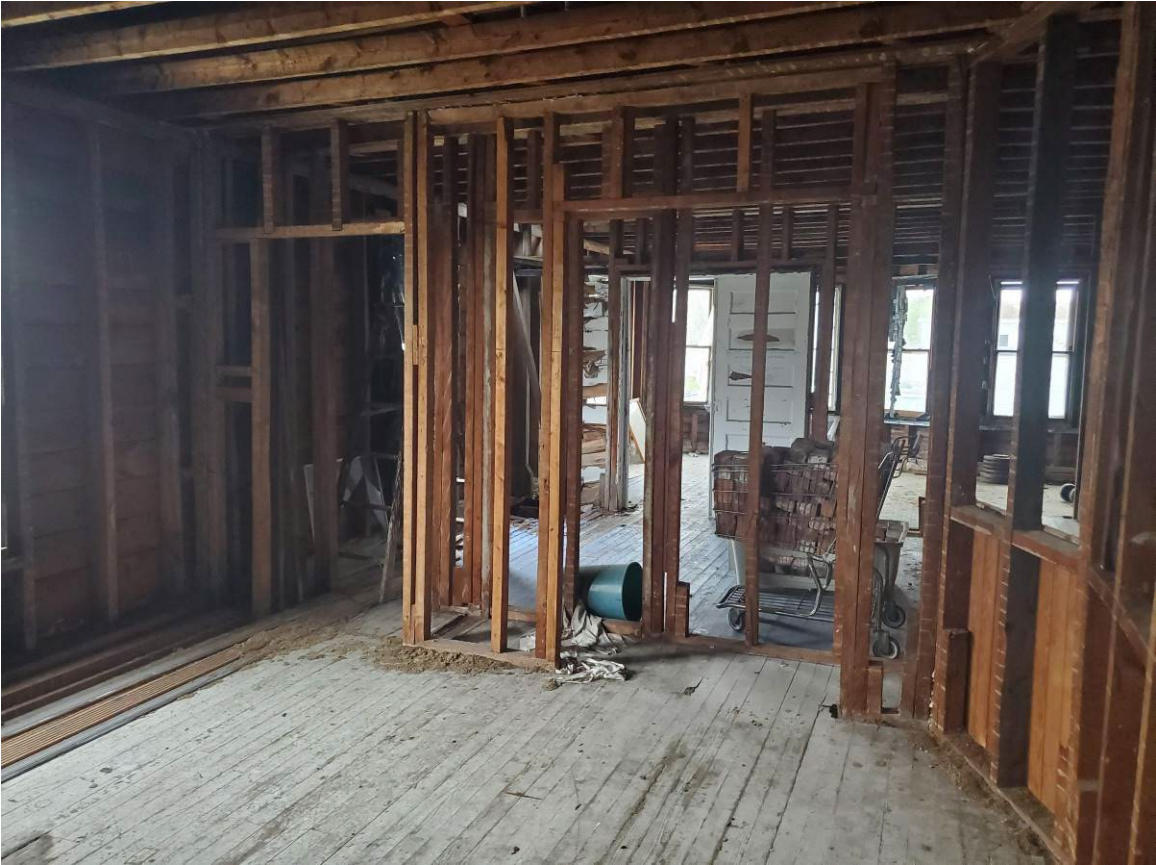
241 Main St, Indian Orchard – Representative photos showing the localized damage from the open chimney hole thorough the roof (top), and characteristic conditions found throughout the upstairs units (bottom).

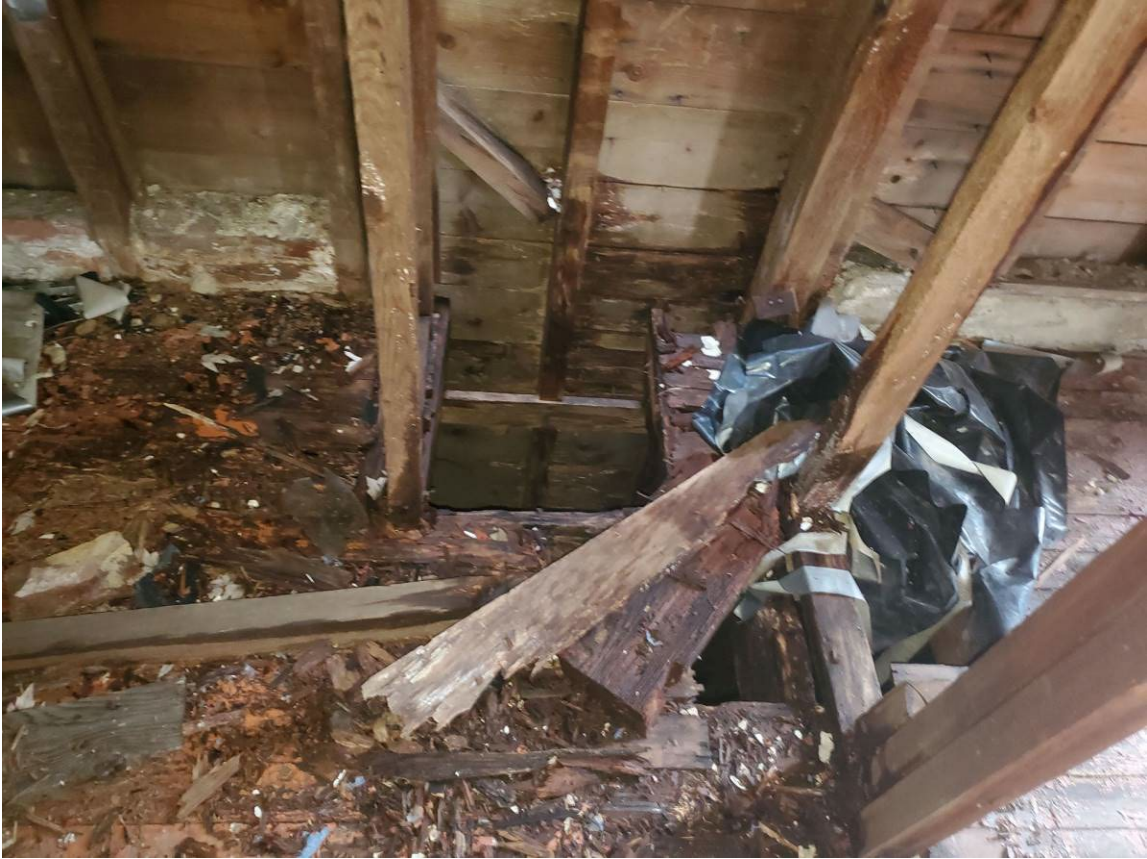
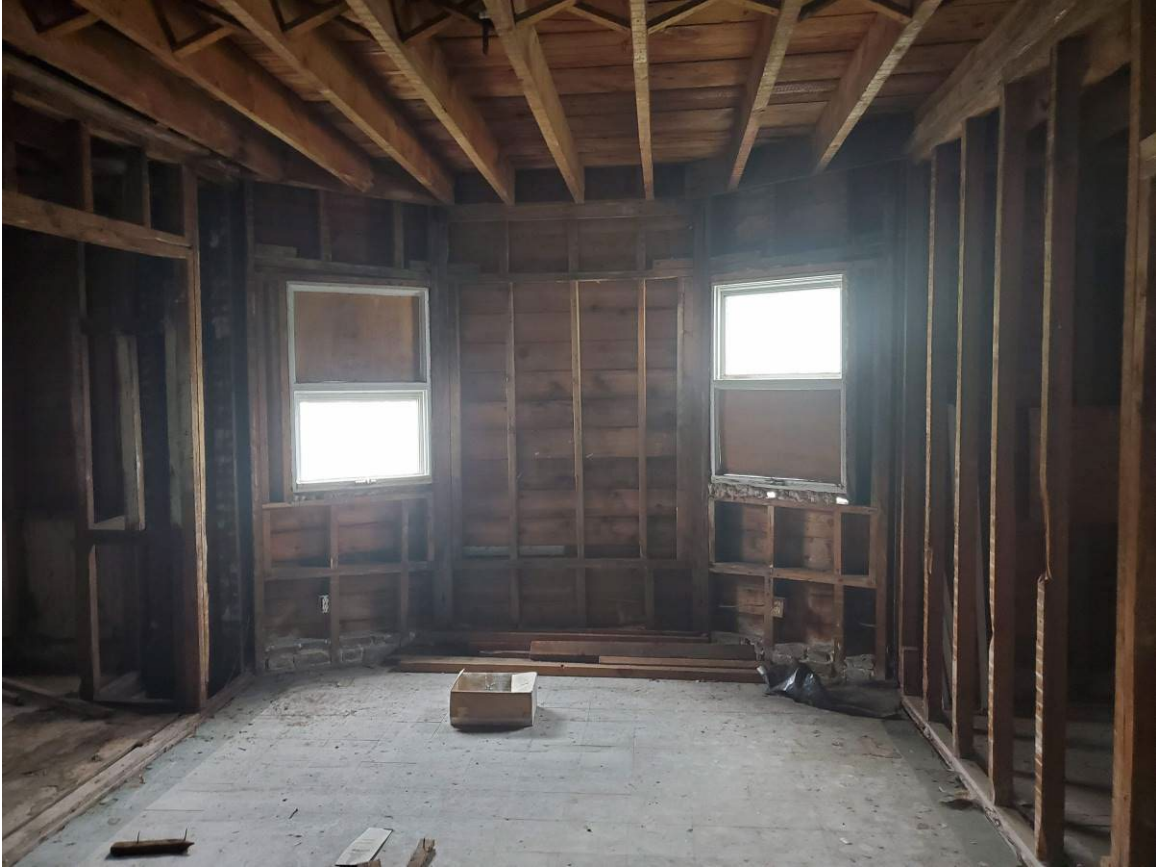
241 Main St, Indian Orchard – Representative photos of Unit 4L which is still in it's original condition. This is the only unit in the building that is not fully gutted.

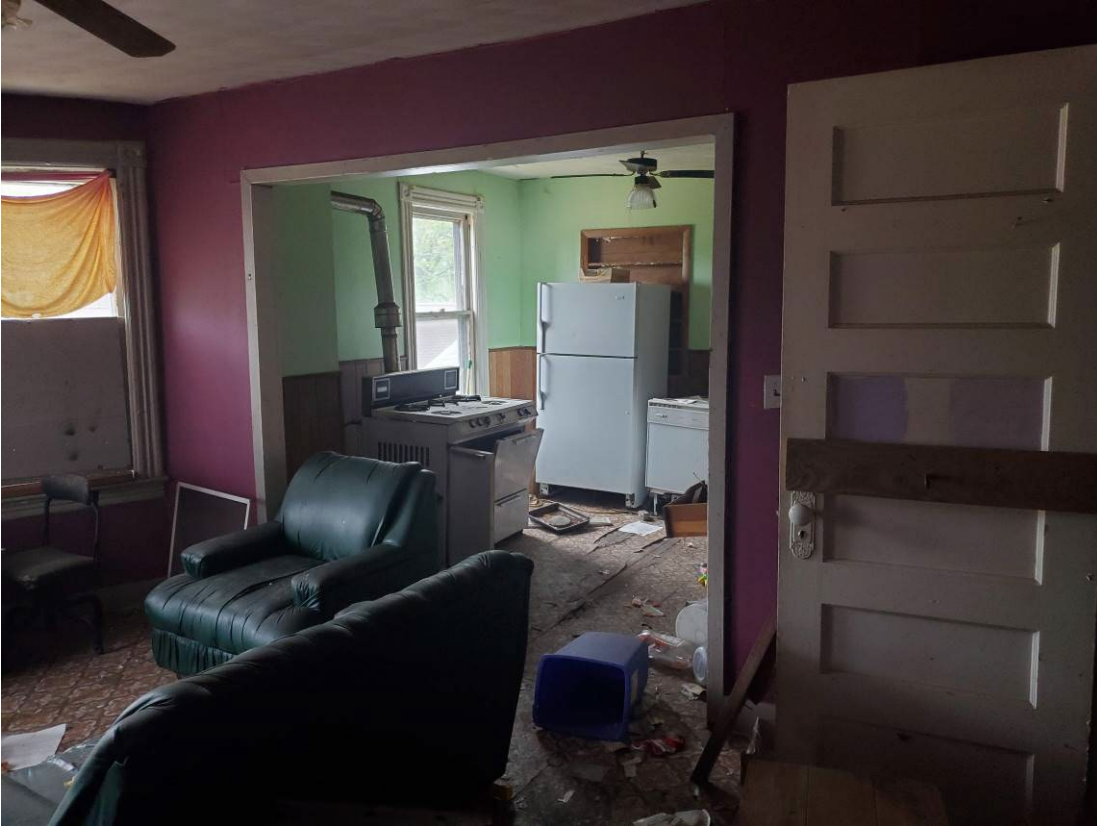
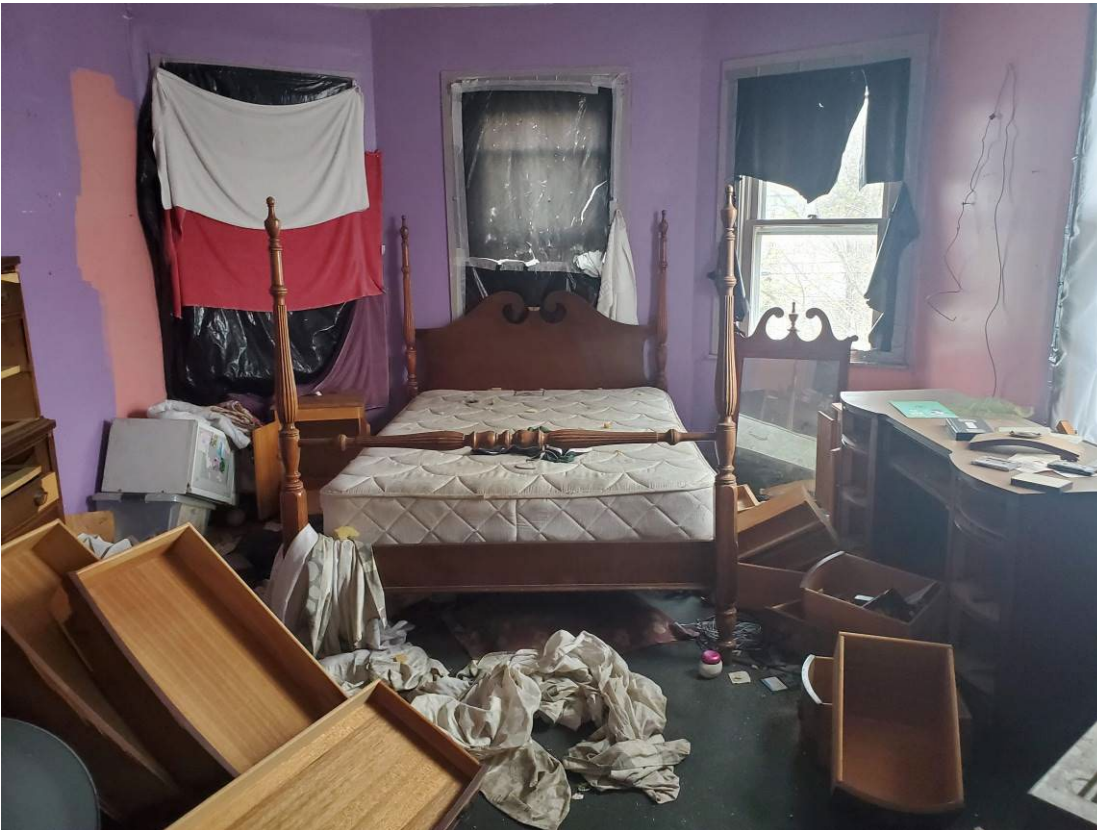
241 Main St, Indian Orchard – Additional photos of Unit 4L
