Witman Properties Inc

121 Main St, Holyoke Ma 01040

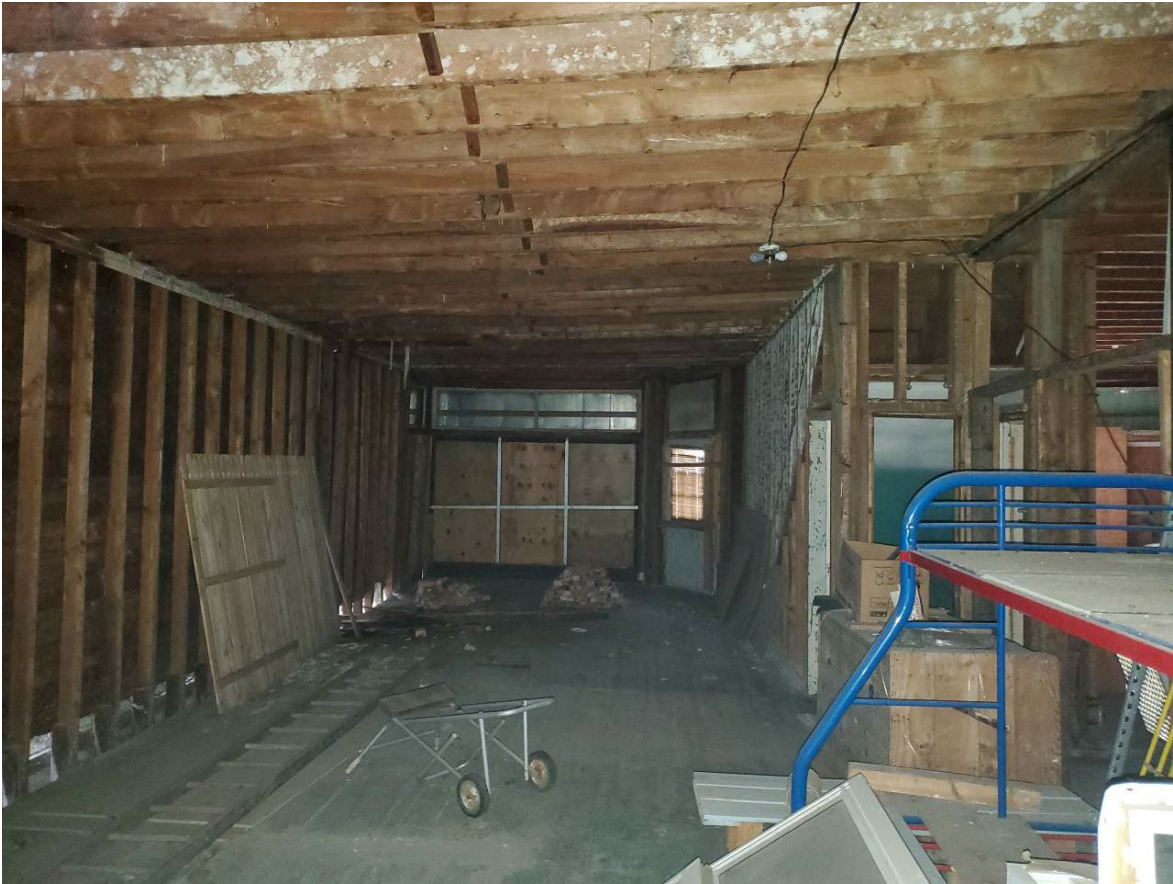
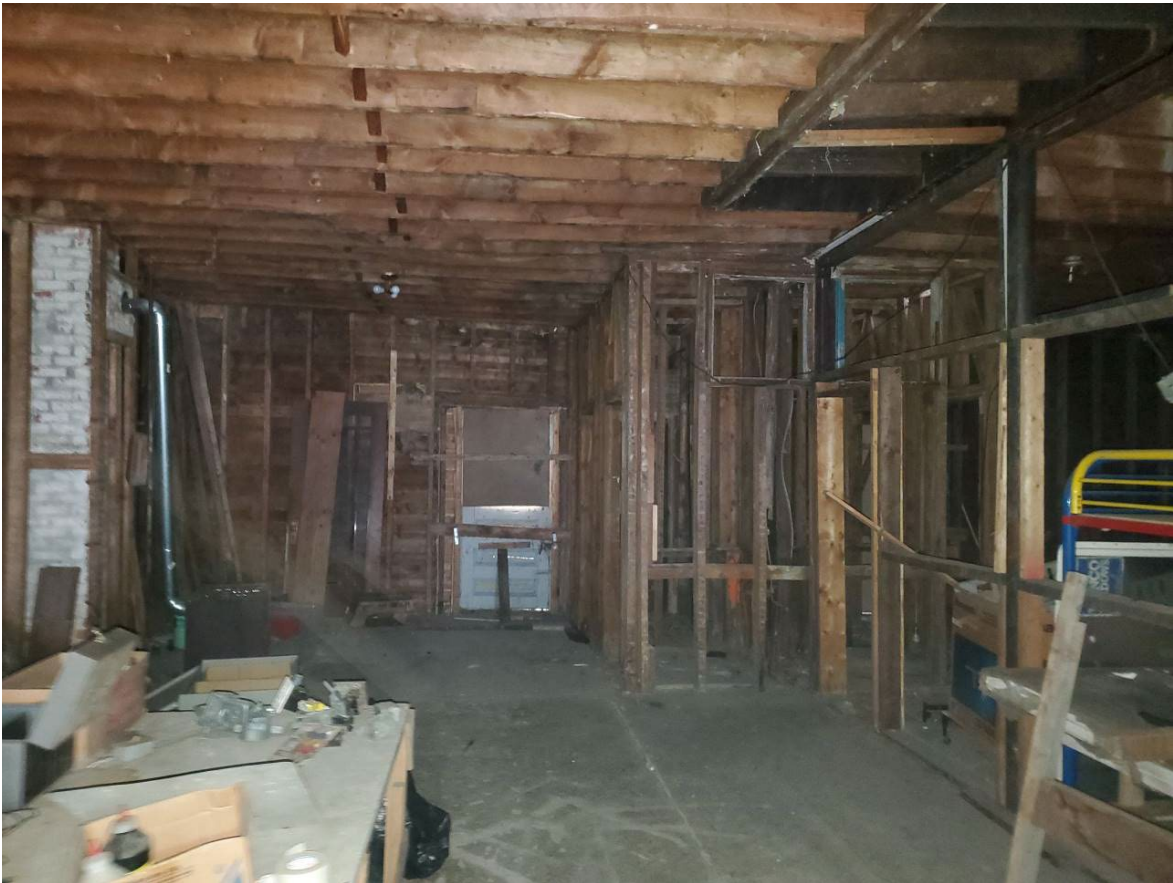
241 Main St, Indian Orchard – Photos showing the current electrical service, meter sockets and fuse boxes, all of which are expected to need replacement.

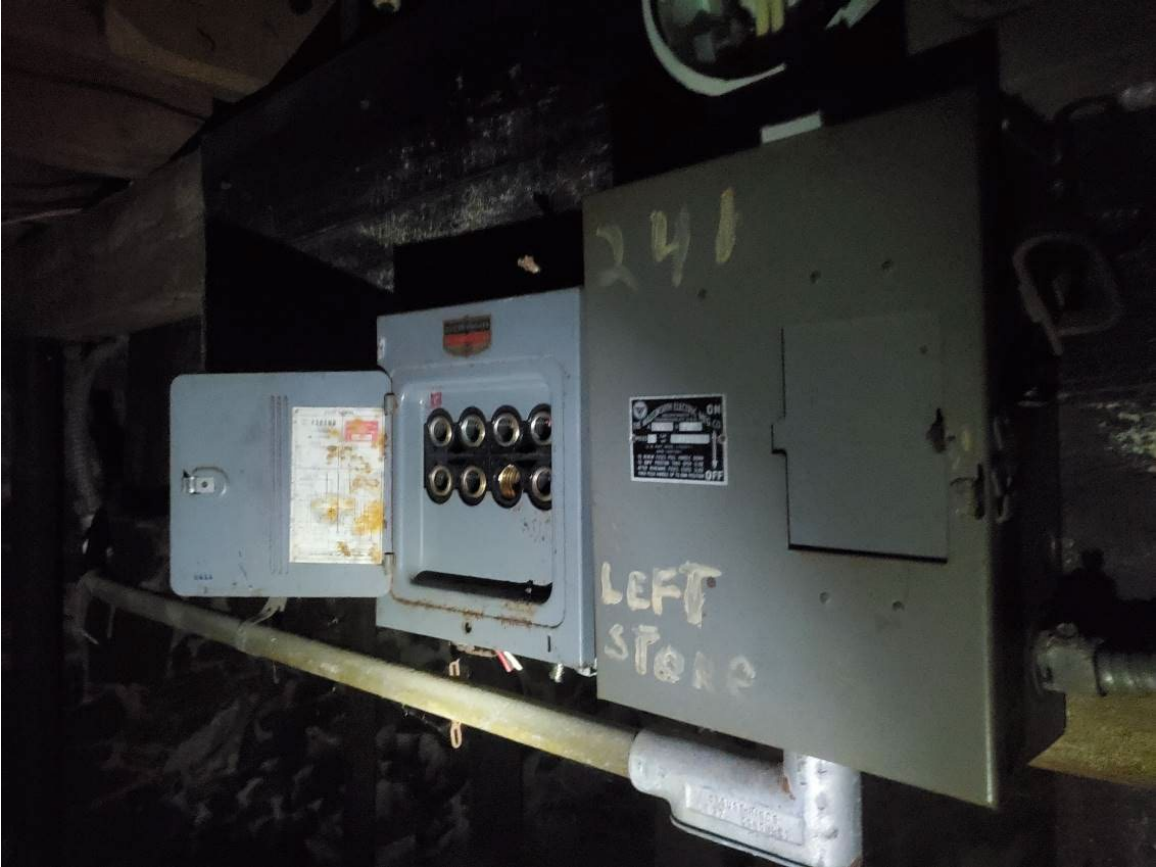
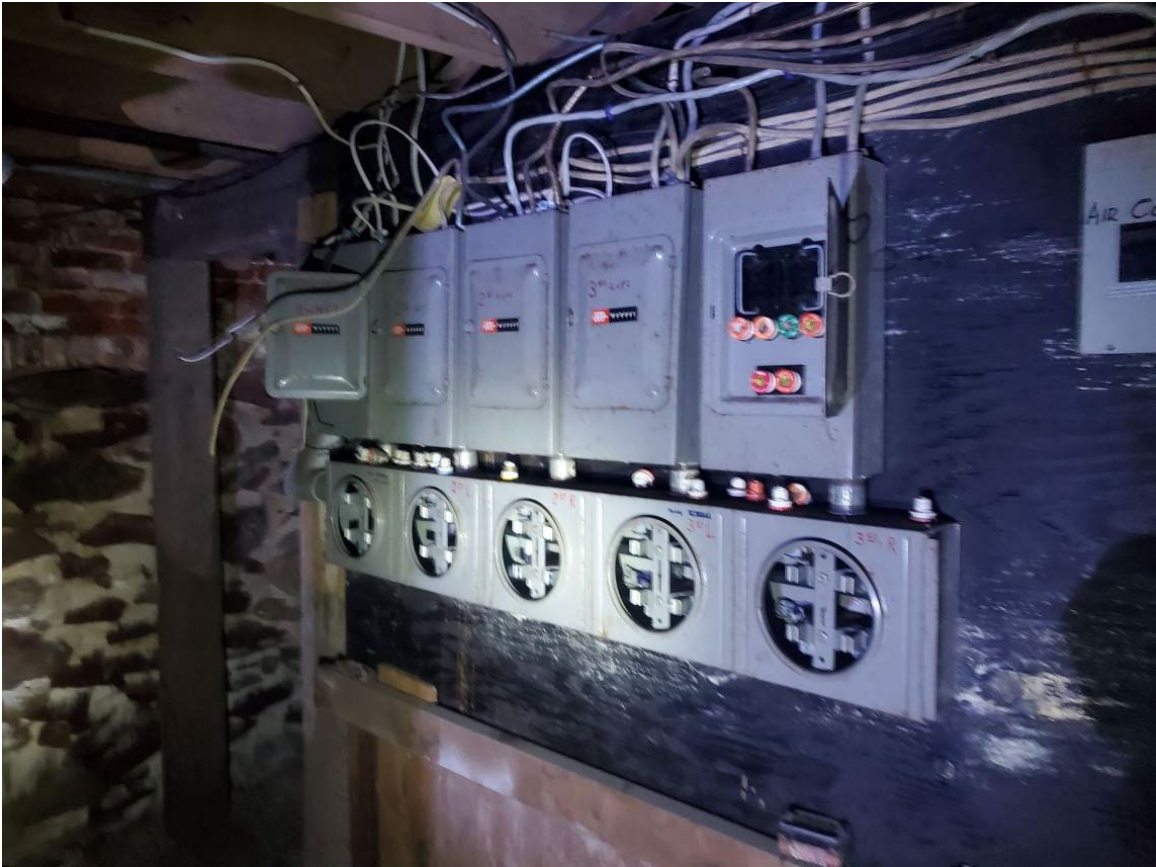
241 Main St, Indian Orchard – Photos showing the current gas service (top) and water main (bottom)

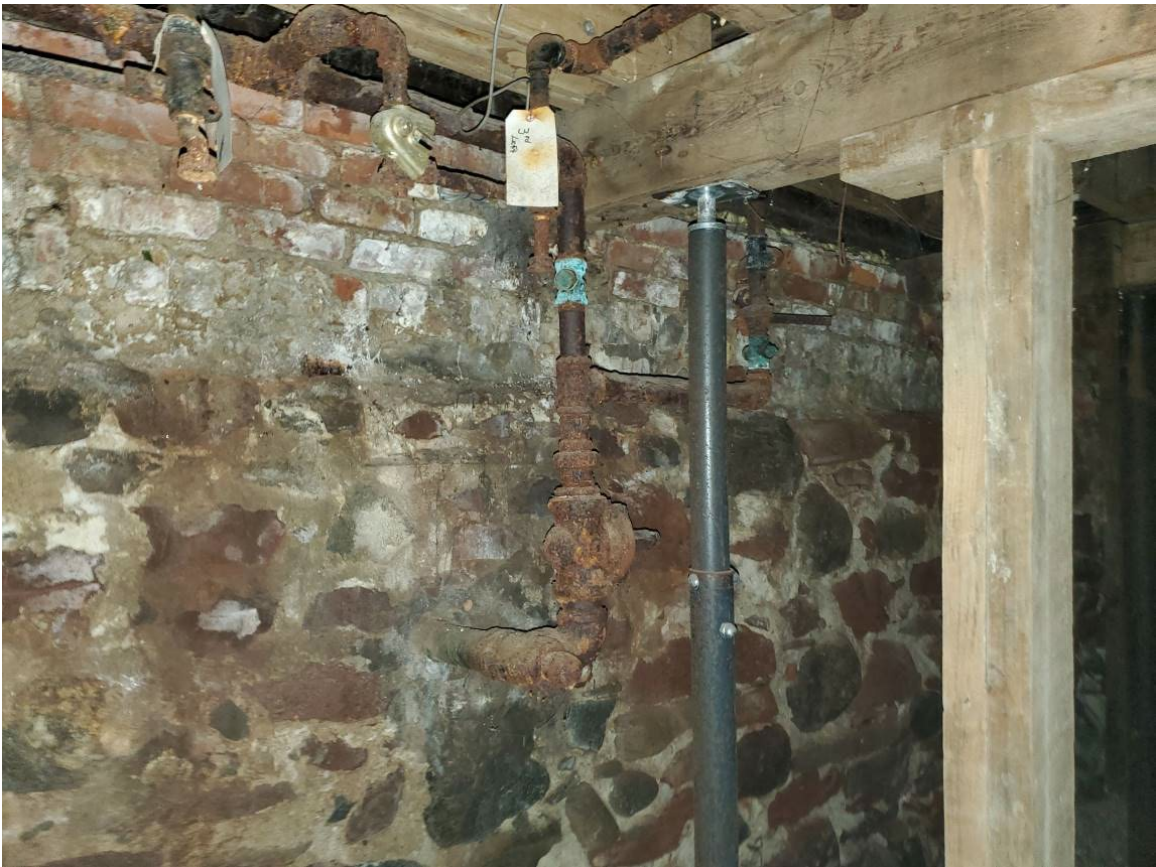
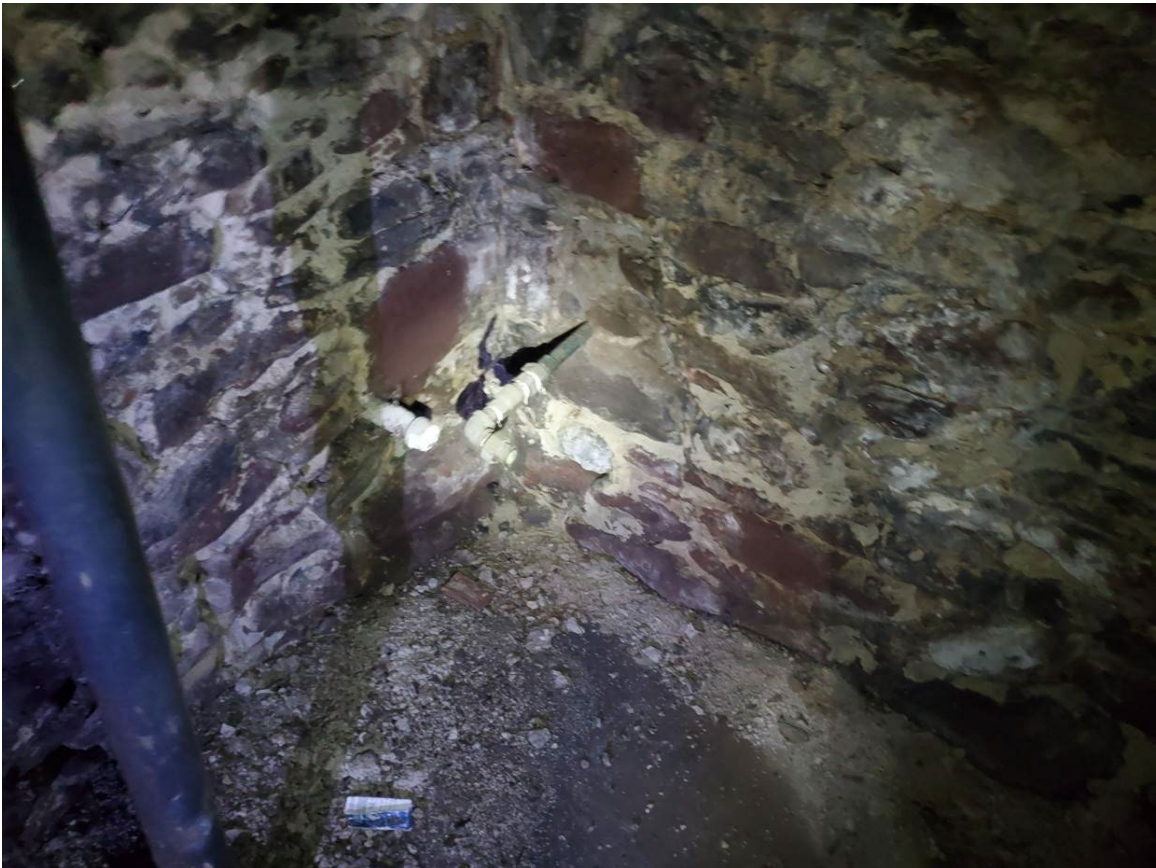
241 Main St, Indian Orchard – Representative photos showing localized water damage in basement (top) and deteriorating floor joists (bottom)

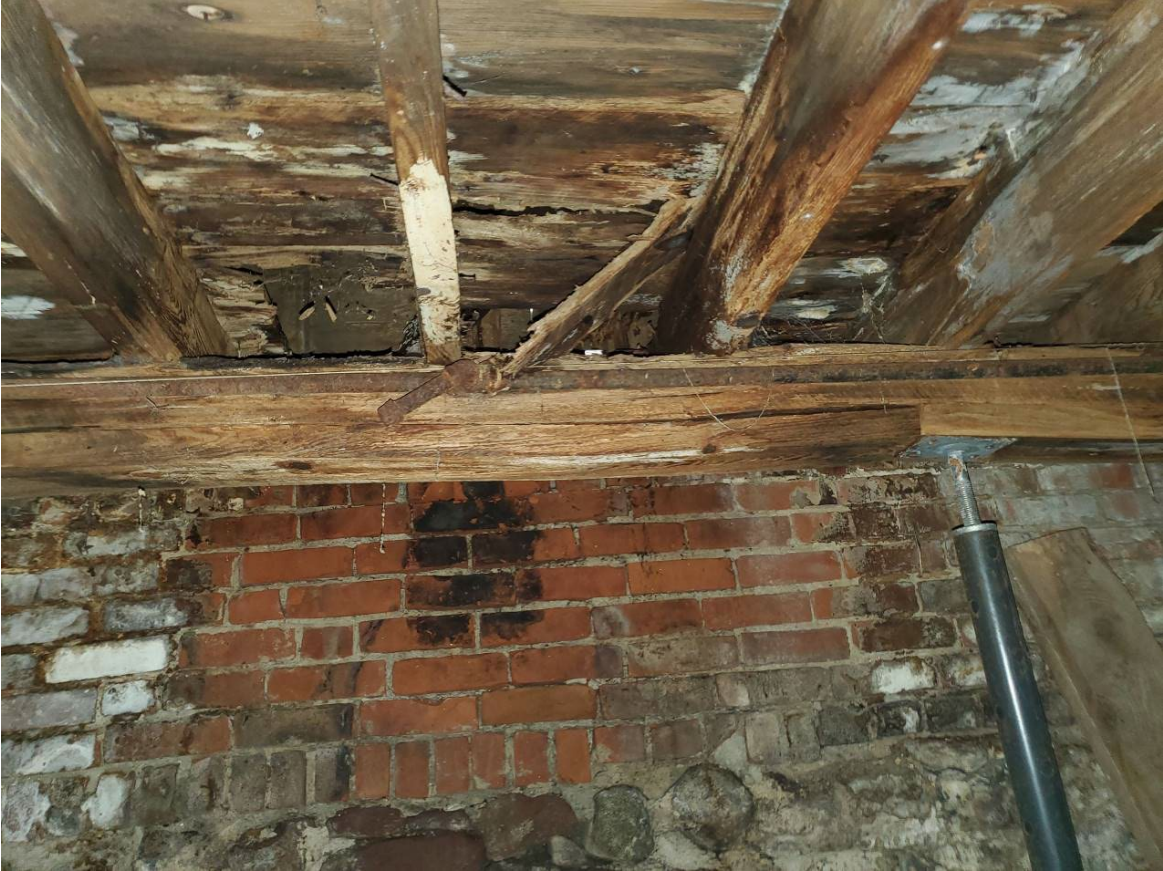
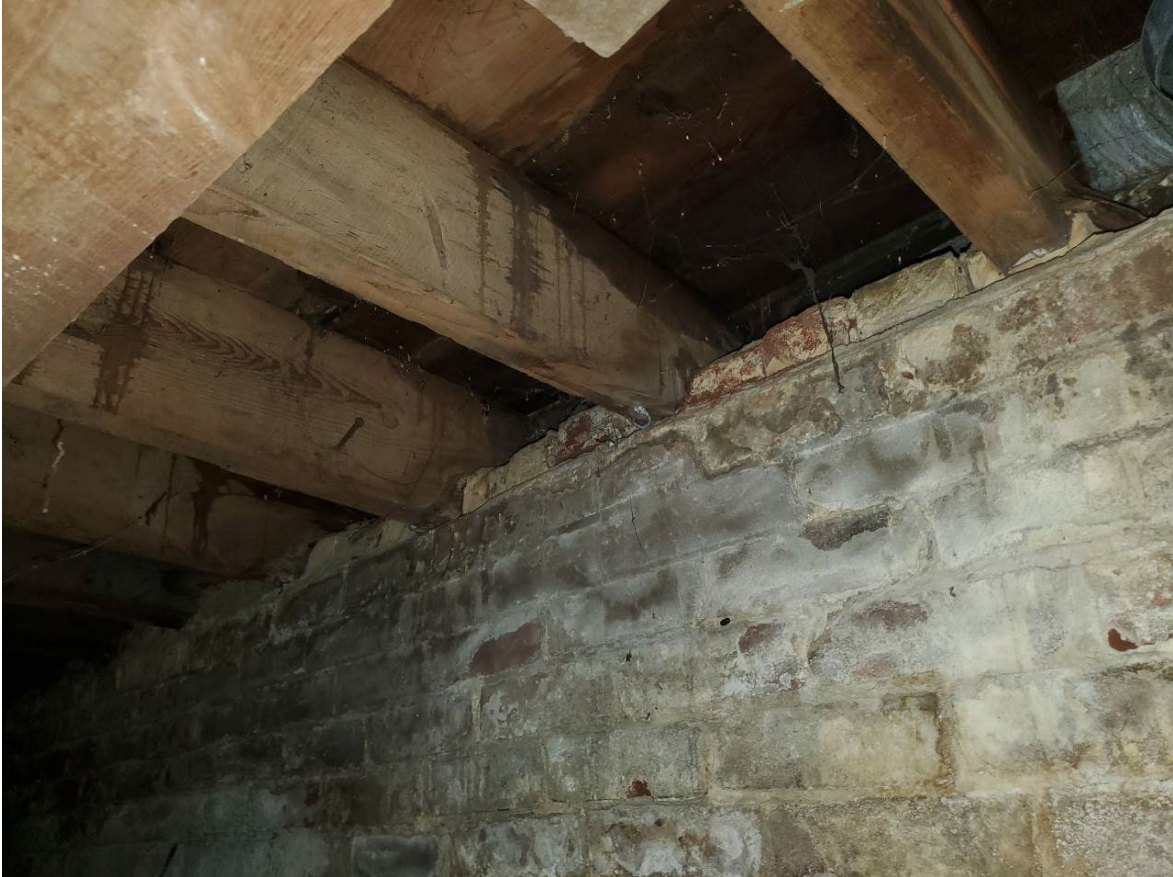
241 Main St, Indian Orchard – Additional photos showing the use of temporary supports and beams in the basement. Some engineering and architectural work is expected to properly evaluate and address.
