## Resiliency Improvements at Watershops Pond Dam

Springfield, Massachusetts

# 2021 DRAWDOWN PERIOD ECOLOGICAL RESOURCE MONITORING SUMMARY REPORT

GZA File No. 15.0166625.20

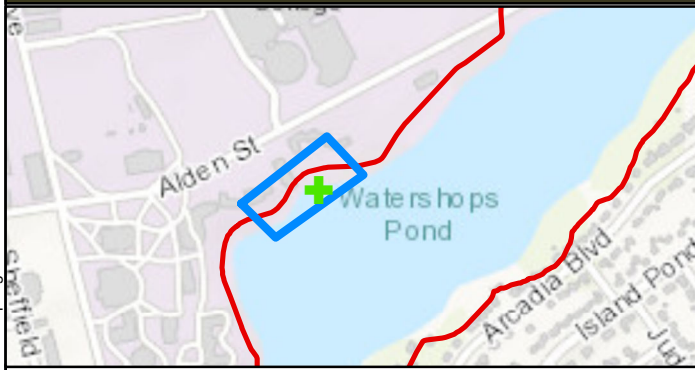
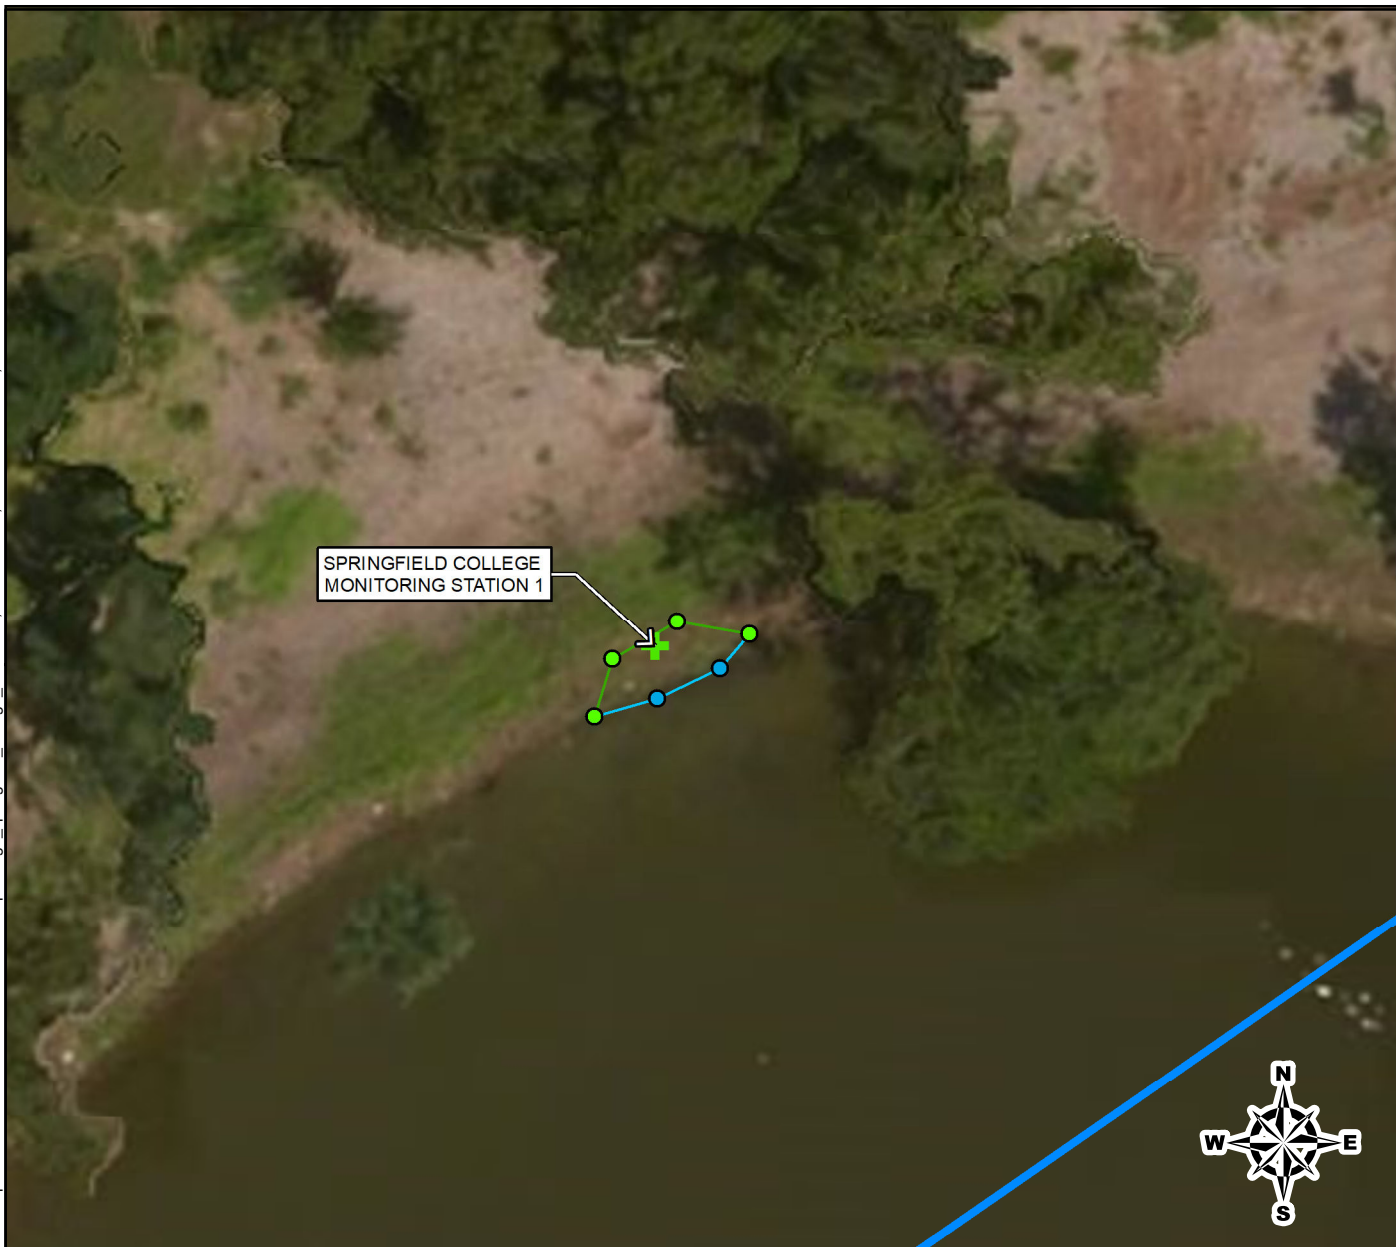
PROJ MGR: TEJ	REVIEWED BY: TEJ	CHECKED BY: SLL	<b>FIG. 3</b>
DESIGNED BY: JRB	DRAWN BY: ARD	SCALE: 1 in = 20 ft	
DATE: 11/24/2020	PROJECT NO: 15.0166625.20	REVISION NO:

**SPRINGFIELD COLLEGE BVW**

Monitoring Station 1 is located within a lower elevation wetland which supports largely emergent vegetation. The depth to groundwater in this portion of the wetland was three (3) inches below ground and the soils were observed to be a saturated mucky-mineral material. On the north side of the wetland, there was a low point in the Bank which appears to facilitate surface inundation into the BVW during periods of high water.

Monitoring Station 2 is located in a shrub-dominated wetland which is higher in surface elevation compared to Monitoring Station 1. The surface level in this portion of the wetland was approximately five (5) inches above Monitoring Station 1. This was directly reflected in the depth to water which was observed at eight (8) inches below ground surface. The evidence of hydrology within the top 12 inches of the soil clearly qualifies the area as a regulated wetland.

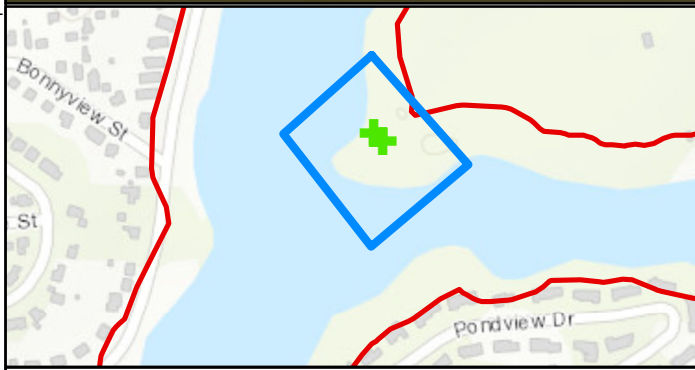
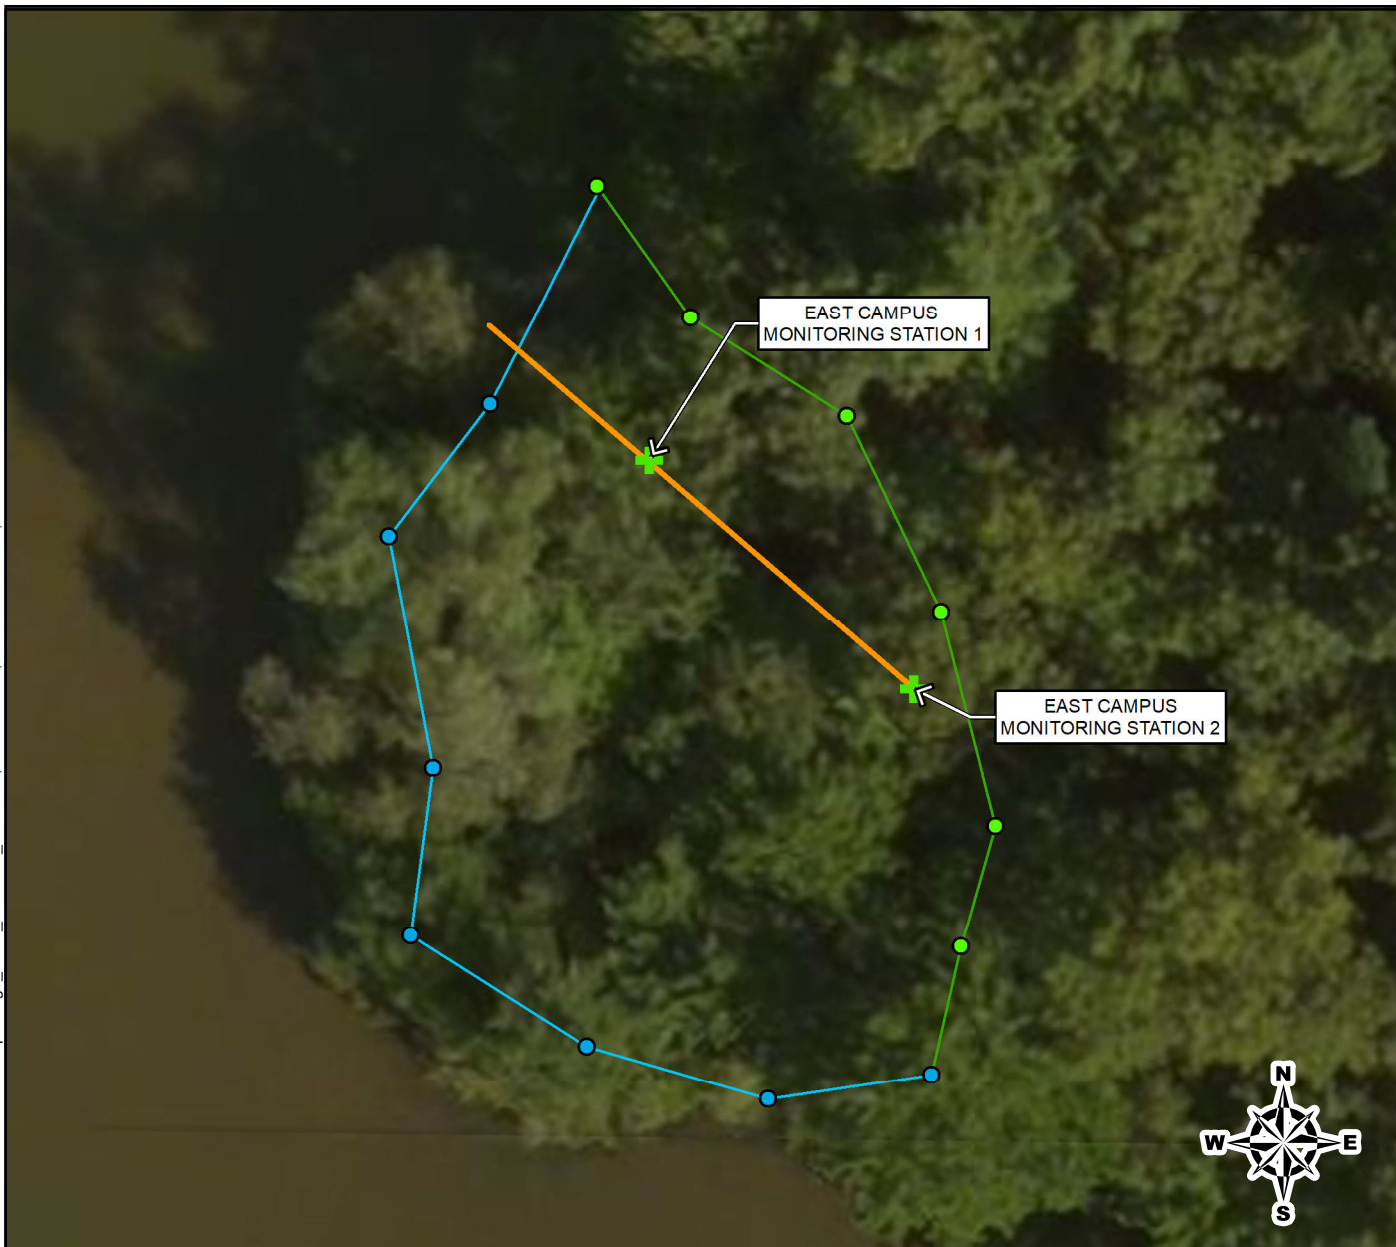
PROJ MGR: TEJ	REVIEWED BY: TEJ	CHECKED BY: SLL	<b>FIG.</b> <b>4</b>
DESIGNED BY: JRB	DRAWN BY: ARD	SCALE: 1 in = 20 ft	
DATE: 11/25/2020	PROJECT NO: 15.0166625.20	REVISION NO:

**SPRINGFIELD COLLEGE**  
**EAST CAMPUS BVW**

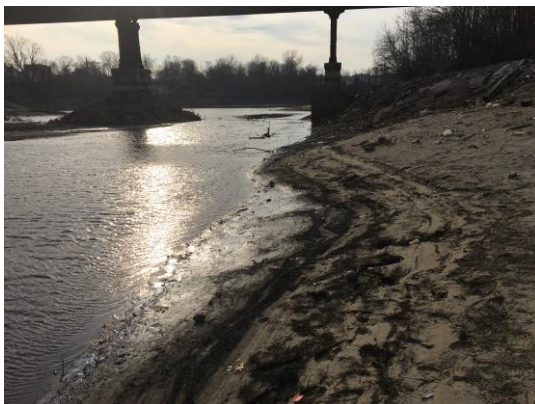
Photo 1: View to West from boat launch (Springfield College). Bridge shown is the unused “railroad bridge.”

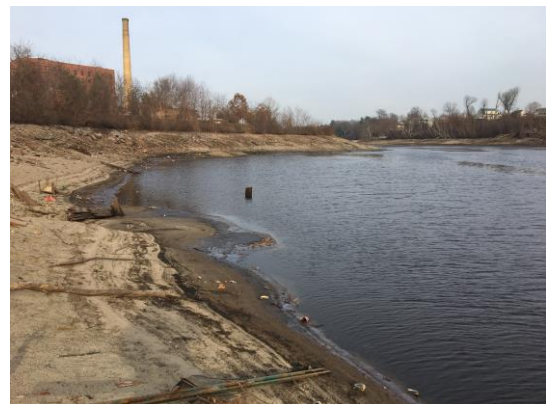
Photo 2: View to East from the boat launch.
