Witman Properties Inc

121 Main St, Holyoke MA 01040
(413)-536-2714

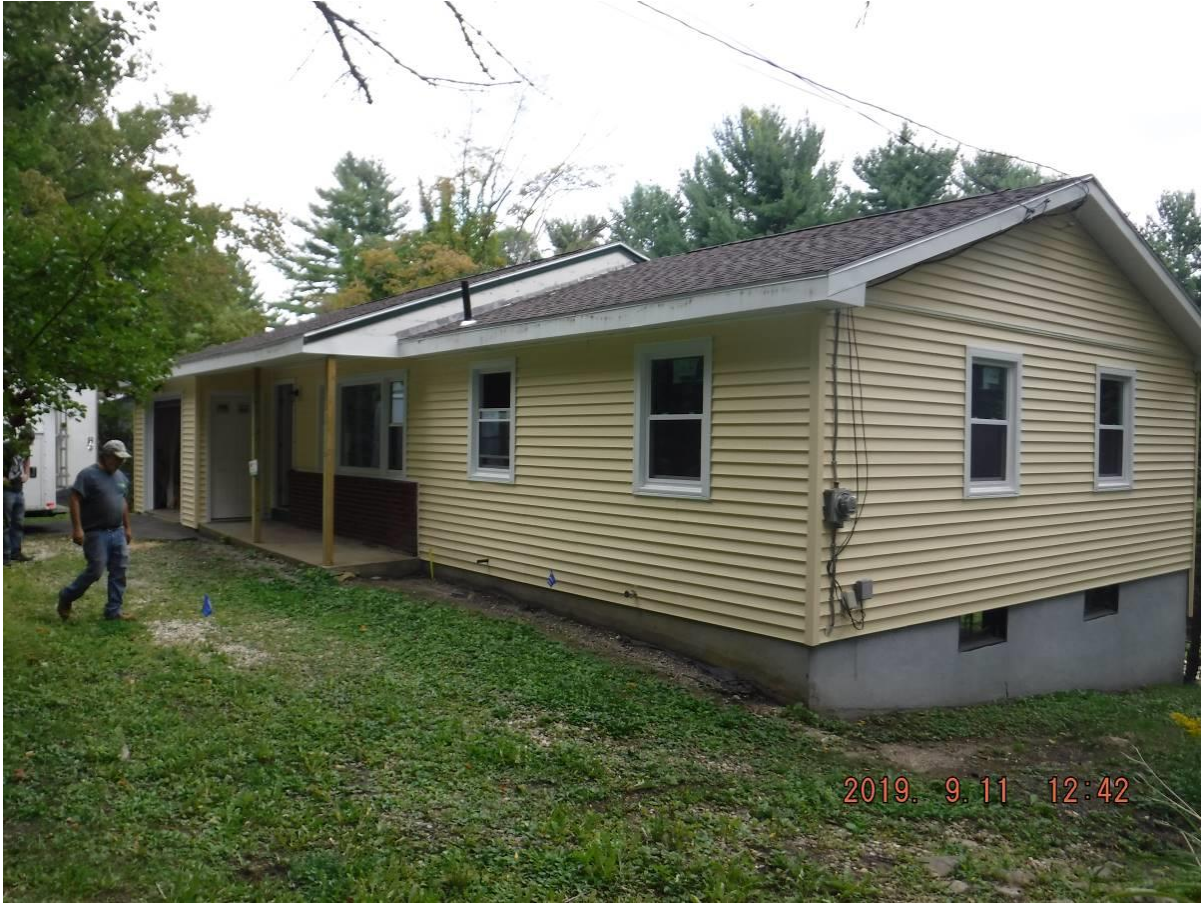
Description of Property/Background:
