Witman Properties Inc

121 Main St, Holyoke MA 01040
(413)-536-2714

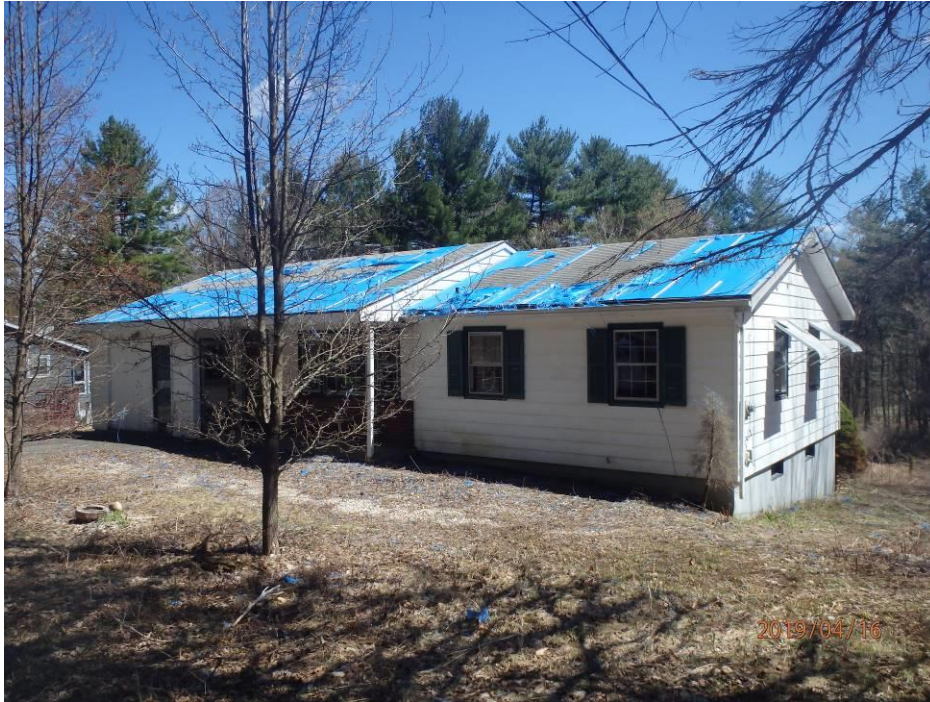
Description of Property/Background:

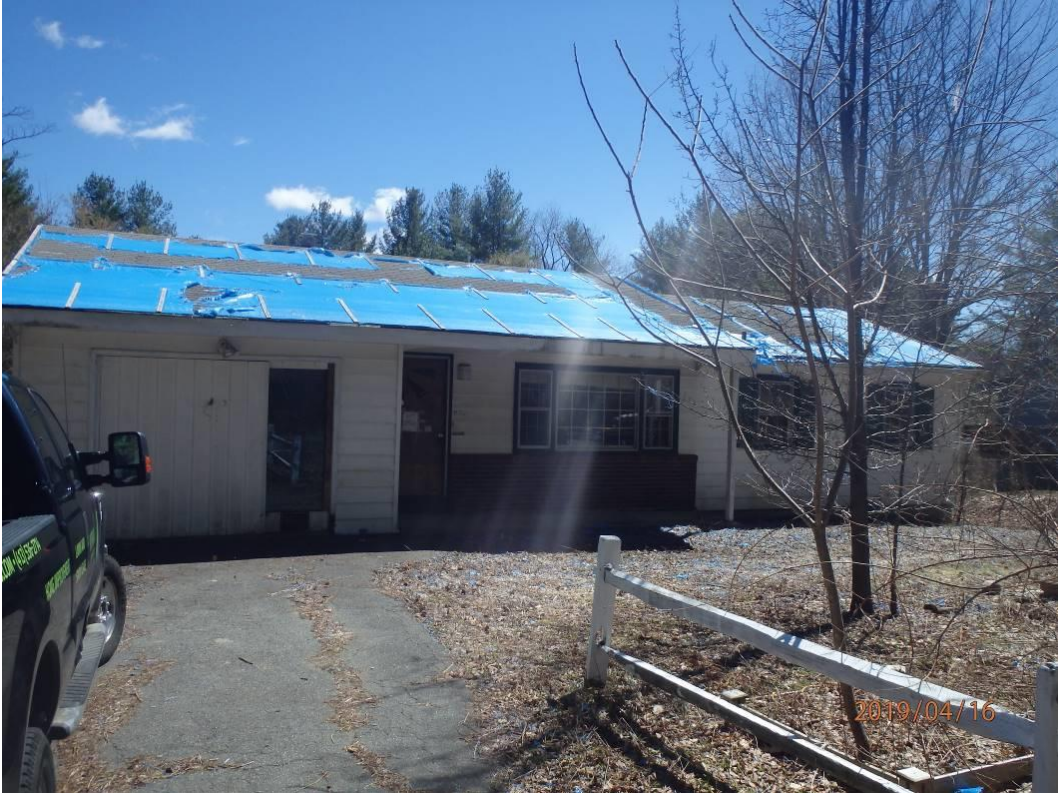
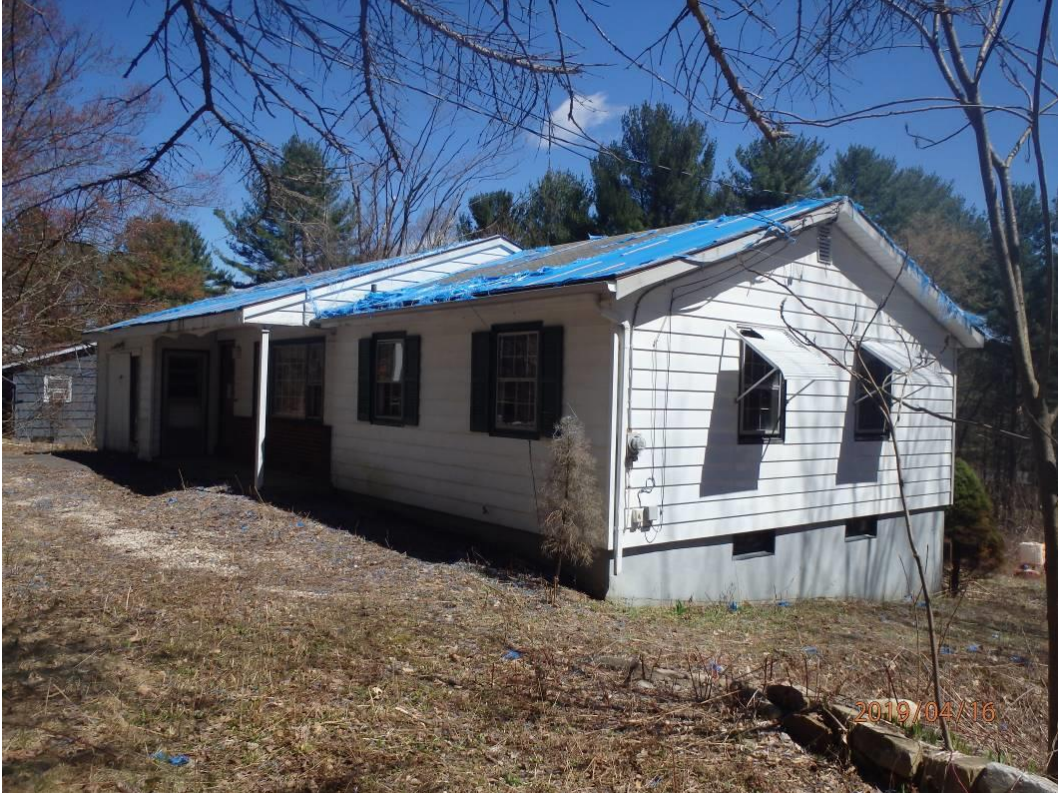
870 East St, Lenox MA Representative exterior photos showing damaged siding, original electrical service (top) and rear porch with rotten wood and missing stairs to ground.

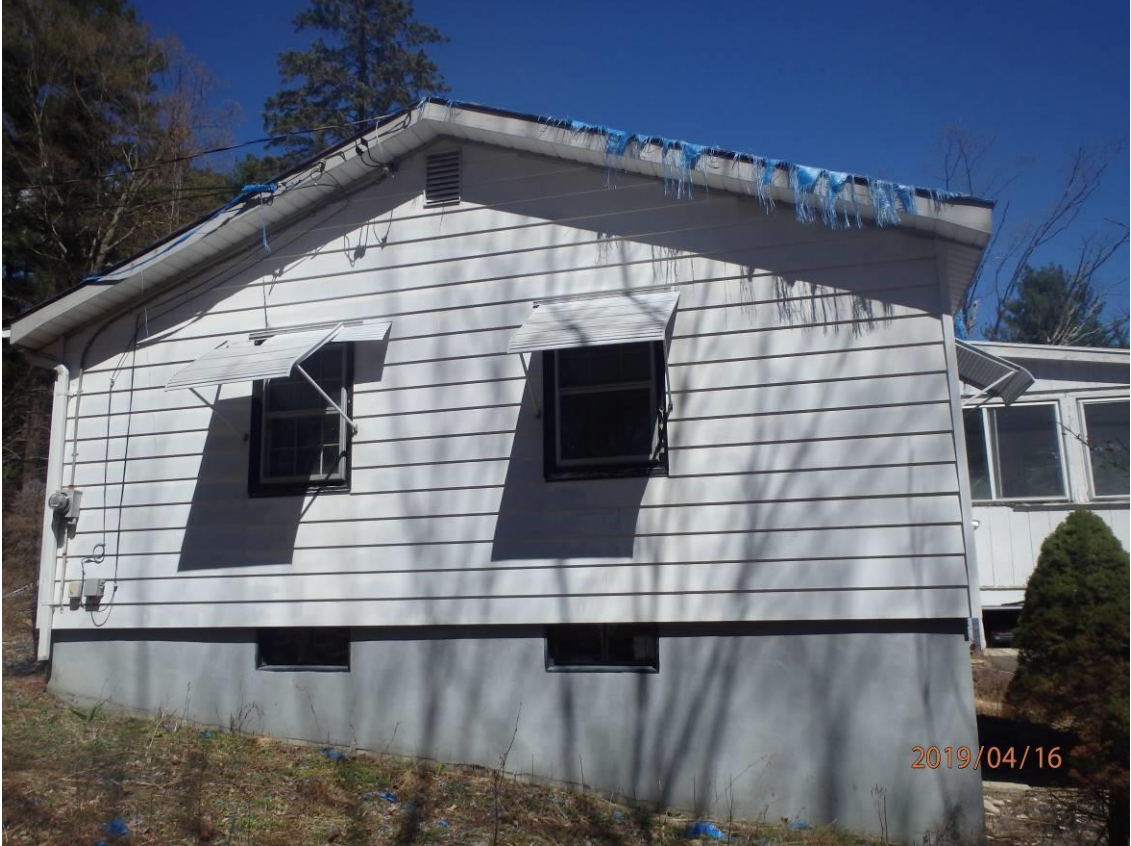
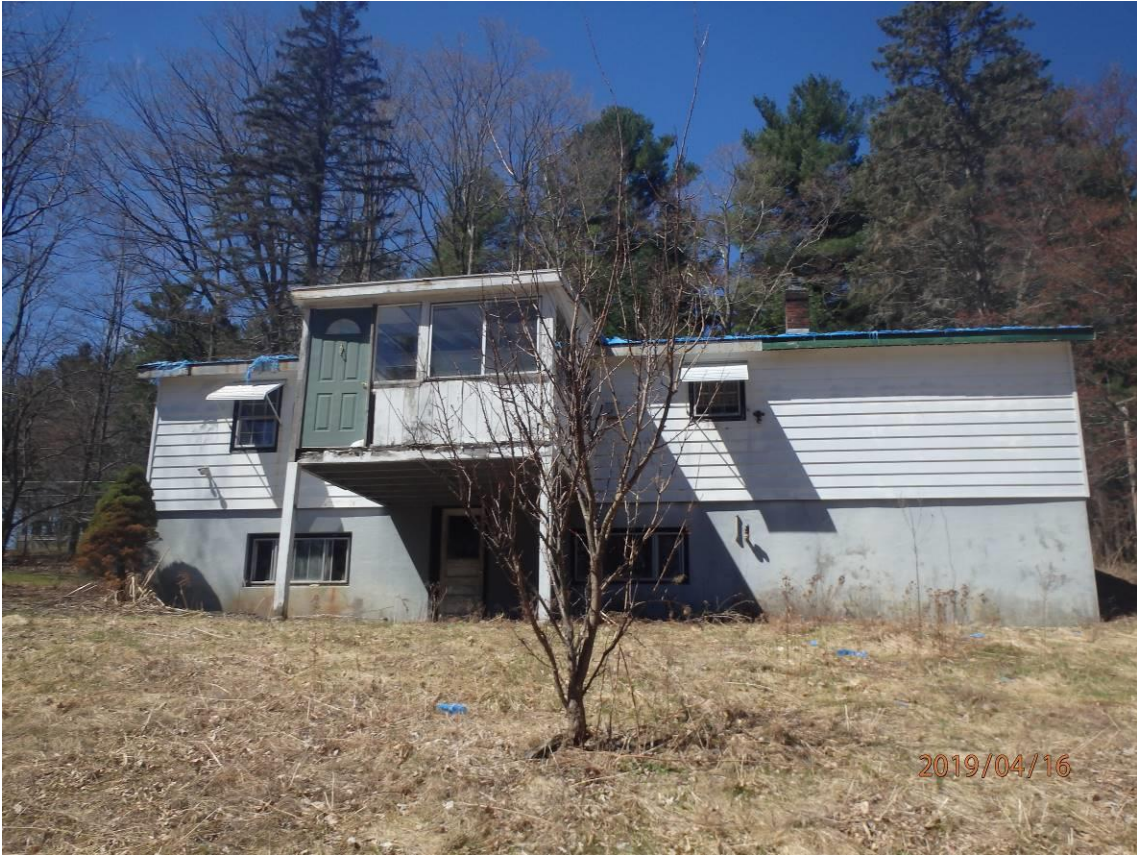
870 East St, Lenox MA – Close up photos of rear porch (top) and garage (bottom). Note how the original garage door was framed in as an effort to create an additional bedroom inside.

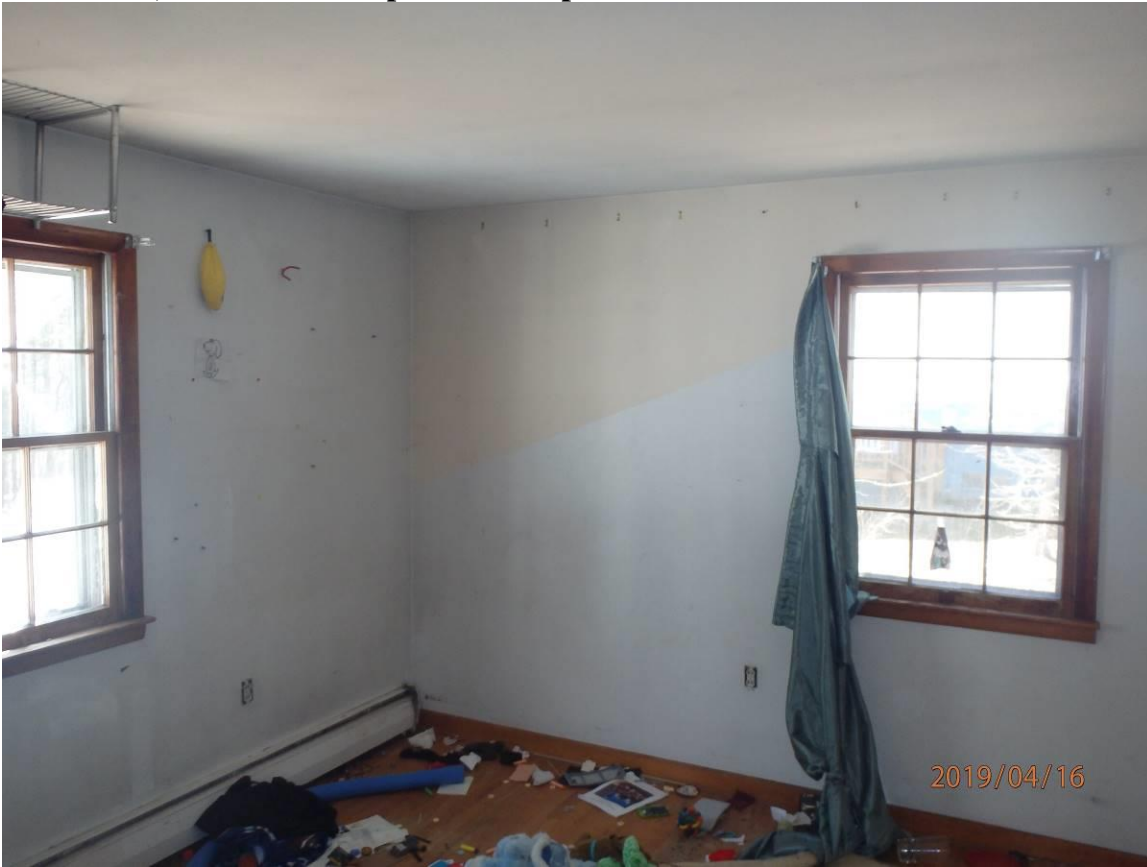
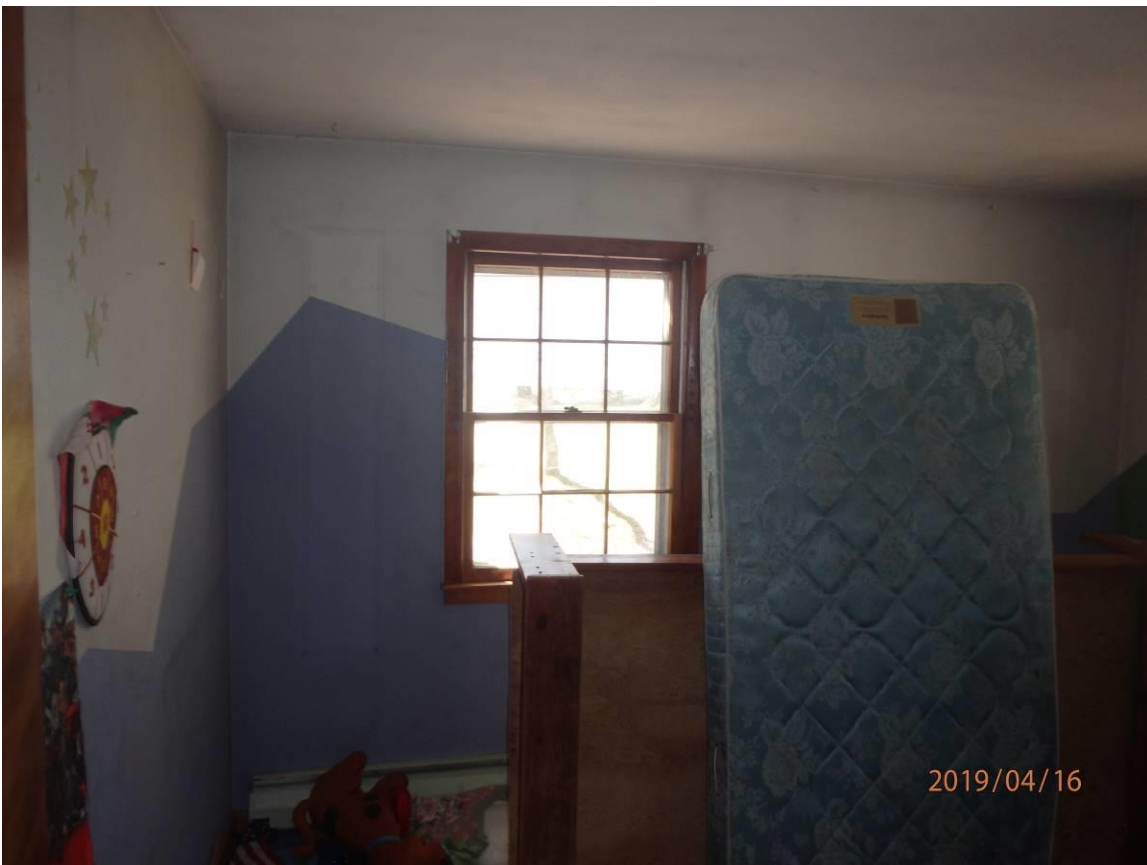
870 East St, Lenox MA –Photos of bathroom with non-impervious wood floor and other damage.

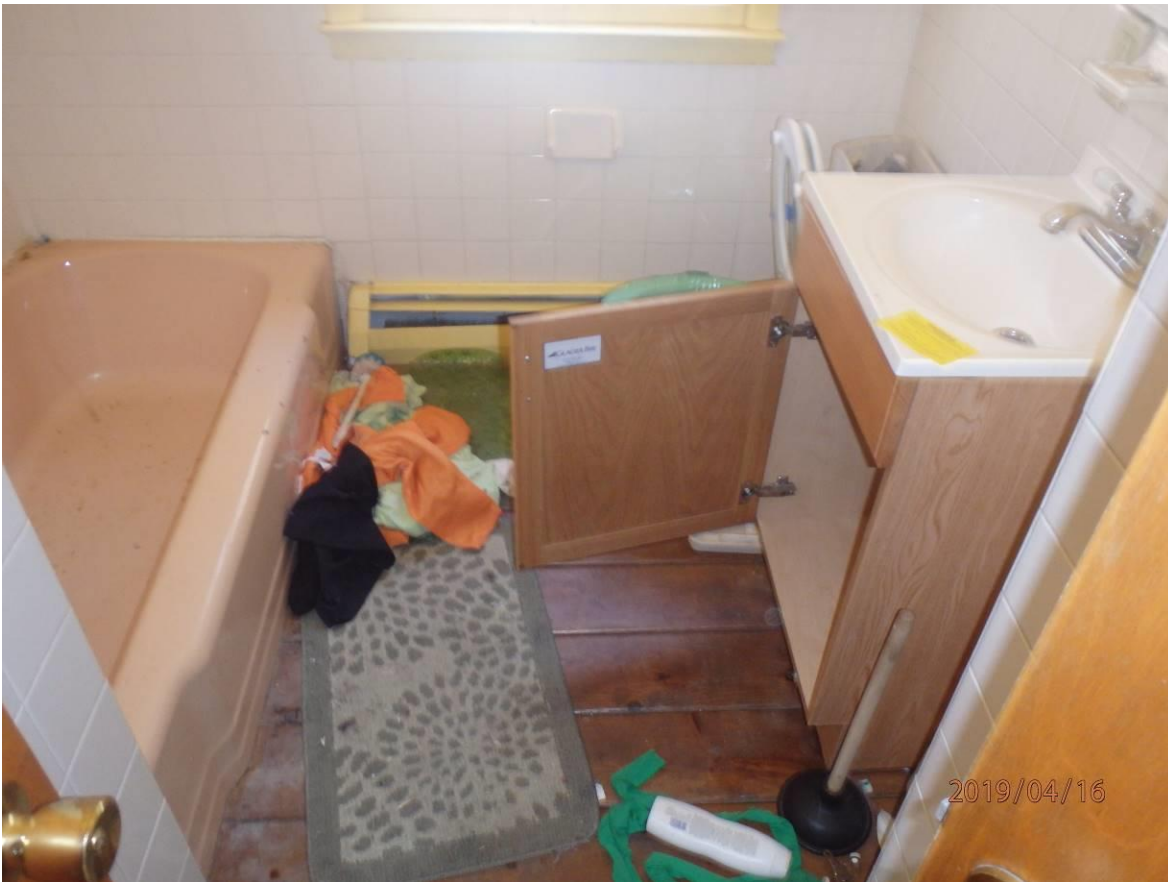
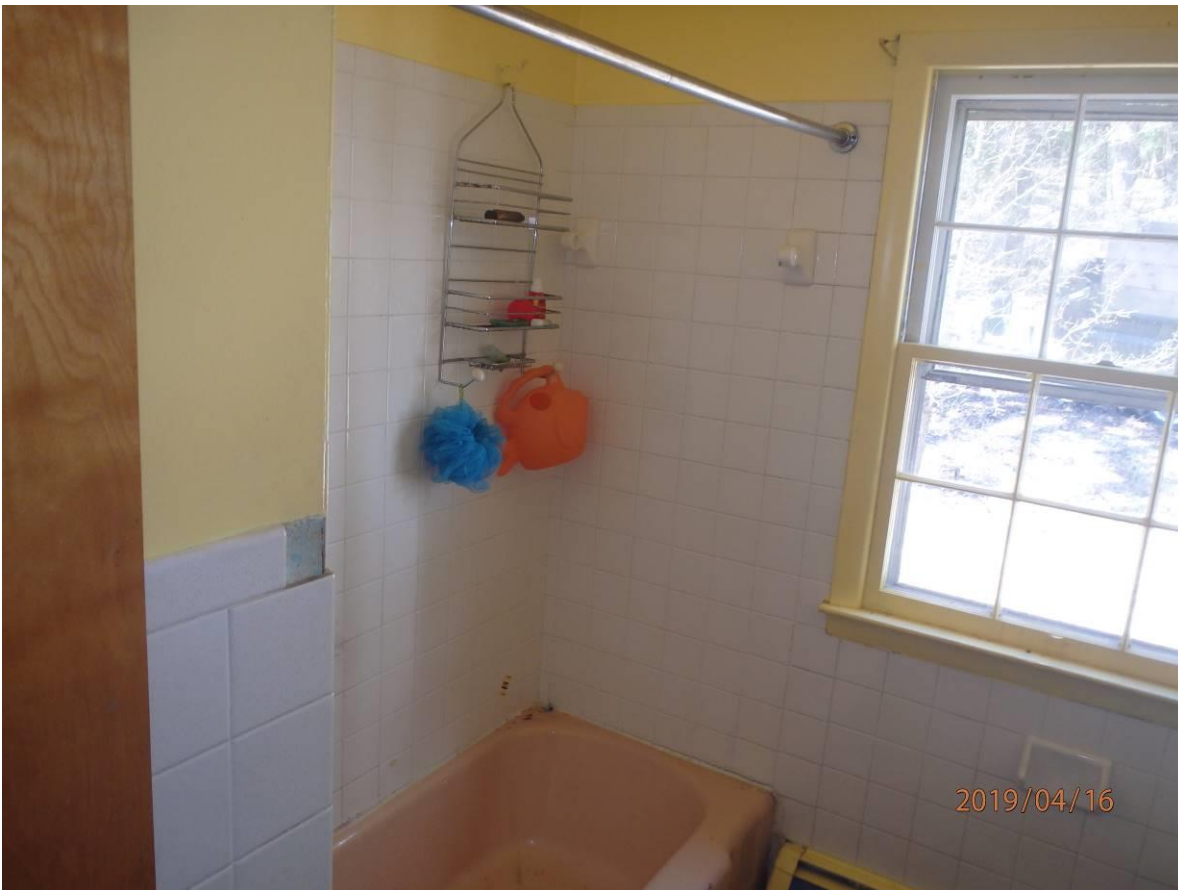
870 East St, Lenox MA – Rear porch (top) where stairs will need to be redone and three season windows removed. The bottom photo is representative of the junk and clutter in the basement.

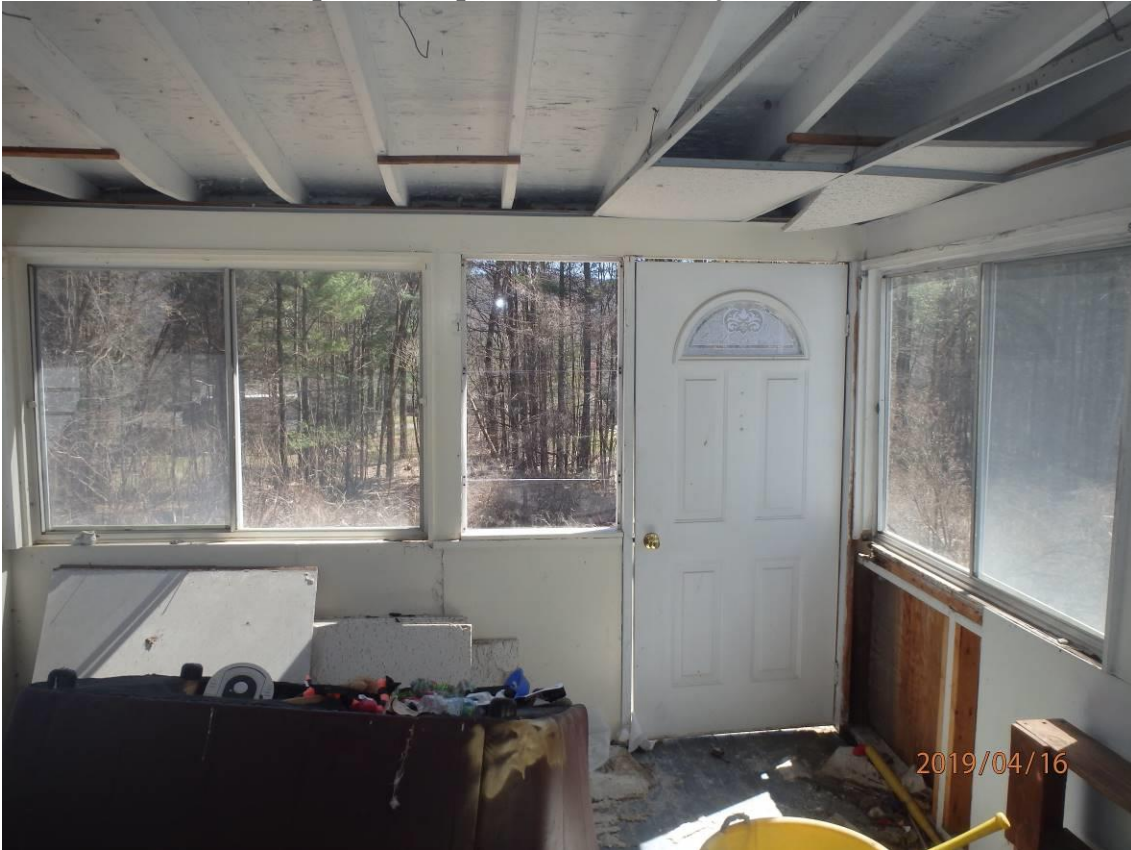
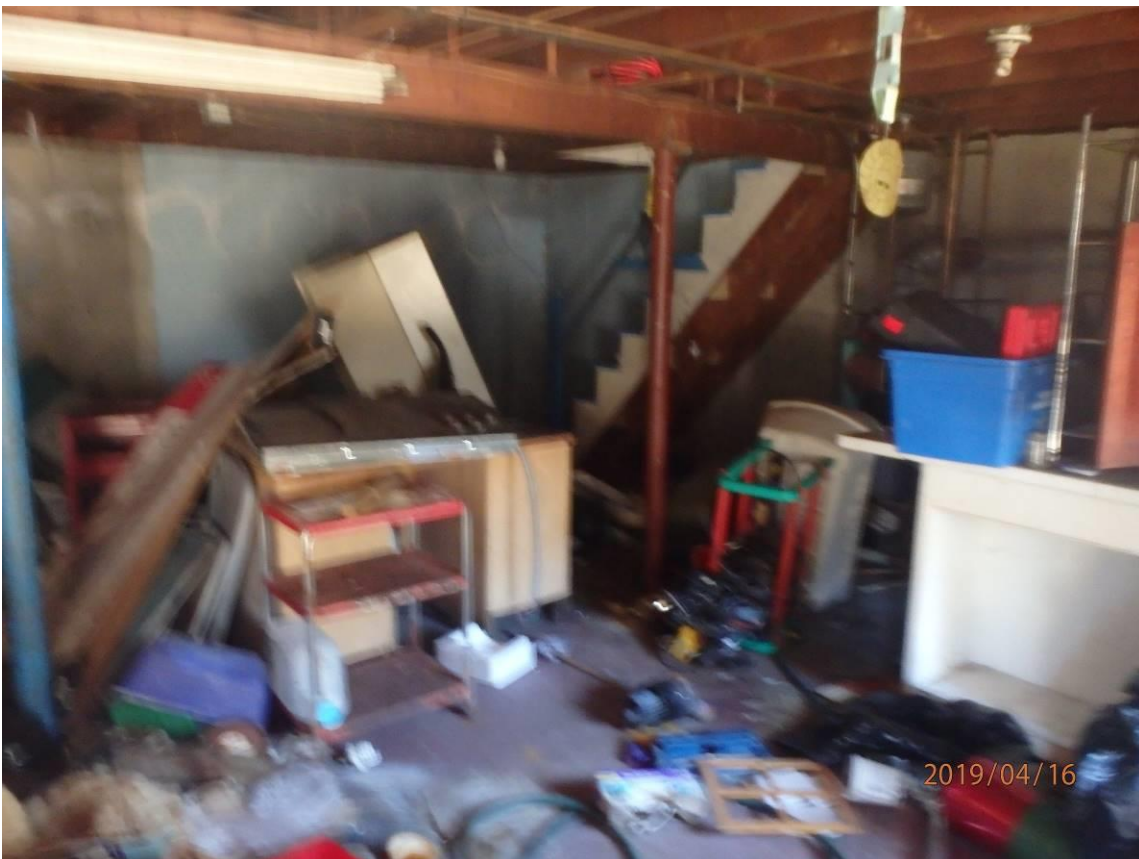
870 East St, Lenox MA – The boiler (top) has aged beyond its expected life and has been partially disassembled for service. We do not expect it to be operational. Plumbing shown below is generally up to code with minimal freeze damage.
