Re: Premises: 66 Pasadena Street, Springfield, MA

**RECEIVER'S MOTION TO APPROVE RENOVATION PLAN**

## Report and Redevelopment Plan for 66 Pasadena St, Springfield MA

### Receivership 13-CV-493

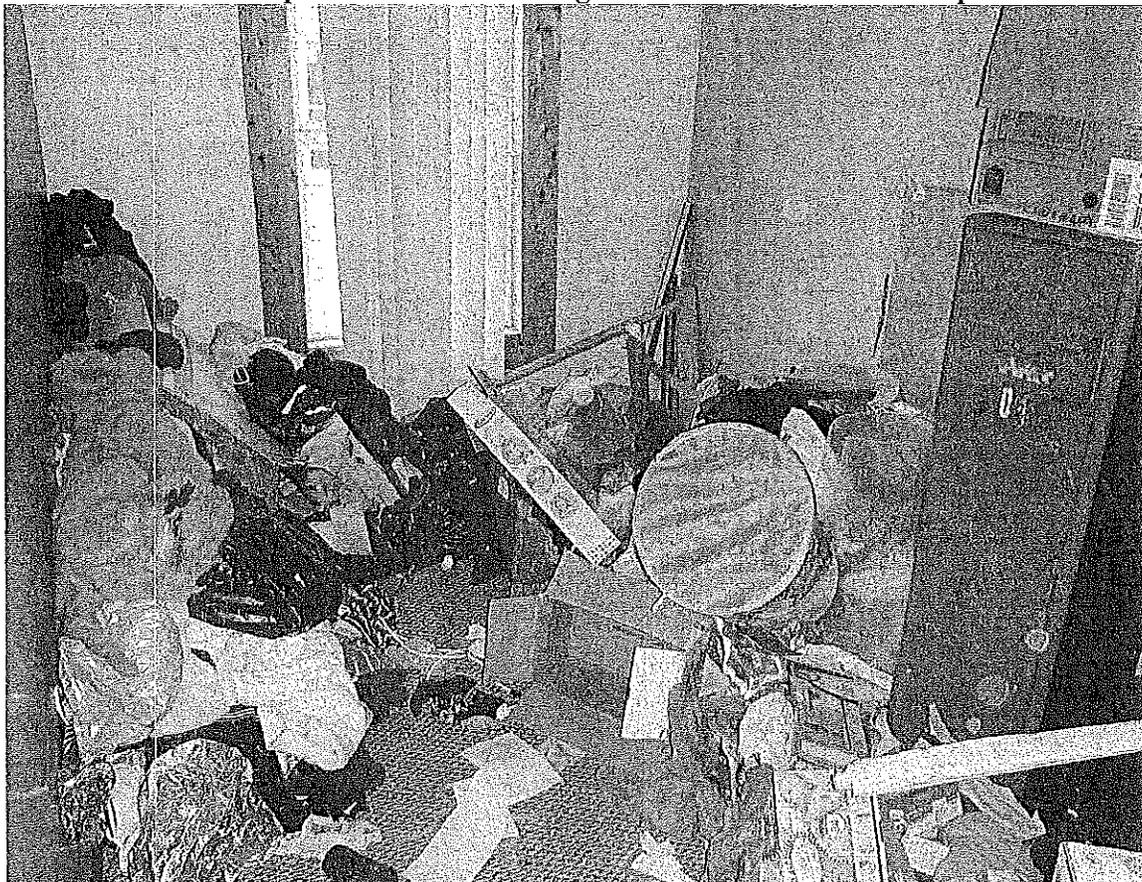
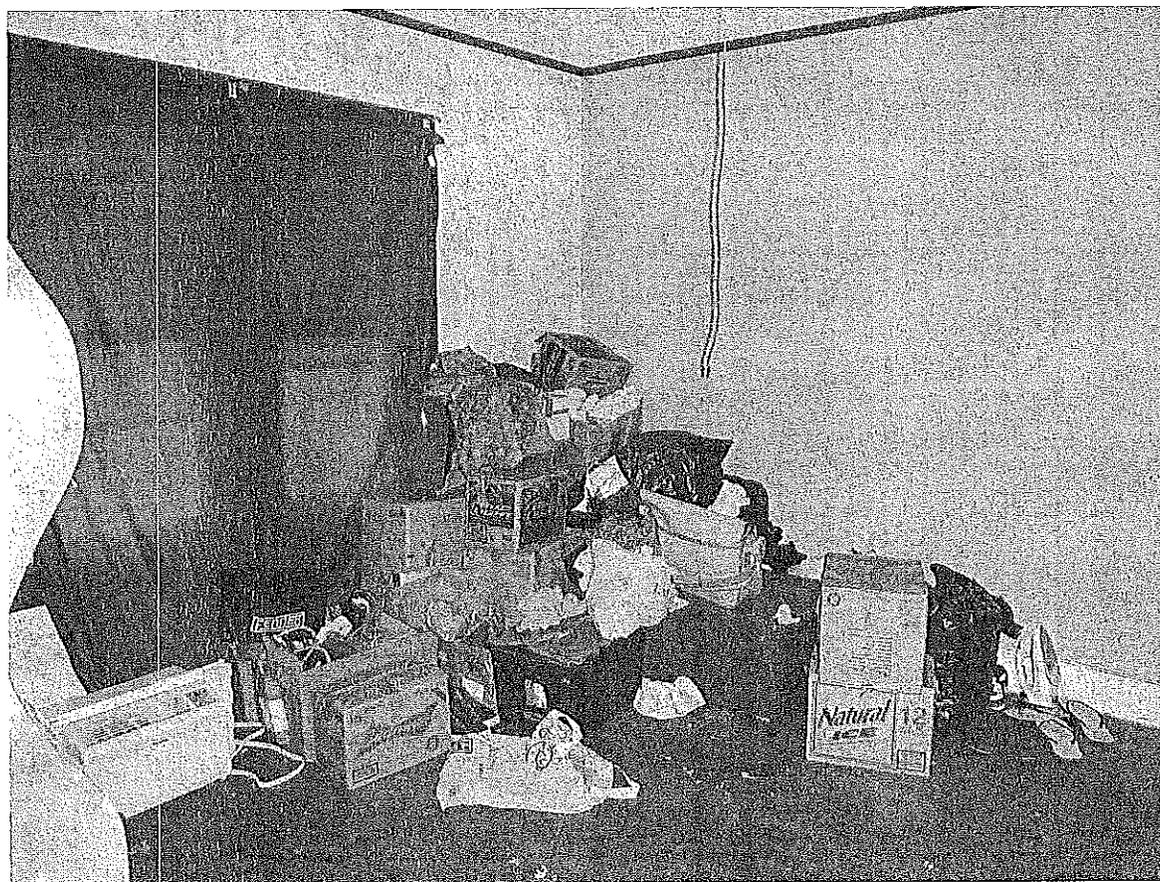
66 Pasadena – Examples of bedrooms being full of trash and in need of paint and floor refinishing.

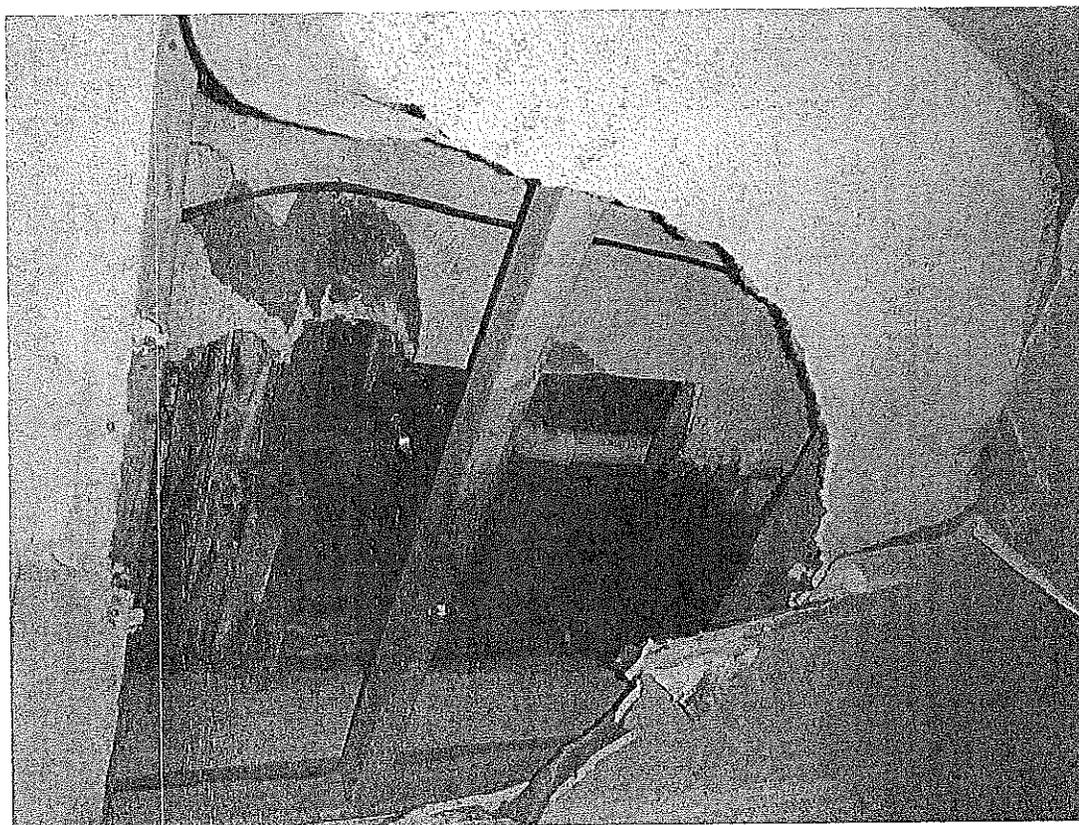
**66 Pasadena – Water Damage – Ceilings throughout the kitchens bathrooms living rooms and dining rooms of both the 1<sup>st</sup> and 2<sup>nd</sup> floor apartments have significant water damage and will need to be gutted and replaced and any mold treated.**

6. Begin repairing water damage to walls, floors and ceilings.
7. Perform Lead Paint Testing
8. Begin Lead remediation which most likely requires window replacement throughout the house.

9. Begin interior repair work including patching drywall, and repairing interior trim, repainting and refinishing and replacing floors as necessary.
10. Replace roof if not already done.

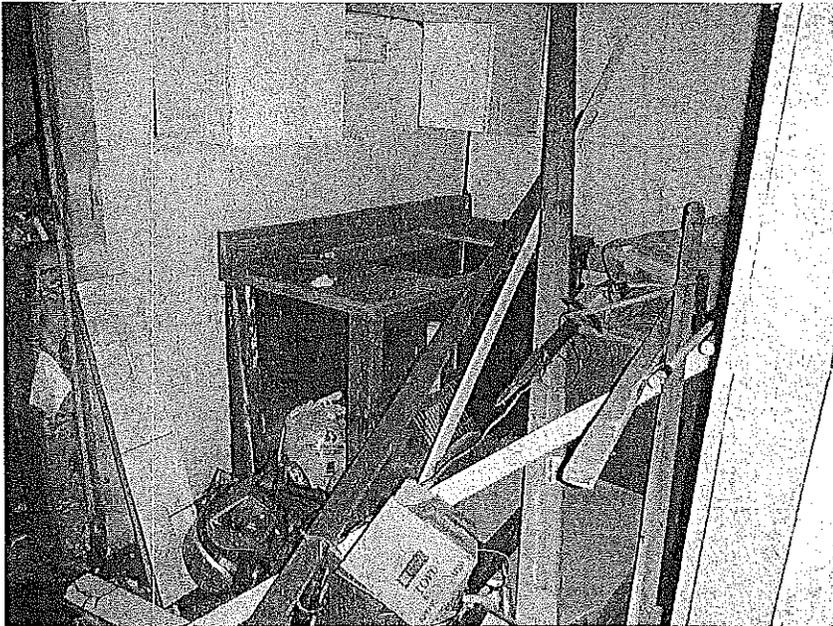
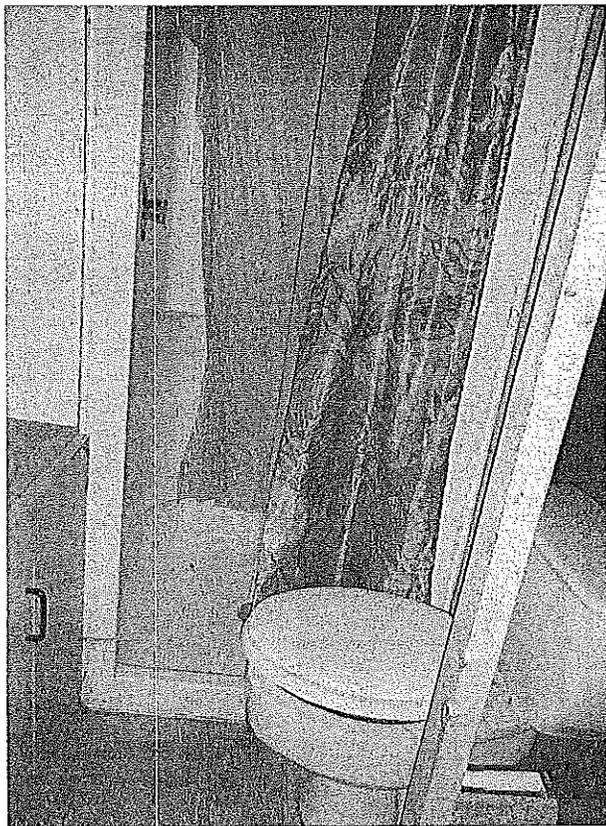
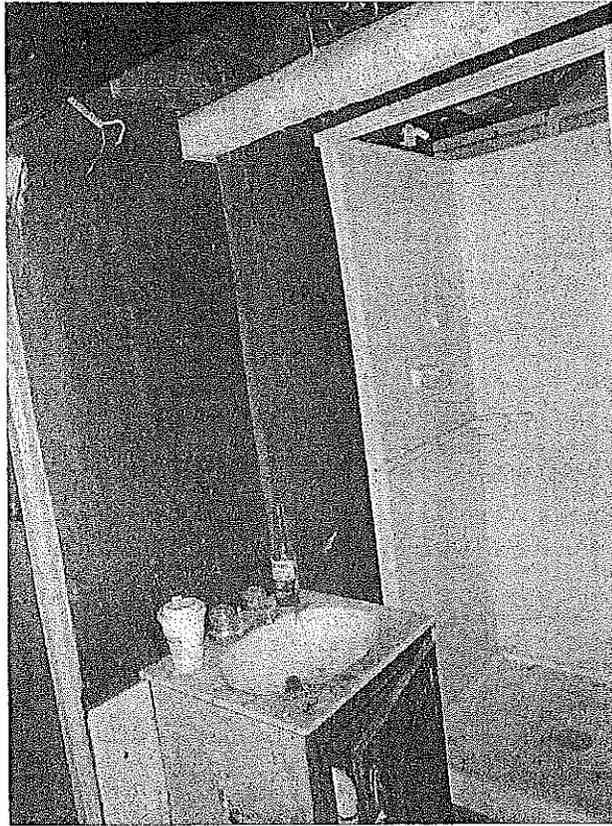
**66 Pasadena – Basement – The basement is full of trash and debris and the remains of two illegal basement apartments. The trash is creating a harborage to vermin as well as creating an unsanitary moldy condition.**

1. Temporarily patch roof until weather permits replacement.
2. Turn electricity on and repair electrical hazards
3. Remove trash from the house and garage
4. Remove trash remains of illegal apartment in the basement.
5. Restore heat and utilities and repair as necessary.

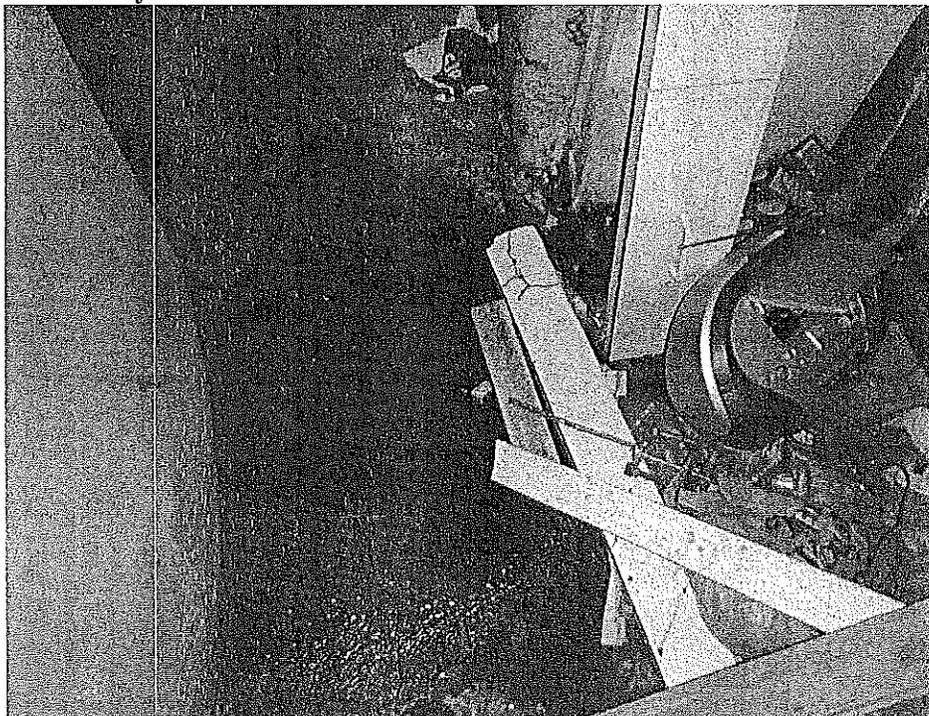
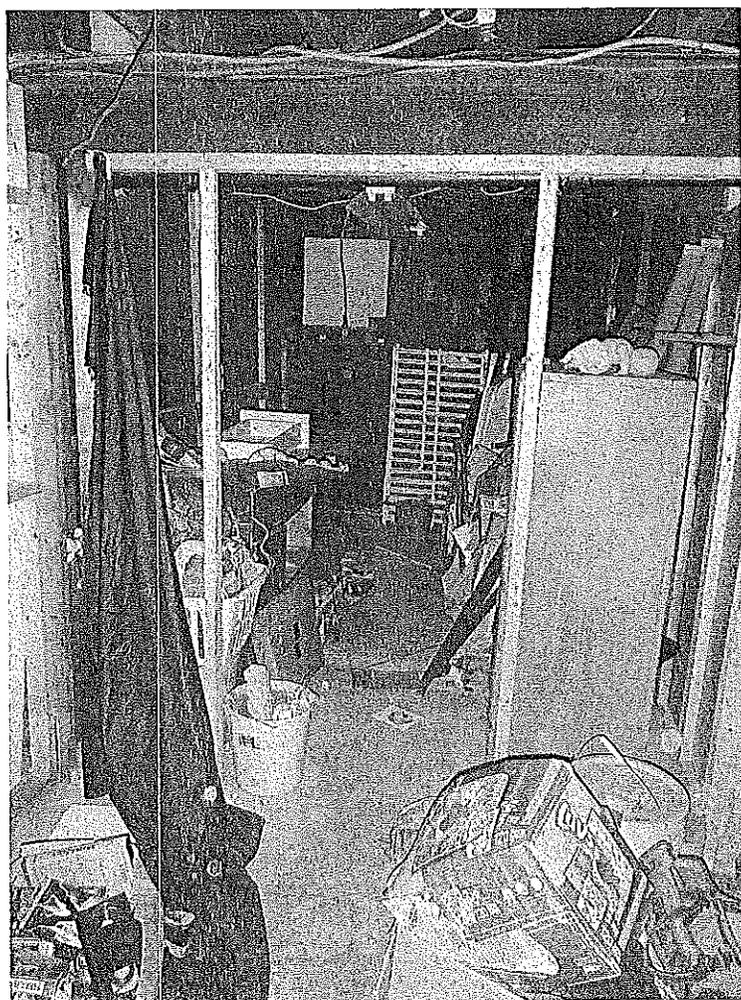
66 Pasadena – Standing water in basement – There is standing water in the basement which is either the result of poor sewer drainage, water leaking in from the room or faulty plumbing. It is creating an unsanitary condition.

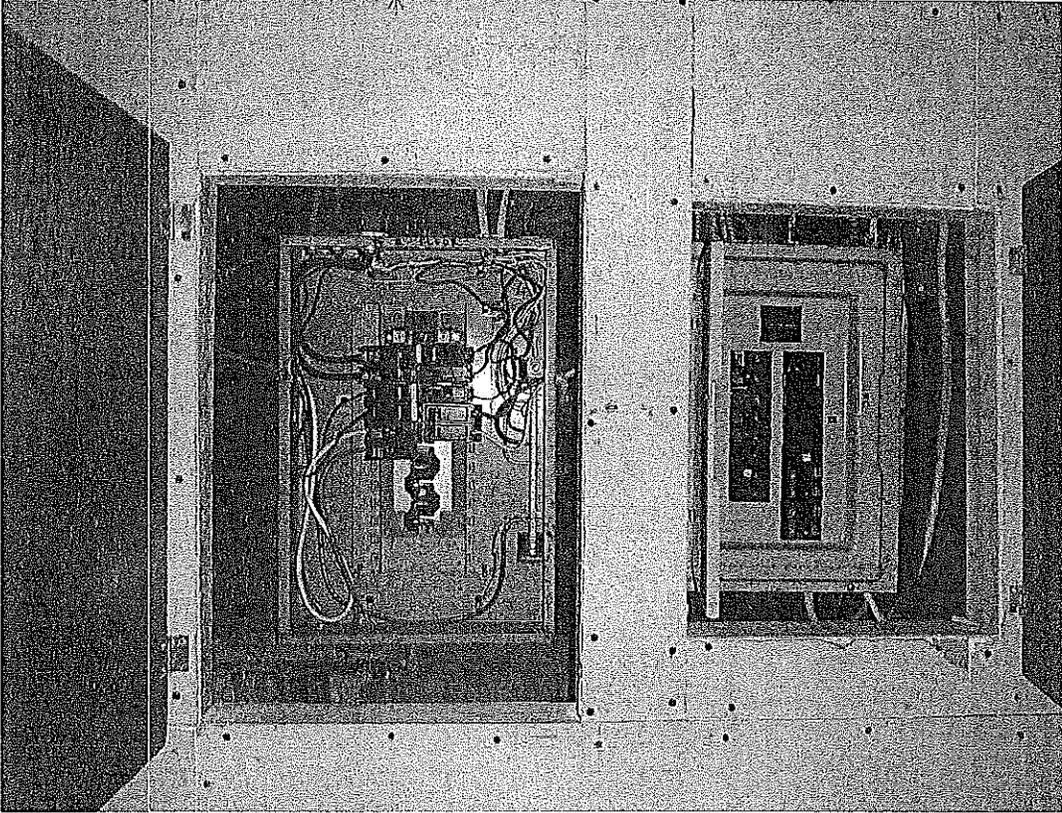
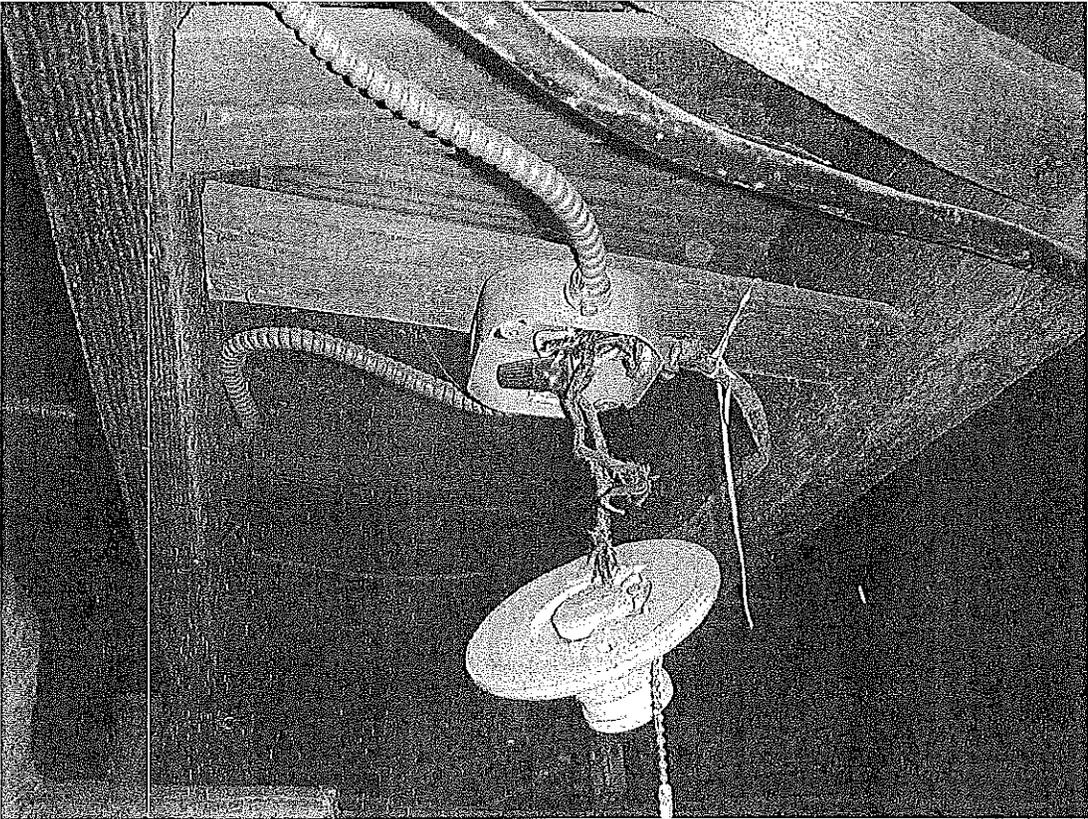
66 Pasadena – Electrical System – The electrical system has been tampered with and throughout the house there are exposed wires and panels.

11. Finish plumbing and electrical work.
12. Finish Cosmetic and de-leading work
13. Permit sign offs & Inspections
14. Market the units for rent.

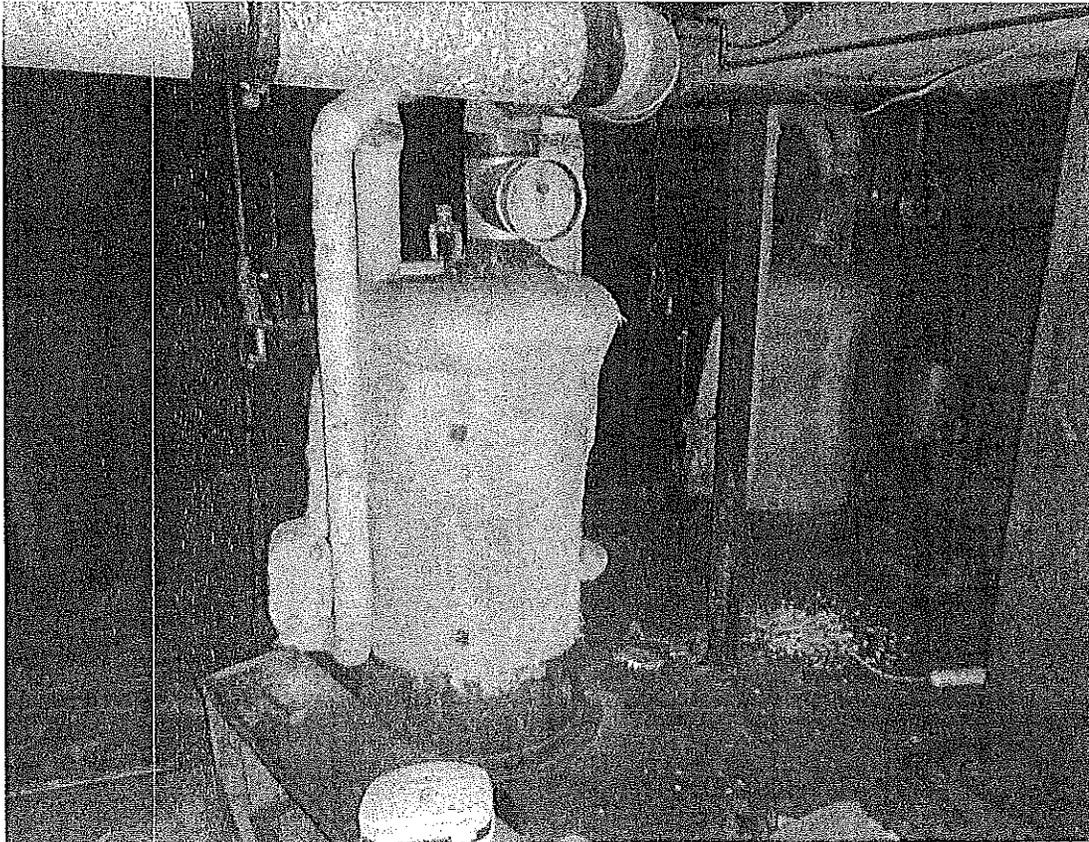
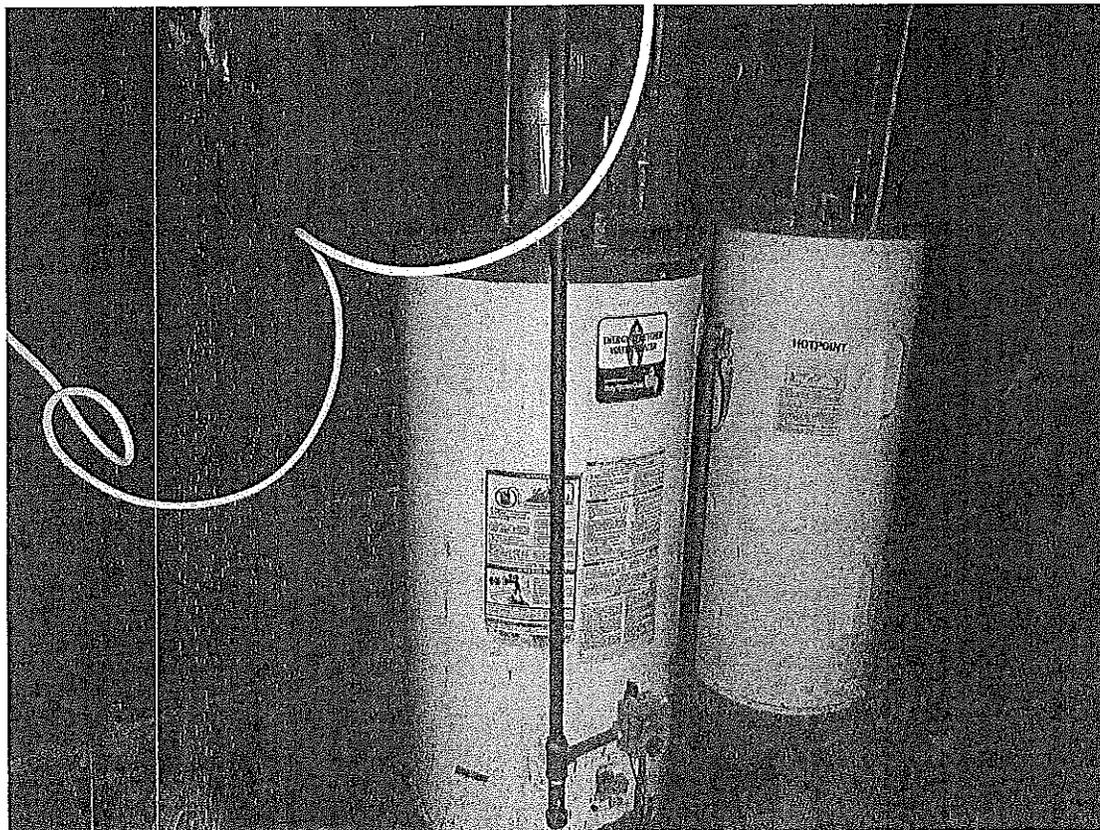
66 Pasadena – Heating Systems & Hot Water Heaters– The heating systems are older obsolete oil fired steam boilers. An evaluation will be made as to whether or not these systems can be serviced or whether replacement is necessary. Hot water heaters will also be tested and replaced as necessary.

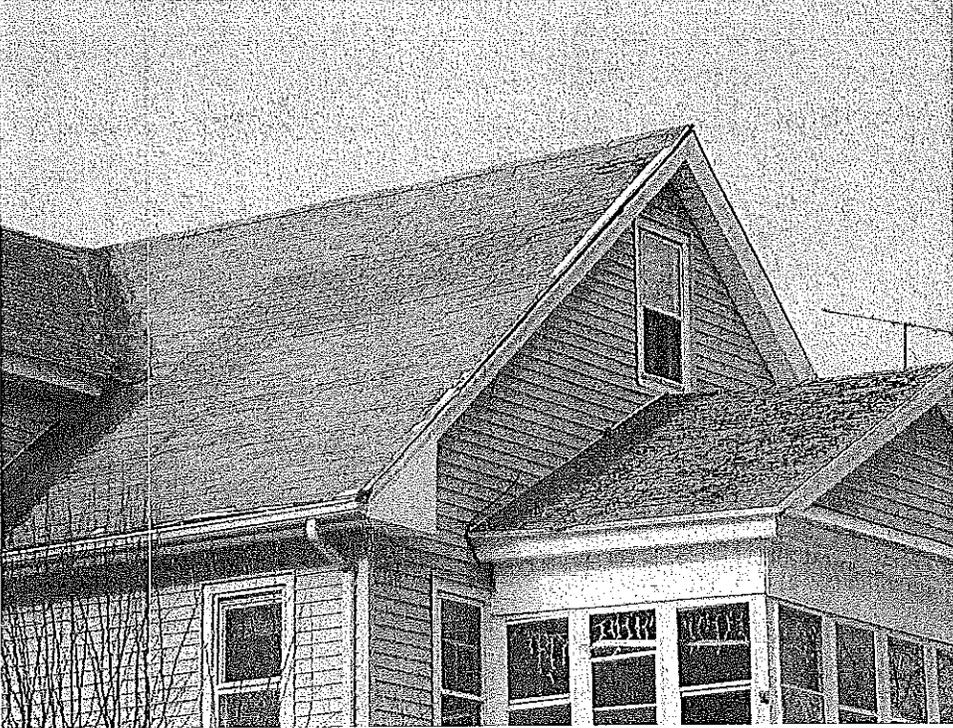
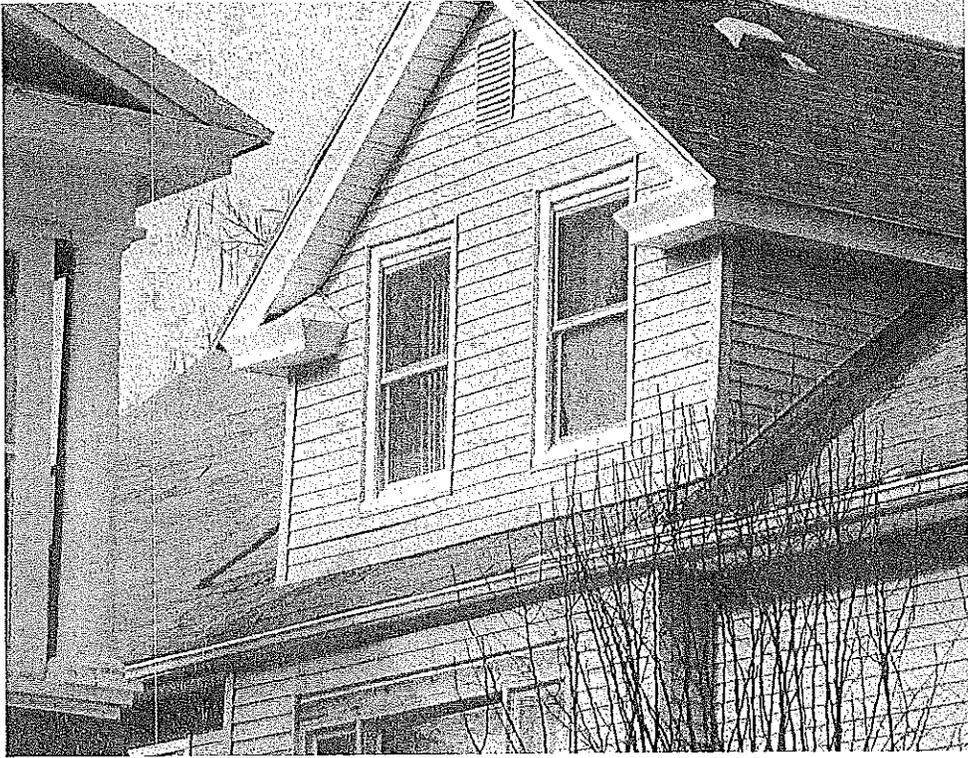
66 Pasadent – Roof detail showing deterioration and patched areas.
