The Springfield Armory

Historic Background

Report by Todd Jones, Historic Preservation Specialist
Federal Emergency Management Agency
October 2011

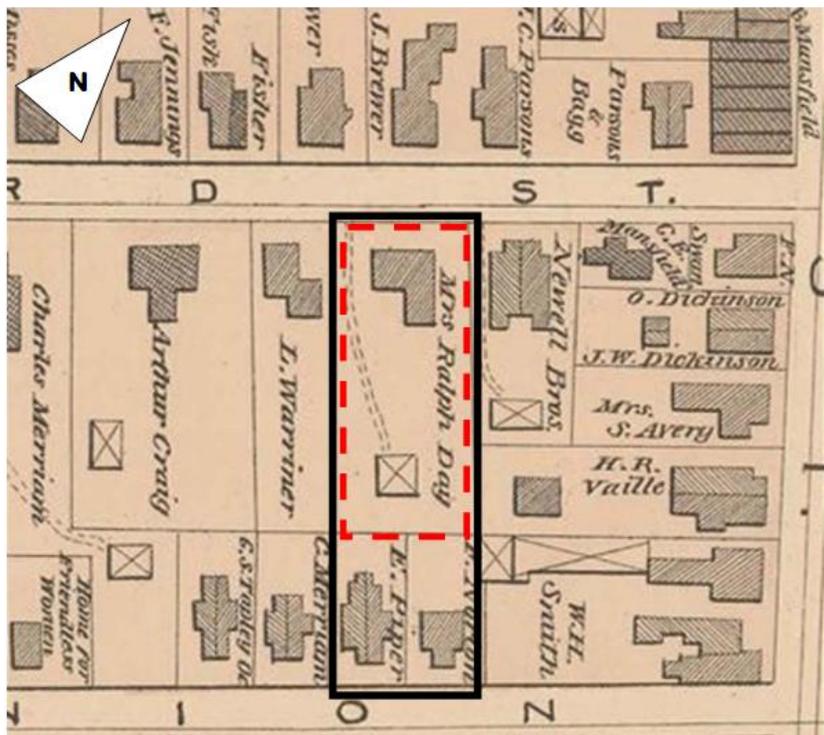
Figure 4: Site of the Springfield Armory in 1882, before construction of the Armory. The dashed red line delineates the location of the 1895 Armory and the black box outlines the site of the 1915 Armory.⁴

The rear portion of the Armory was known as the “Drill Shed,” and featured low buttressed walls of granite, brownstone, and brick supporting a gable roof. A series of small arched-windows placed evenly along the side walls allowed the sun to beam in from the east and west (*see figure 9*). The vast gymnasium-like interior space was primarily used by soldiers for assembly, practice, and exercise (*see figure 6*). In a 1910 Adjutant General’s Report, the Drill Shed was described as a 75’ X 146’ structure.⁶ Its southern extent terminated at a one-story projection labeled “boat shed,” associated with the Connecticut River located 1200’ to the west, as well as the Armory’s Naval Brigade.⁷ The Drill Shed extended as far south as the property lines of E. J. Piper and the late F. Norton⁸ (*see figures 4 and 5*).

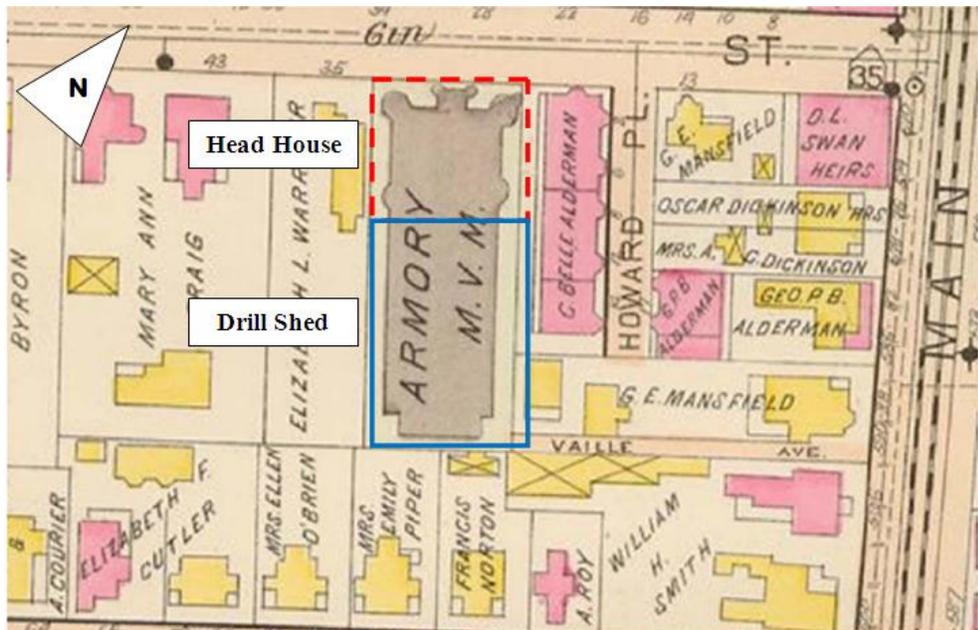
Figure 5: This 1899 map shows the 1895 Head House (dashed red line) and 1895 Drill Shed (blue).⁵

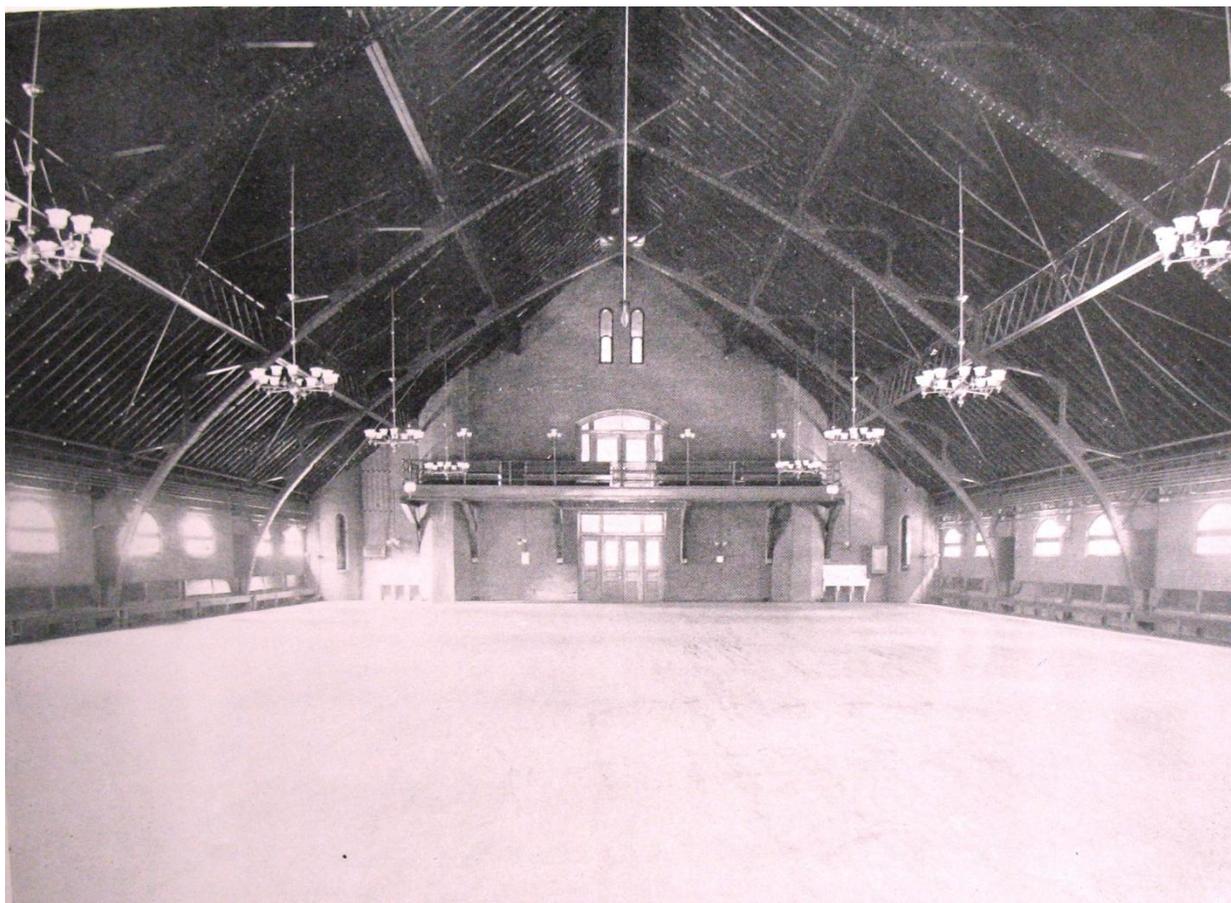
Figure 6: The interior of the 1895 Drill Shed as it appeared c. 1899. The image is looking north towards the Head House.⁹

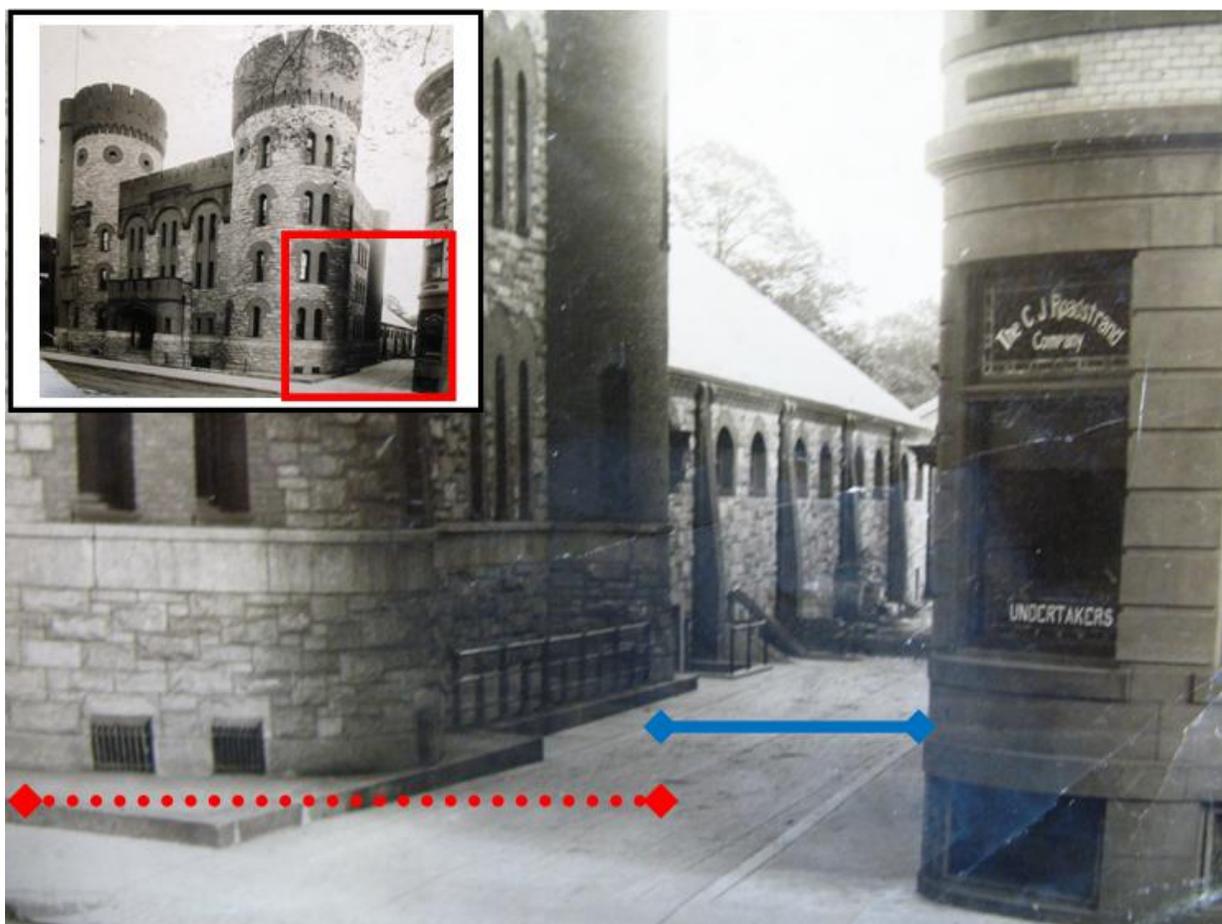
Figure 9: Circa 1910 photograph detailing the stylistic uniformity between the 1895 Head House (delineated by the dotted red line above) and Drill Shed (delineated by solid blue line). Note the Drill Shed’s gable roof and buttresses (center).¹⁴

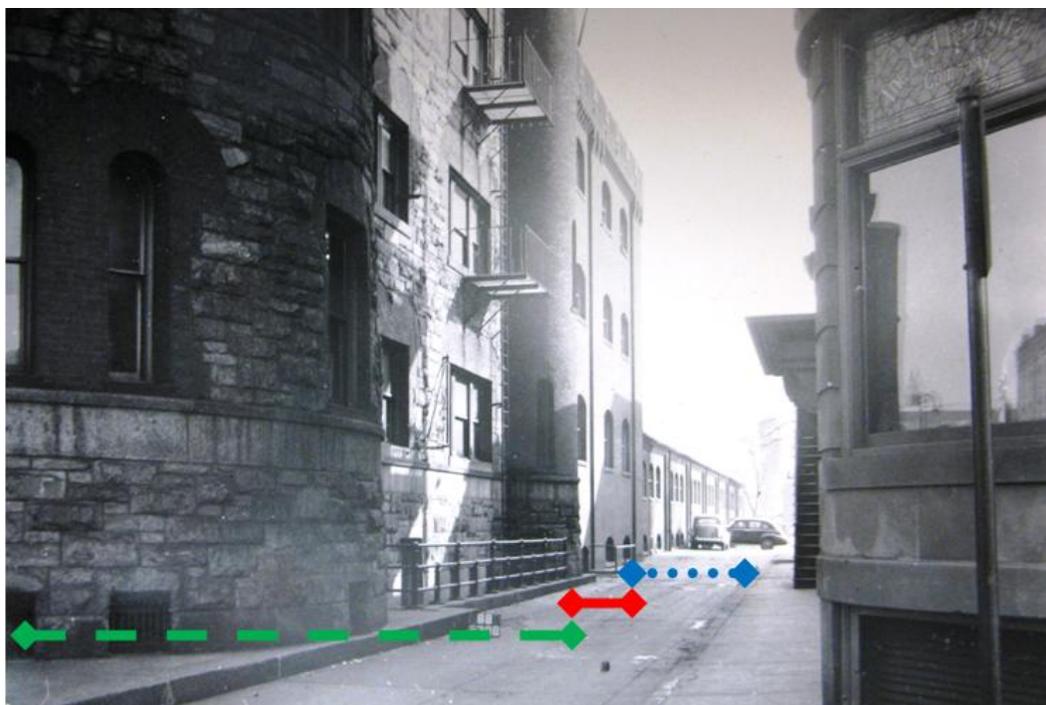
Figure 10: The 1915 Armory as it appeared in 1939. This view is looking southeast from Howard Street, with the Armory at left and center. The dashed green line details the extent of the original 1895 Head House; the solid red line shows the length of the 1915 addition to the Head House; the dotted blue line exhibits the span of the 1915 Drill Shed.¹⁸

The original 1895 Drill Shed was deconstructed to make room for the expansion, but some of it was re-used, such as two of its steel trusses. The Head House Addition and a portion of the 1915 Drill Shed were also likely constructed on the foundation walls of the original 1895 Drill Shed.¹⁹ The Head House Addition nearly doubled the size of the 1895 Head House, extending to the south approximately the same length and width as the earlier structure. Historic maps indicate that the properties to the south owned by Piper and Norton's estate were acquired by the state for this expansion (*see figure 10*).²⁰

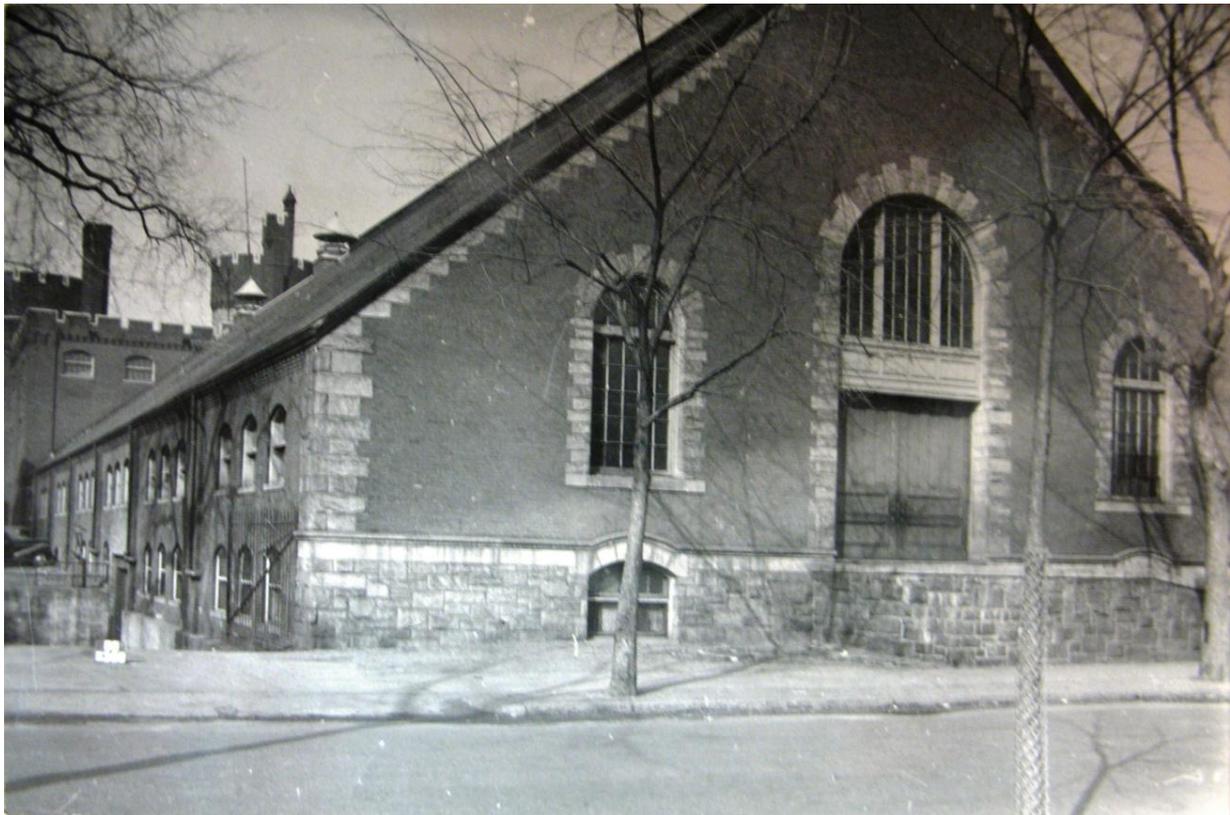
Figure 11: The Drill Shed as it appeared in 1939 from Union Street looking north towards the Head House.²²

The new 1915 Drill Shed was directly attached to the Head House Addition. At 211' in length, this new Drill Shed was longer than its predecessor, but retained a similar gable roof with an even more impressive expanse of unbroken slate tiles, interrupted only by two rooftop copper ventilators. Tongue-and-grove board sheathing upon a complex system of steel joists and purlins supported the roof. Long steel trusses spanned from east to west, and the impressive roof structure was intentionally exposed on the interior. The brick gable end on Union Street had large wooden doors and arched windows, echoing the style of the 1895 Head House in a much simplified form. The large interior room of the new Drill Shed consisted of over 16,000 square feet of floor space. According to the *Springfield Republican* in 1915, "the drill shed easily makes the largest hall in the city"²³ The expanded Drill Shed basement created a massive storage area, even offering access and subterranean space for numerous army wagons, and later automobiles. The basement also included a bowling alley, rifle range, and billiard room among other amenities.²⁴

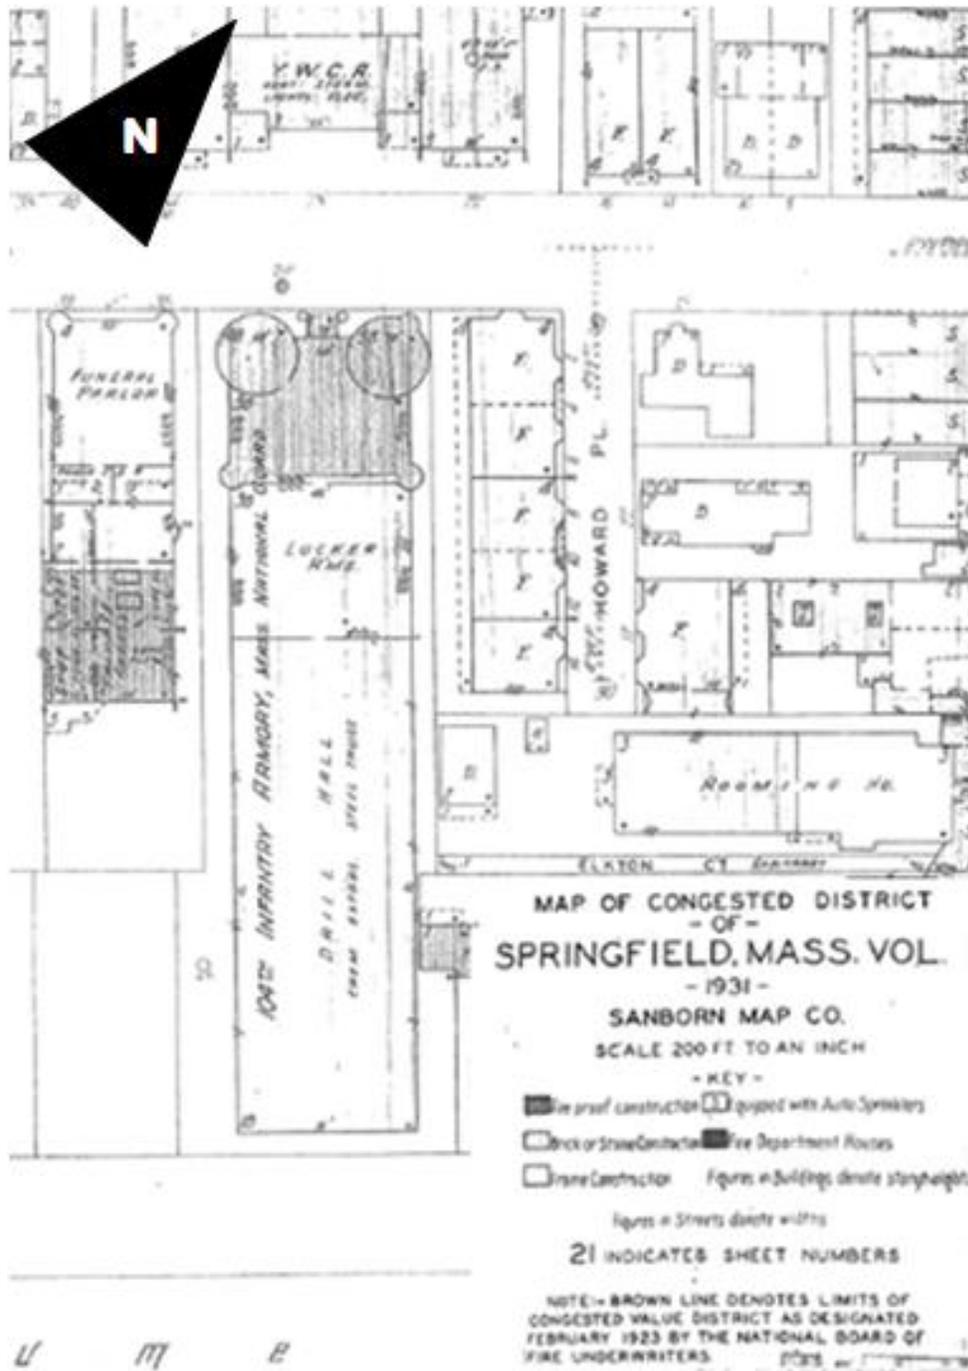
Figure 12: 1931 Sanborn Map showing Armory.³⁵

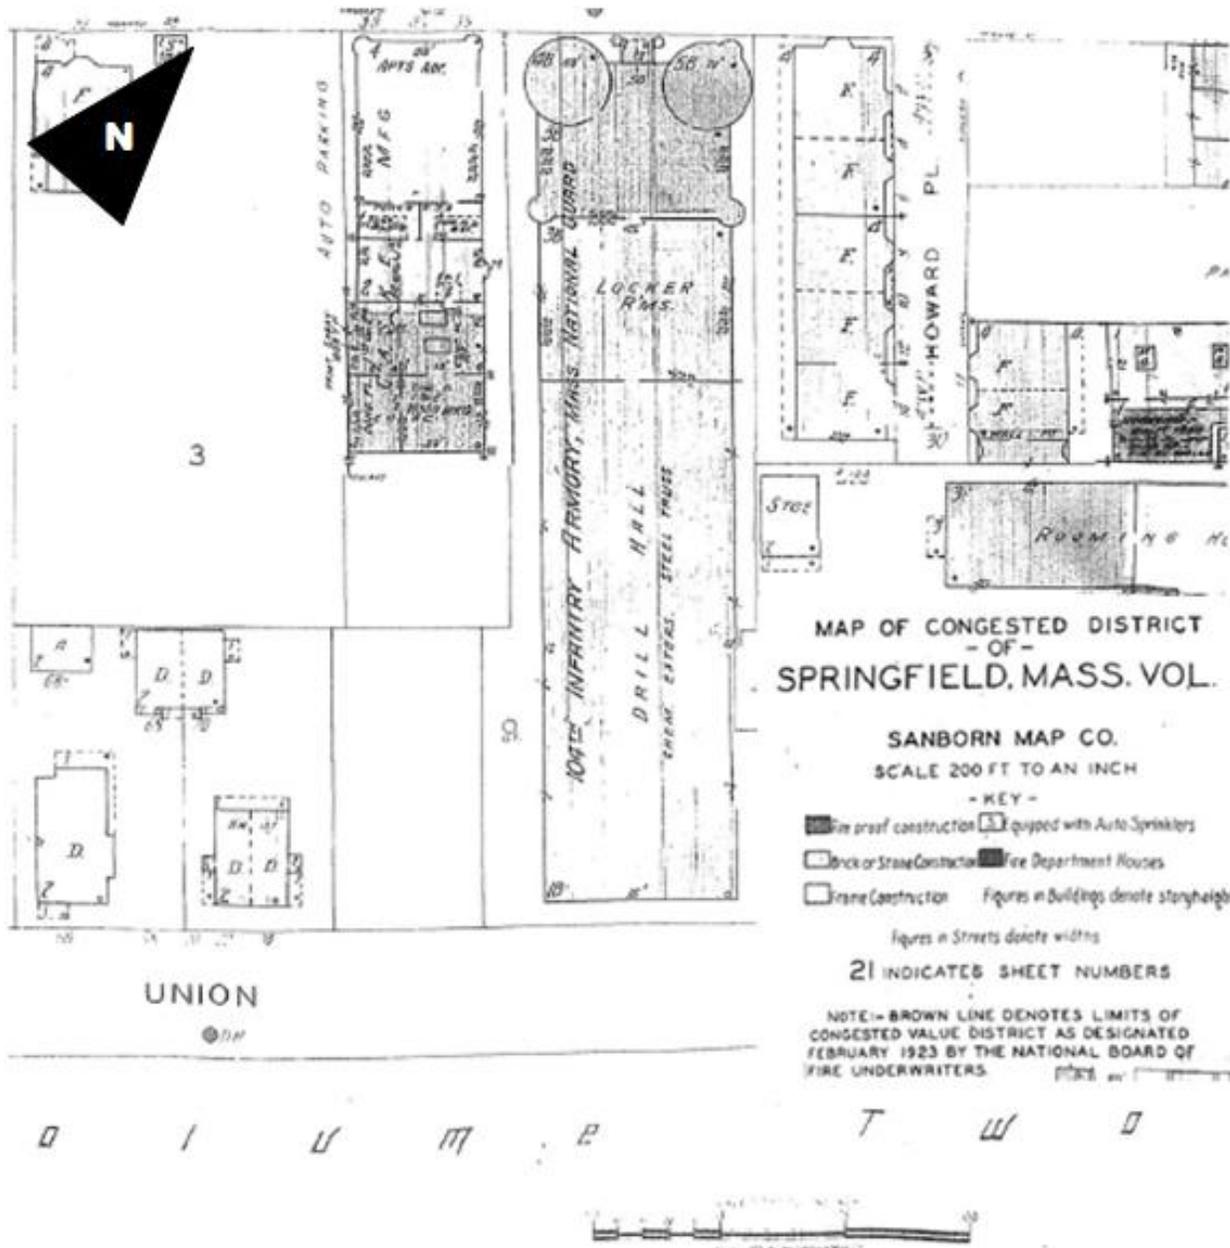
Figure 13: 1950 update to 1931 Sanborn Map.³⁶

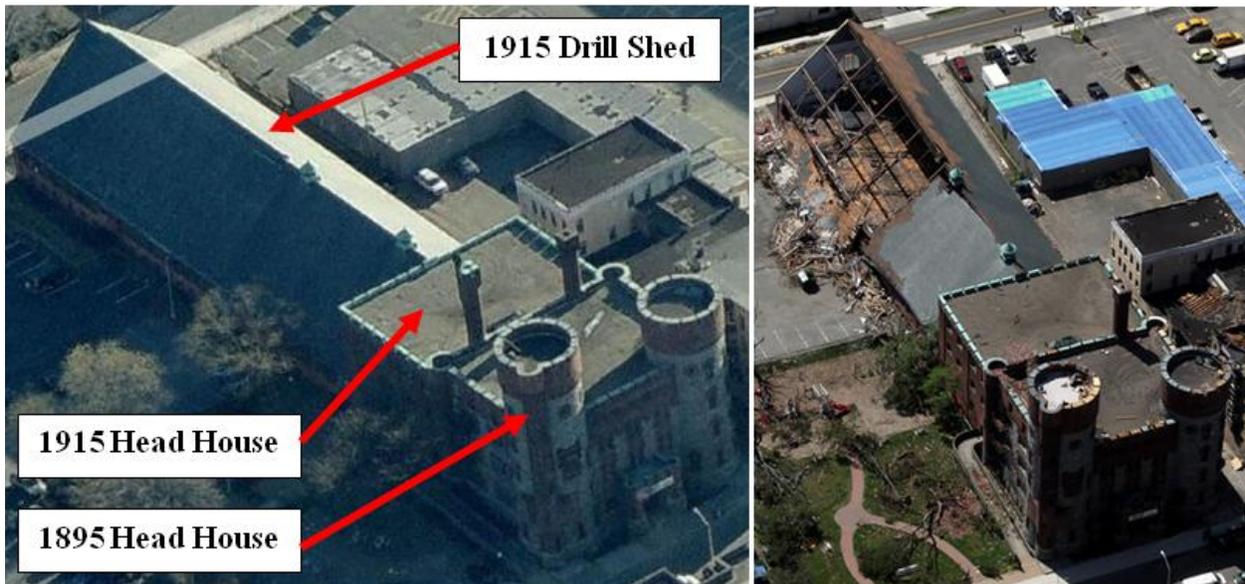
Figure 14: Pre-tornado (left) and post-tornado (right) images of the Springfield Armory

On the afternoon of June 1, 2011, the Drill Shed provided essential cover for the last time, as a group of people rushed into the structure's stone basement to escape the horrific winds and screams of an unthinkable urban tornado. The people thankfully survived; the Drill Shed sadly did not. The tornado carved a visible path of destruction through the city's South End, from the Connecticut River, up Central Street, all the way to Springfield's eastern border. The Head House suffered superficial damages compared to the devastation brought upon the Drill Shed. The eastern half of the roof had almost entirely fallen to the ground, taking a large portion of the brick side wall with it and exposing a massive amount of the interior. On July 2, 2011, officials saw it prudent to demolish the Drill Shed for health and safety reasons on account of its structural deficiencies.
