RESILIENCY IMPROVEMENTS AT WATERSHOPS POND DAM DRAWDOWN PERIOD MONITORING REPORT #9

SEPTEMBER 14, 2021

RESILIENCY IMPROVEMENTS AT WATERSHOPS POND DAM
1 ALLEN STREET
SPRINGFIELD, MASSACHUSETTS

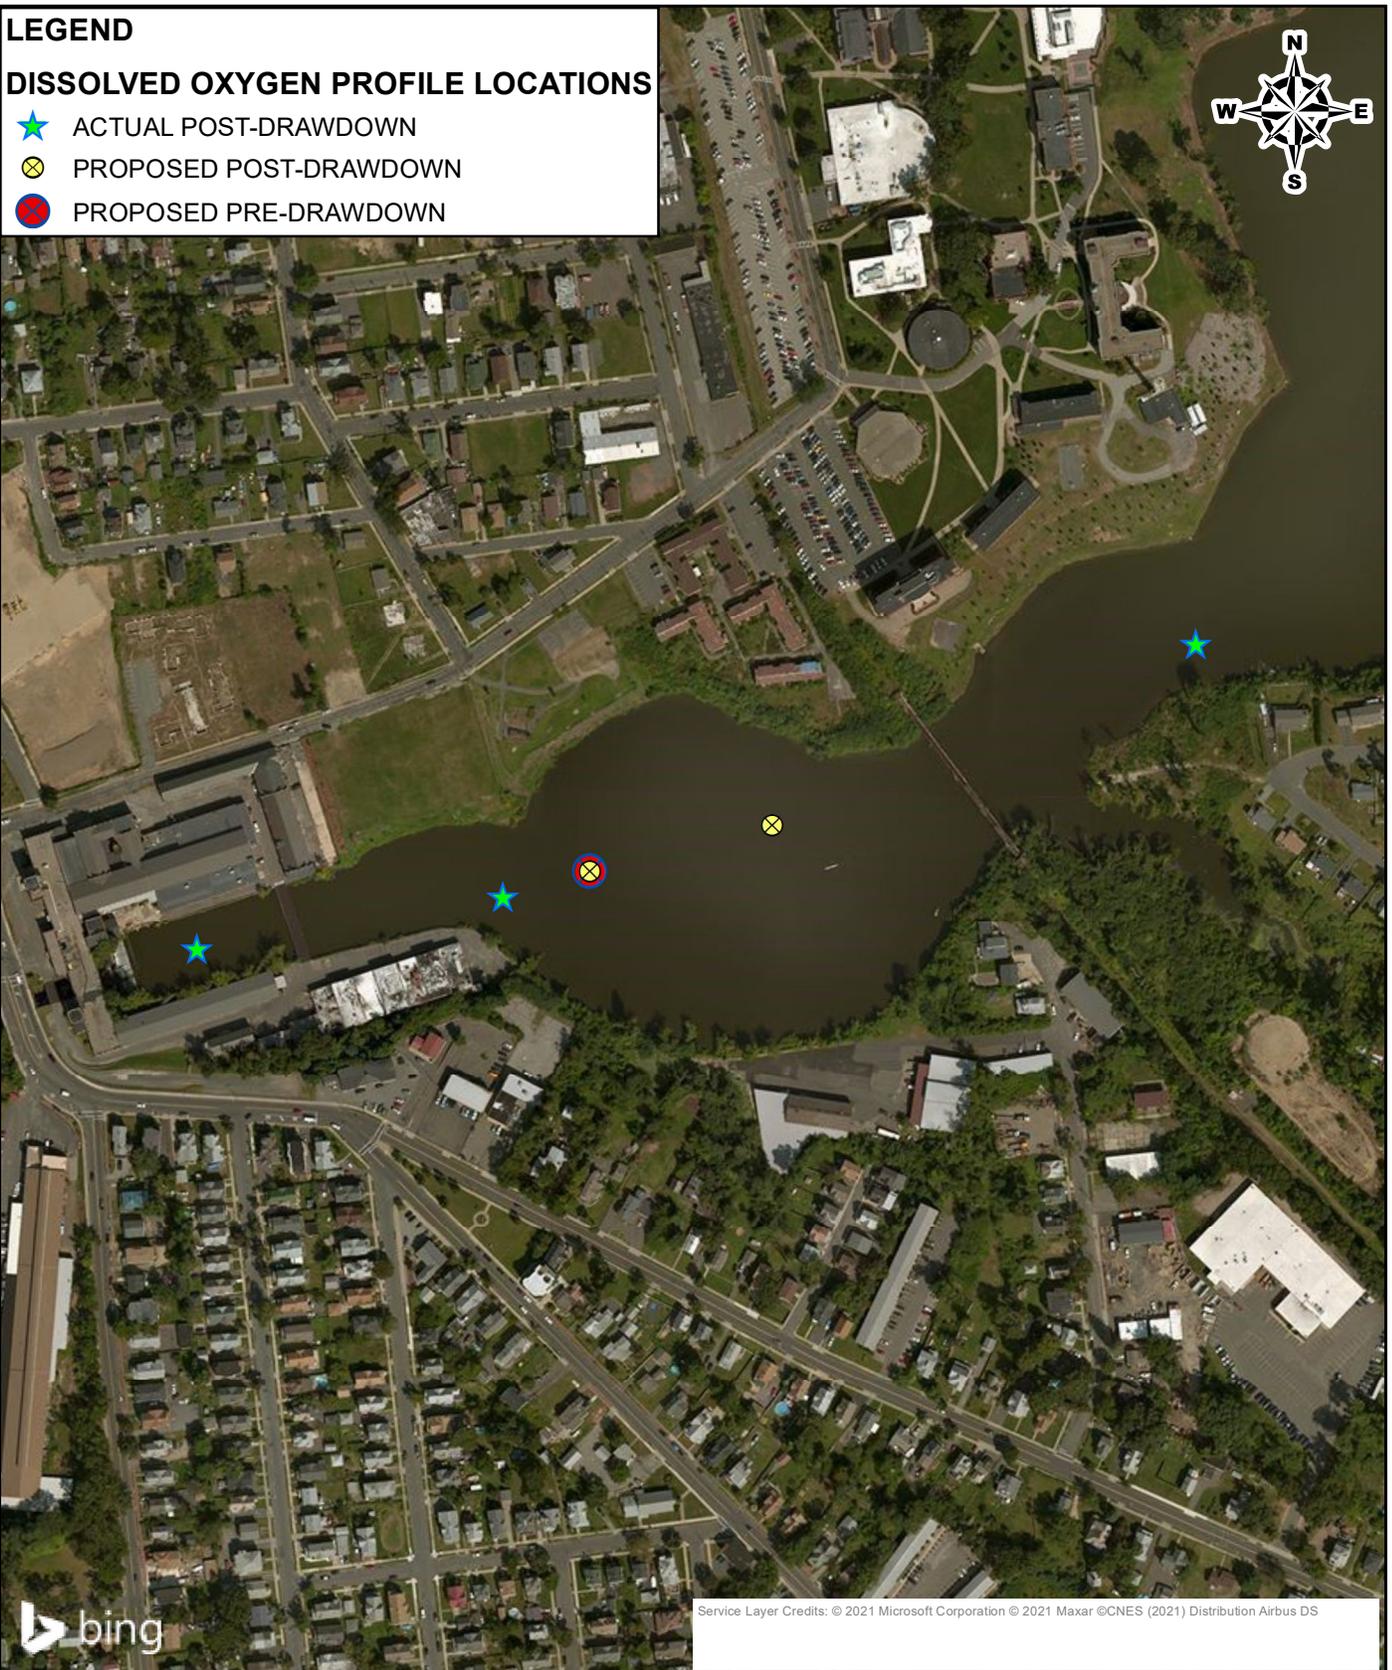
FIG.
1A

The current water quality monitoring event was conducted on September 14, 2021. Monitoring was repeated at the two locations selected during the first sampling event, conducted December 15, 2020, and at a third sampling location near the dam which was added on March 23, 2021, to take advantage of deeper residual pool depth for monitoring (see **Figure 1A** for data collection locations).

DISSOLVED OXYGEN PROFILE MONITORING LOCATIONS

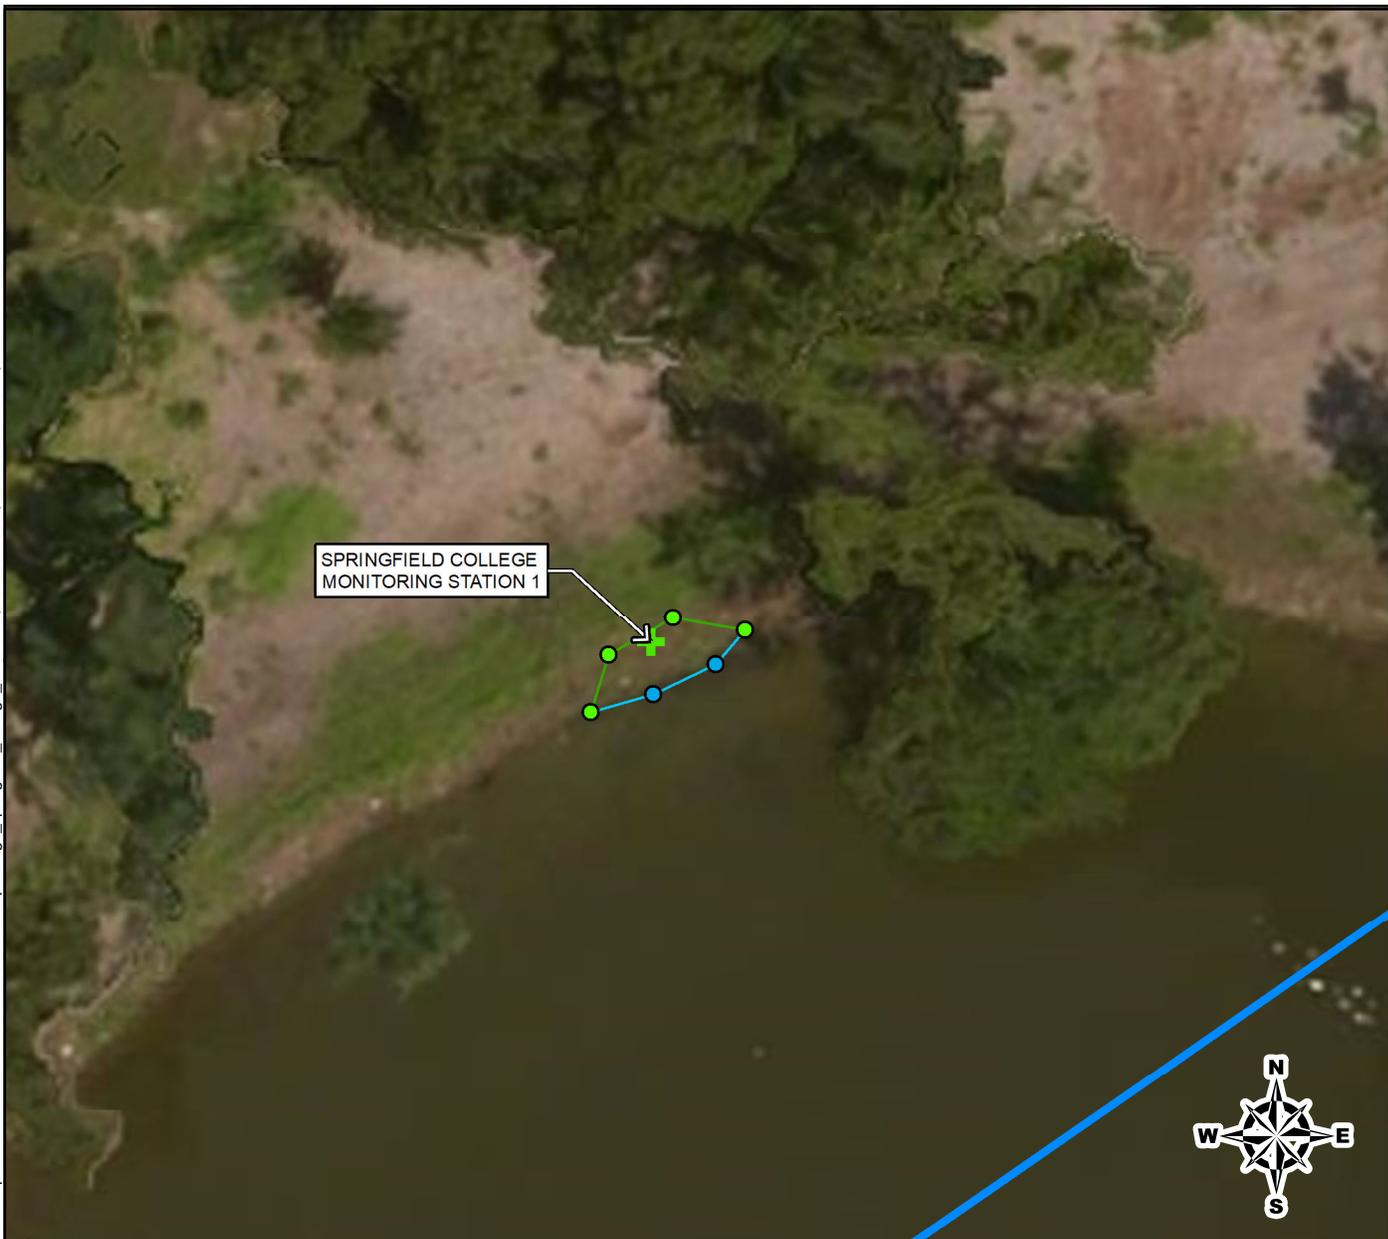
PROJ MGR: TEJ	REVIEWED BY: TEJ	CHECKED BY: SLL	FIG. 2
DESIGNED BY: JRB	DRAWN BY: ARD	SCALE: 1 in = 20 ft	
DATE: 11/24/2020	PROJECT NO: 15.0166625.20	REVISION NO:

SPRINGFIELD COLLEGE BVW

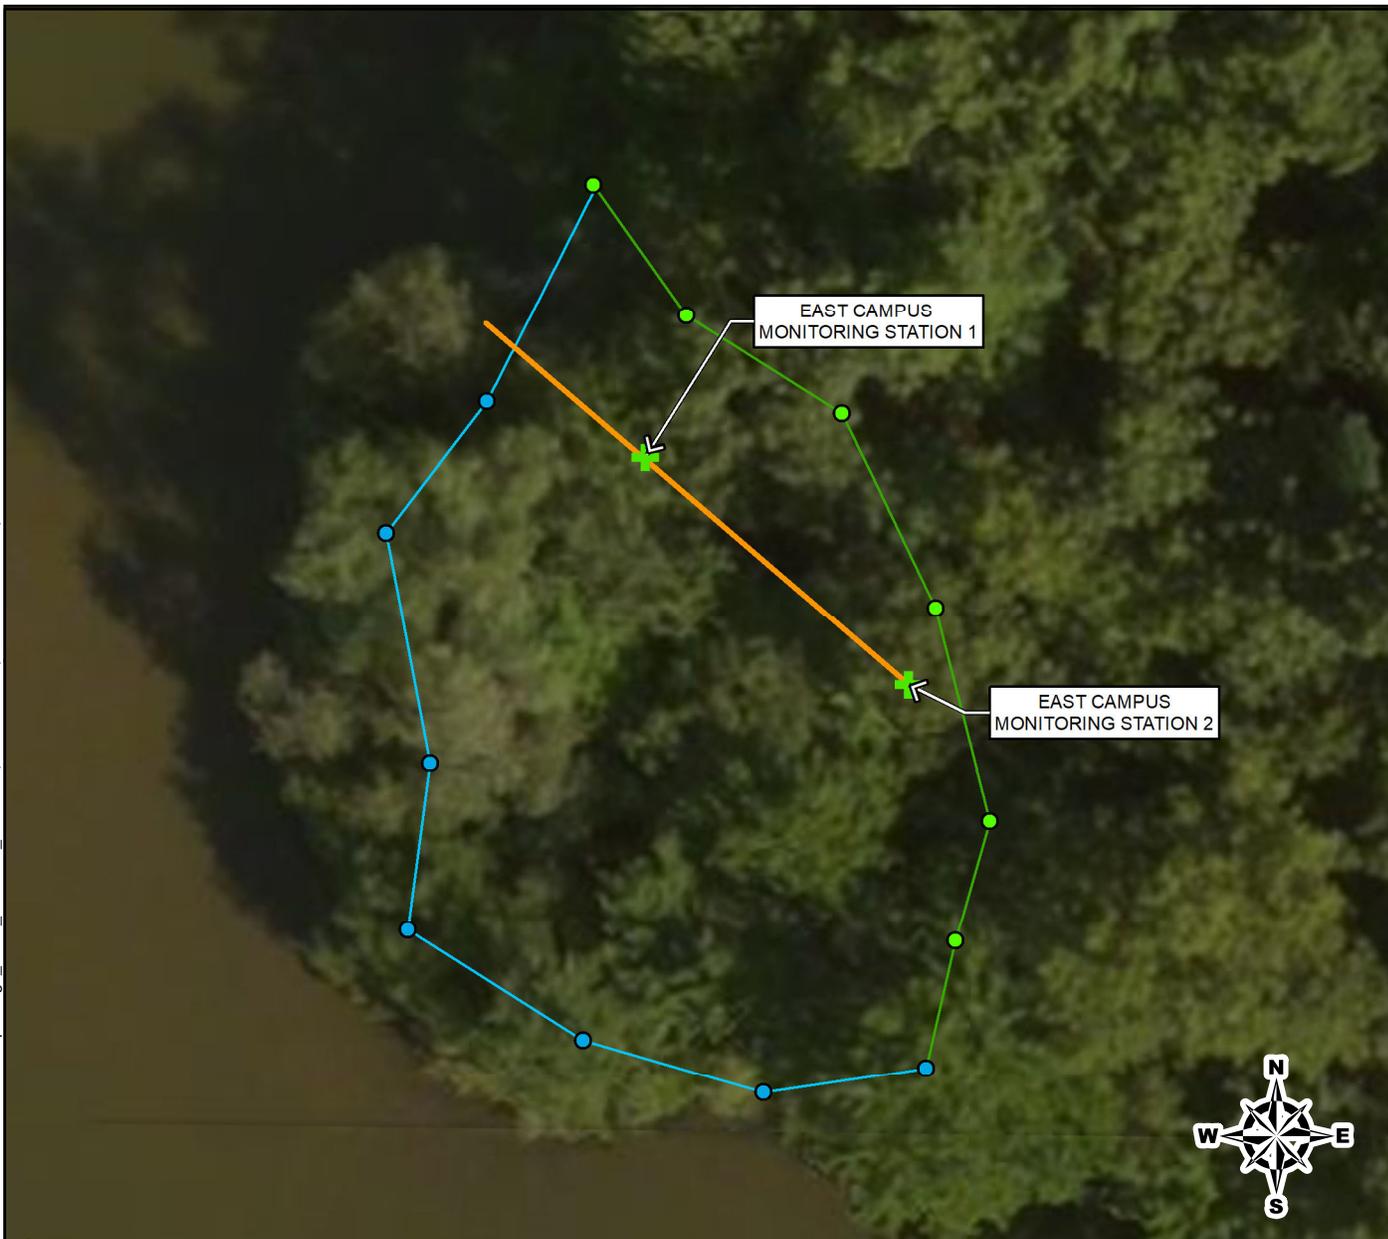
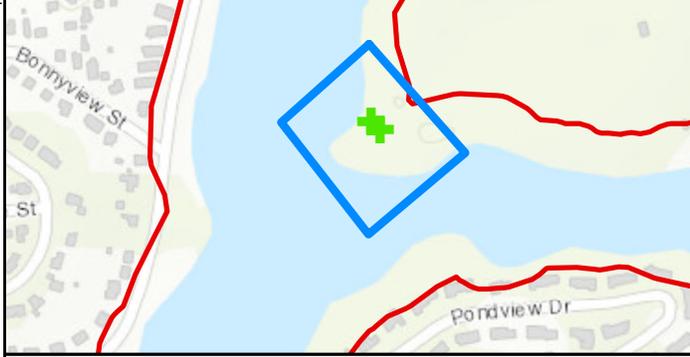
PROJ MGR: TEJ	REVIEWED BY: TEJ	CHECKED BY: SLL	FIG. 3
DESIGNED BY: JRB	DRAWN BY: ARD	SCALE: 1 in = 20 ft	
DATE: 11/25/2020	PROJECT NO: 15.0166625.20	REVISION NO:

SPRINGFIELD COLLEGE
EAST CAMPUS BVW

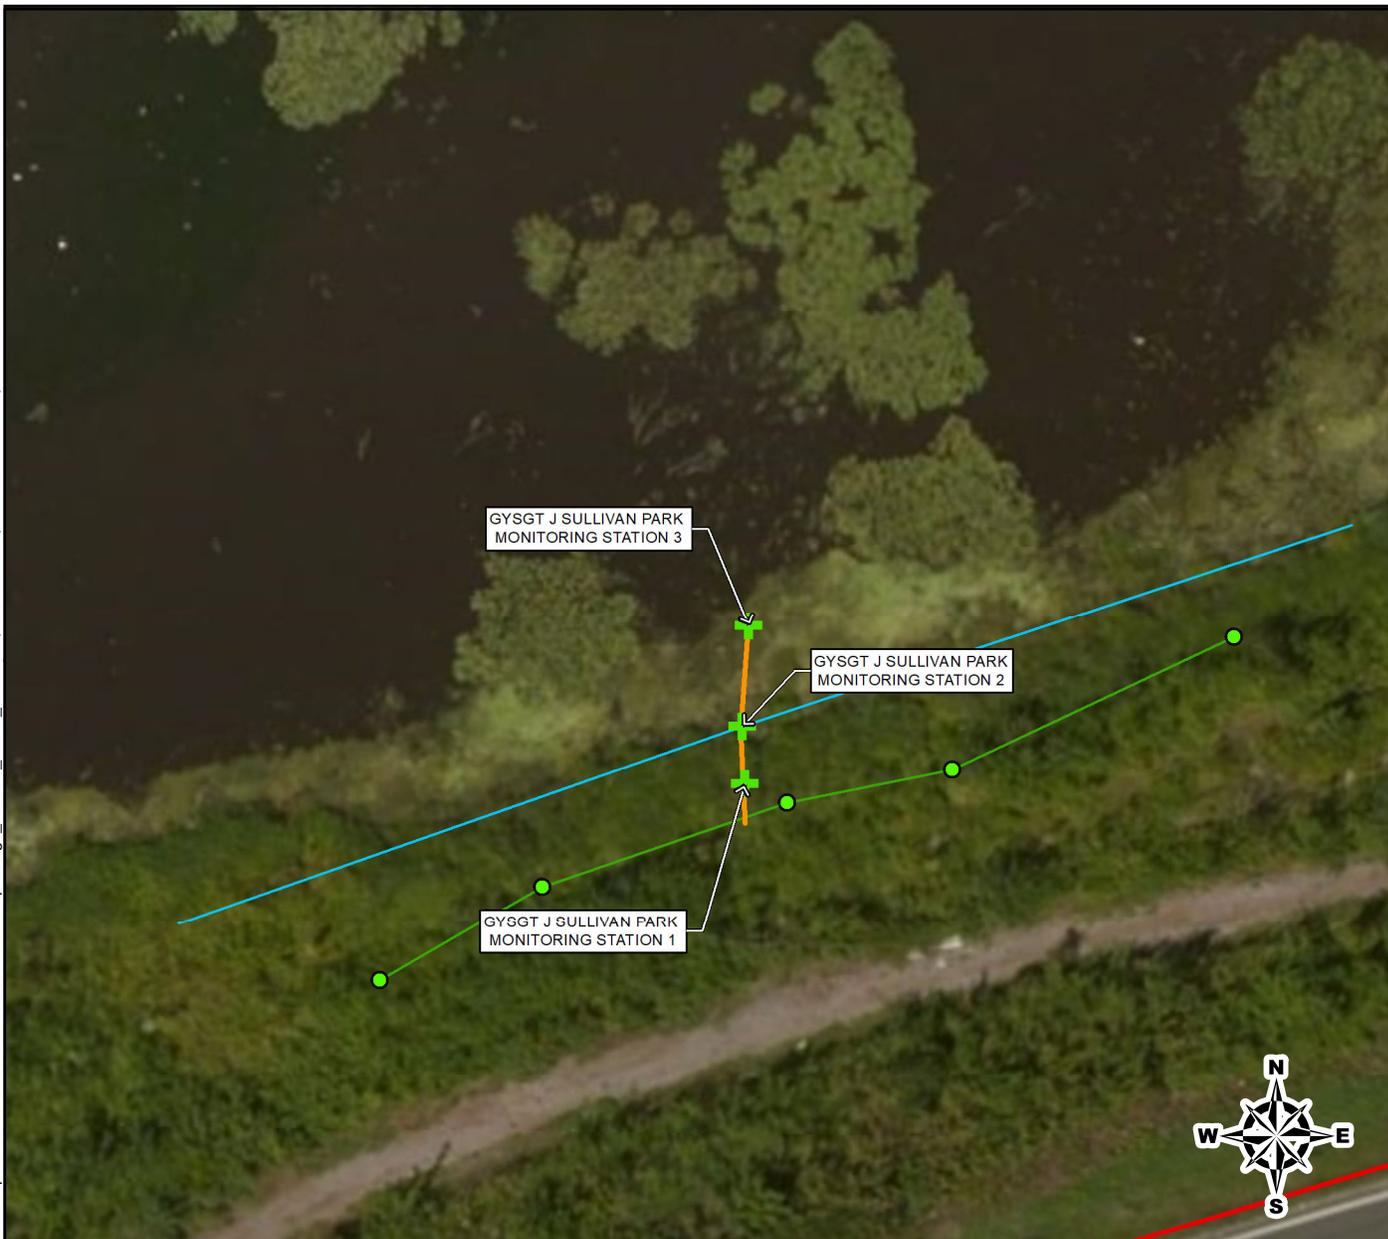
PROJ MGR: TEJ	REVIEWED BY: TEJ	CHECKED BY: SLL	FIG. 4
DESIGNED BY: JRB	DRAWN BY: ARD	SCALE: 1 in = 30 ft	
DATE: 11/24/2020	PROJECT NO: 15.0166625.20	REVISION NO:

Most observed changes in herbaceous vegetation composition were not significant with the exception of duckweed. The percentage of duckweed coverage at Sullivan Park Station 3 decreased by 85%. Duckweed is an aquatic plant which floats at the top of the water column; however, there is no standing or ponded water at this sample station currently. The duckweed is anticipated to return when the pond is refilled. Other herbaceous vegetation which shifted over 20% included an increase of clearweed, sensitive fern, jewelweed, and arrow-leaf tear-thumb at Sullivan Park. These increases indicate that the wetland is receiving sufficient surface inundation and groundwater inputs to sustain a wetland habitat despite the drawdown. These data will be discussed and analyzed further in the annual wetland monitoring report. Following the refilling of the pool, wetland impacts, and potential mitigation measures will be discussed.

GYSGT. J. SULLIVAN PARK BVW
