**REMOVAL PROGRAM
AFTER ACTION REPORT
FOR THE
FORMER CHAPMAN VALVE/CRANE CO. SITE
SPRINGFIELD (INDIAN ORCHARD), HAMPDEN COUNTY, MASSACHUSETTS
24 August through 3 November 2015**

Weston Solutions, Inc.
Superfund Technical Assessment and Response Team IV (START)
101 Billerica Avenue, Building 5, Suite 103
North Billerica, Massachusetts 01862

February 2016

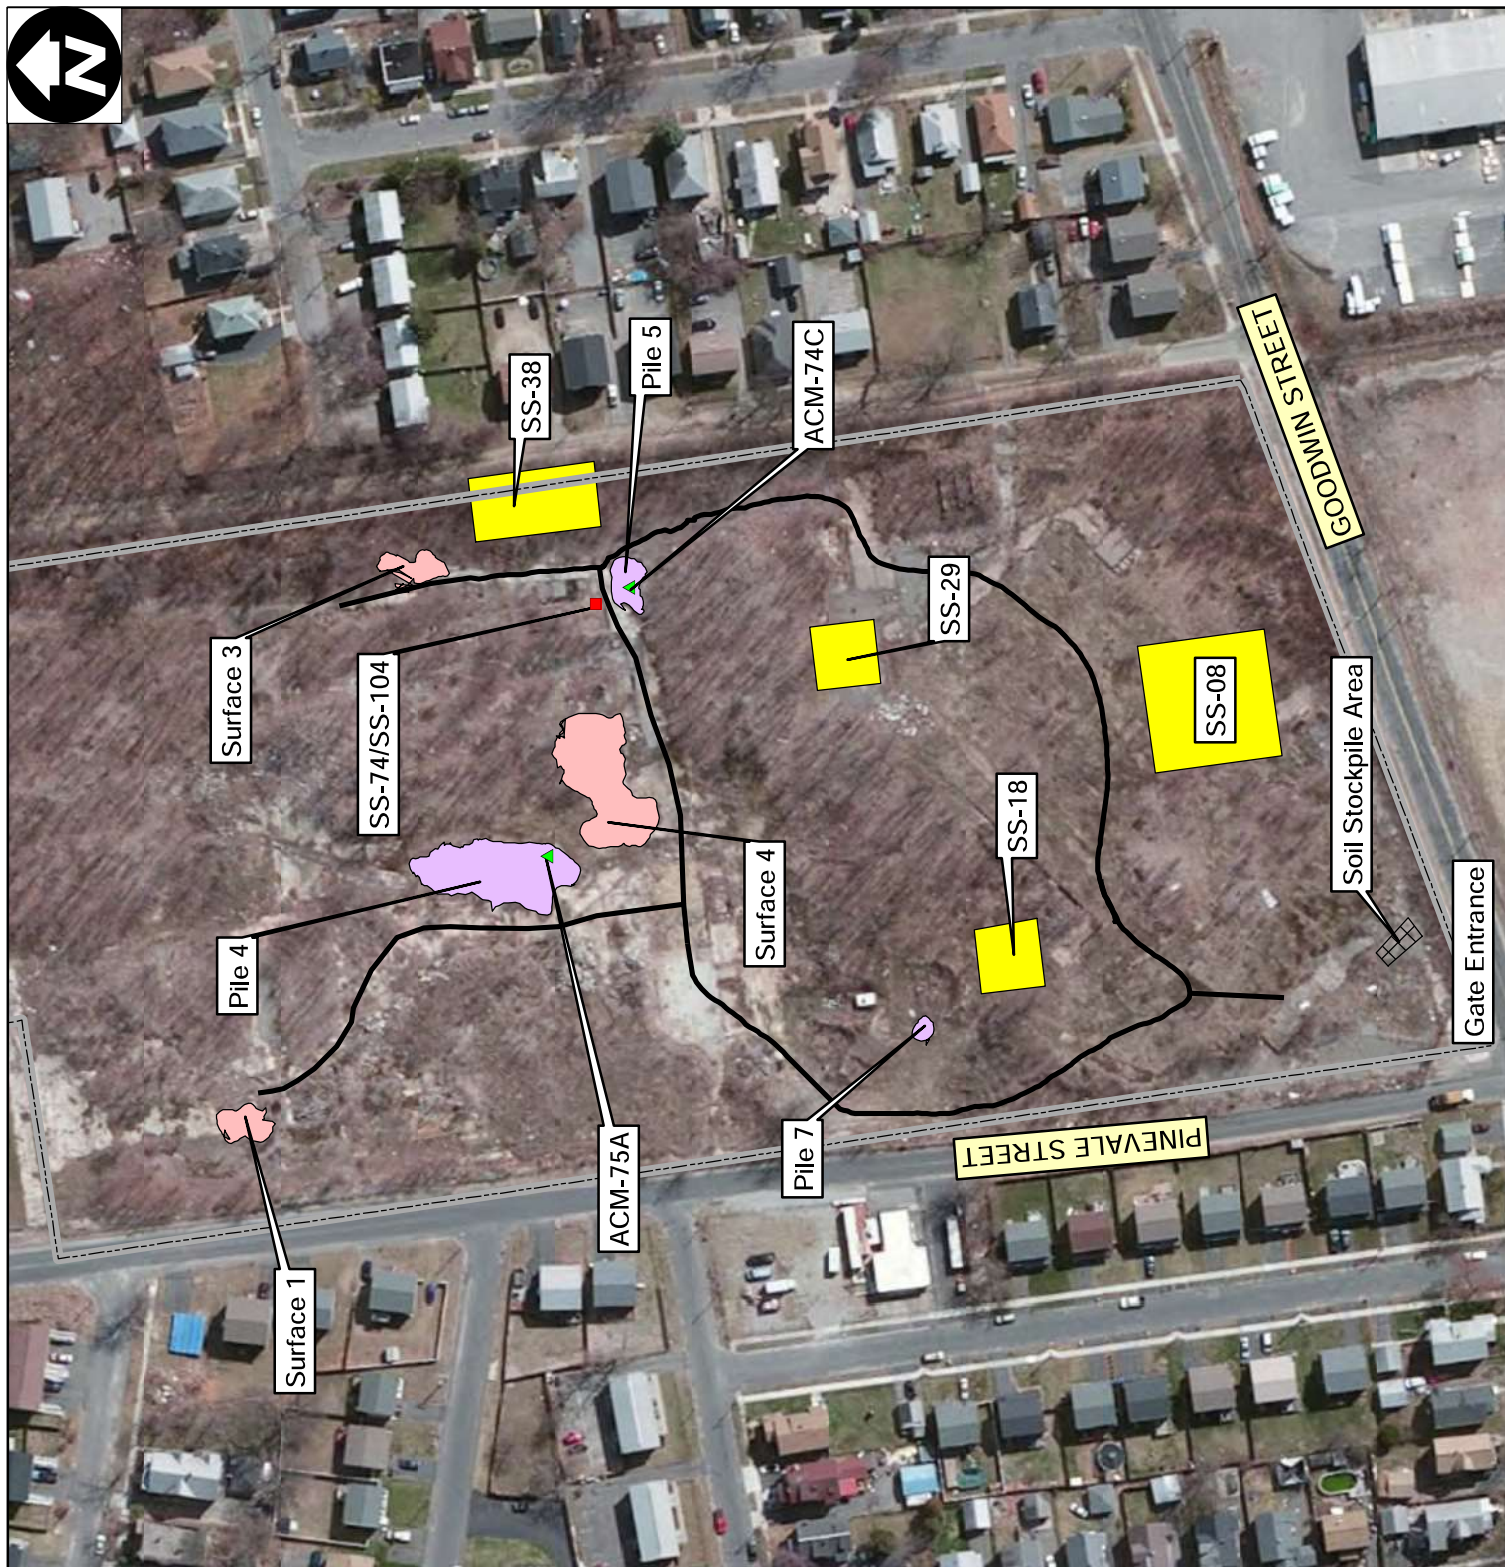
Excavation Area Map

The Former Chapman Valve/Crane Co. Site (the site) is located adjacent to 121 Pinevale Street in the village of Indian Orchard, Springfield, Hampden County, Massachusetts (MA) (see Figure 1 – Site Location Map) [1]. The site does not have a specific street number address, but is referred to as a commercial property along Pinevale Street on the City of Springfield Property Record Card, Map Identification Number 097550086. The geographic coordinates of the approximate center of the site are 42° 09' 17" north latitude and 72° 29' 59" west longitude. The original property was 54 acres, but the site now only covers approximately 16 acres. The original 12 factory buildings have all been demolished, leaving only the foundation slabs, most of which were demolished by 1996. The site is bordered by Moxon Street and residential properties to the east; Pinevale Street and residential properties to the west; an industrial property owned by the city of Springfield to the north; and Goodwin Street, a Solar Panel Farm, and vacant lots that were part of the original 54 acres to the south (see Figure 2 – Excavation Area Map) [2]. The site is currently owned by the City of Springfield.

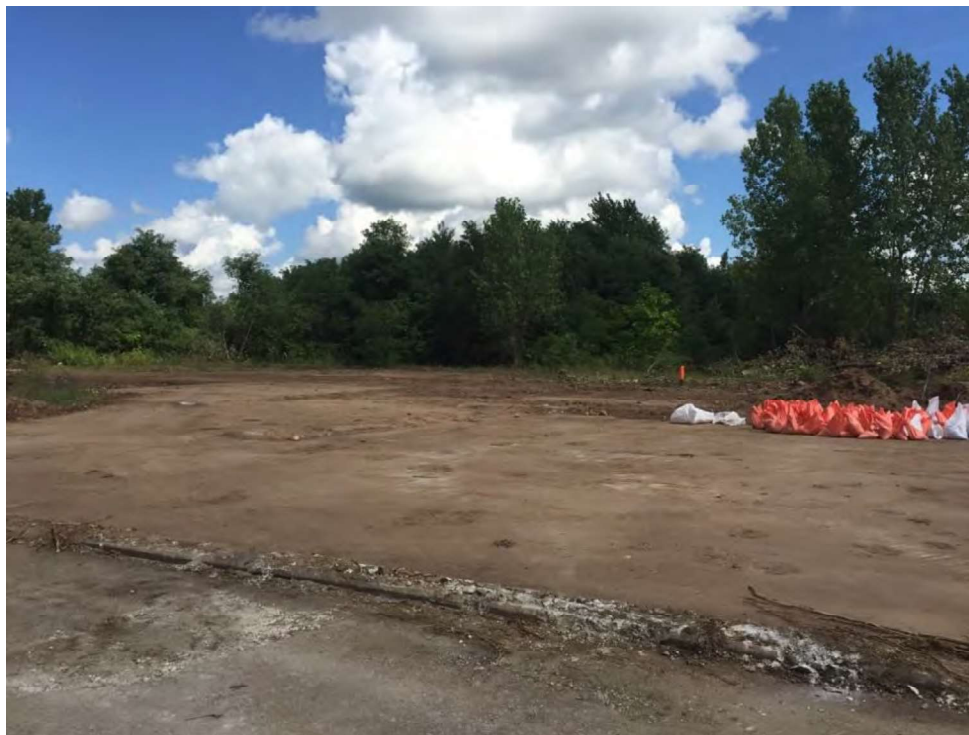
SCENE: View of the access road entrances. Photograph taken facing northeast.

Site preparation activities conducted by ERRS personnel consisted of mobilizing personnel and equipment; preparing a support zone, contamination reduction zone, and staging area; removing debris, tree stumps, and vegetation from the work areas; and construction of a temporary road to allow access to asbestos contaminated areas.

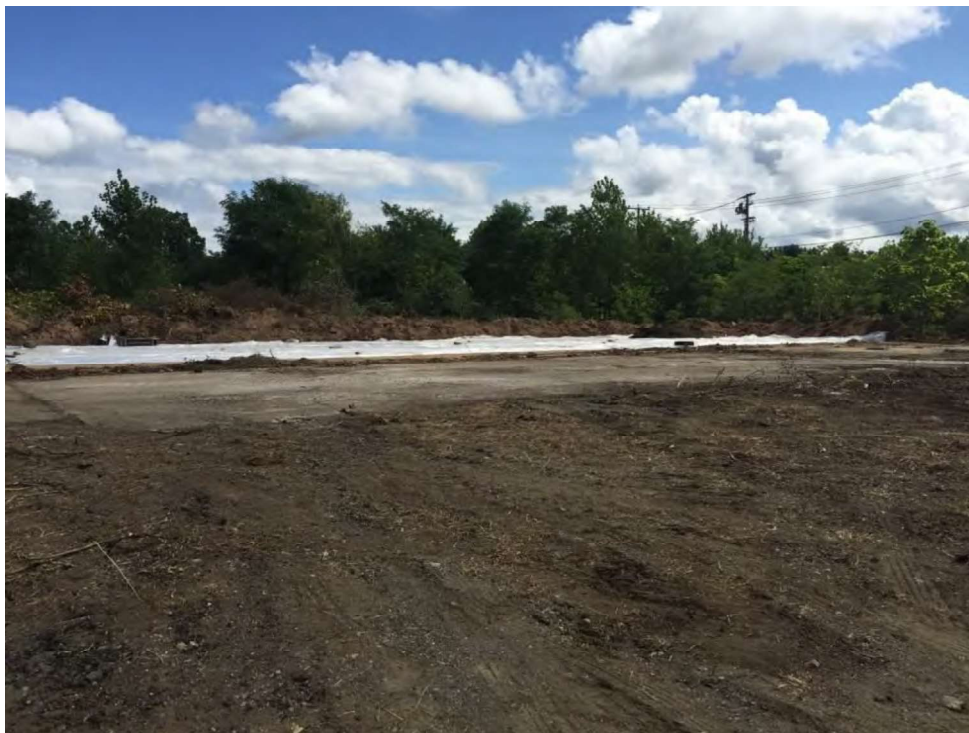
SCENE: View of the soil pile staging area. Photograph taken facing east.

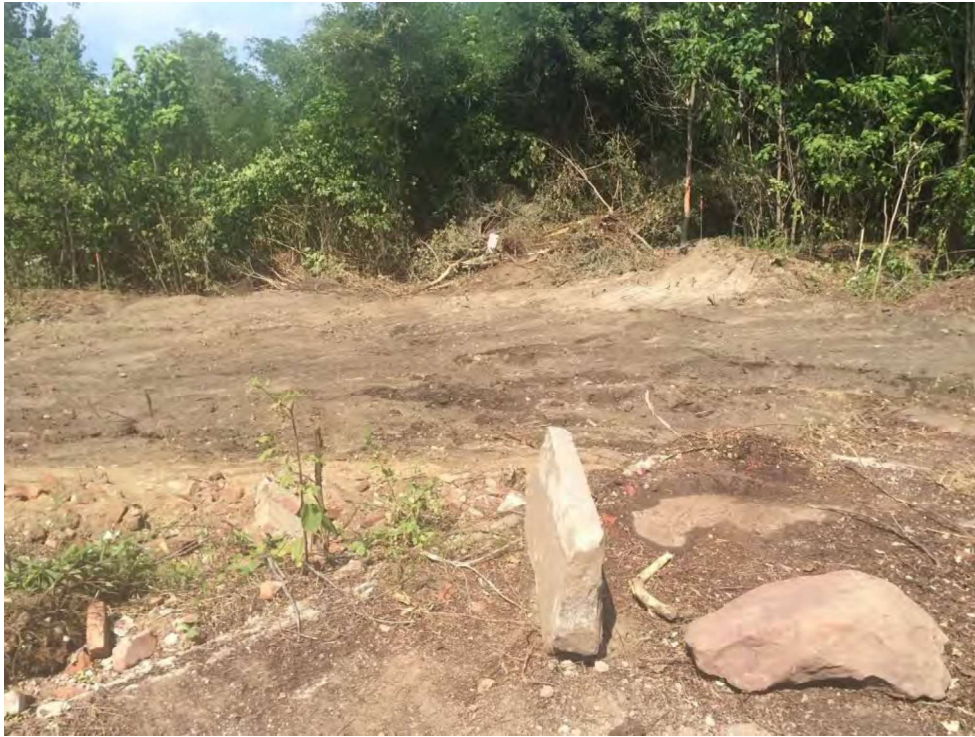
SCENE: View of grid area SS-18 at the completion of excavation activities. Photograph taken facing north.

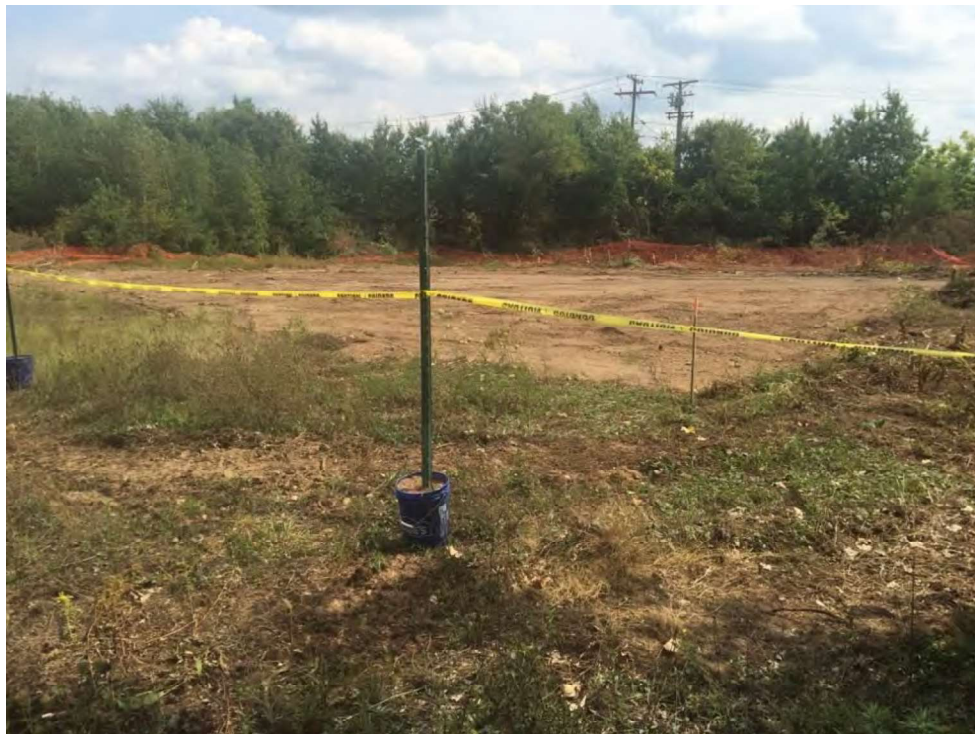
SCENE: View of grid area SS-08 at the completion of excavation activities. Photograph taken facing north.

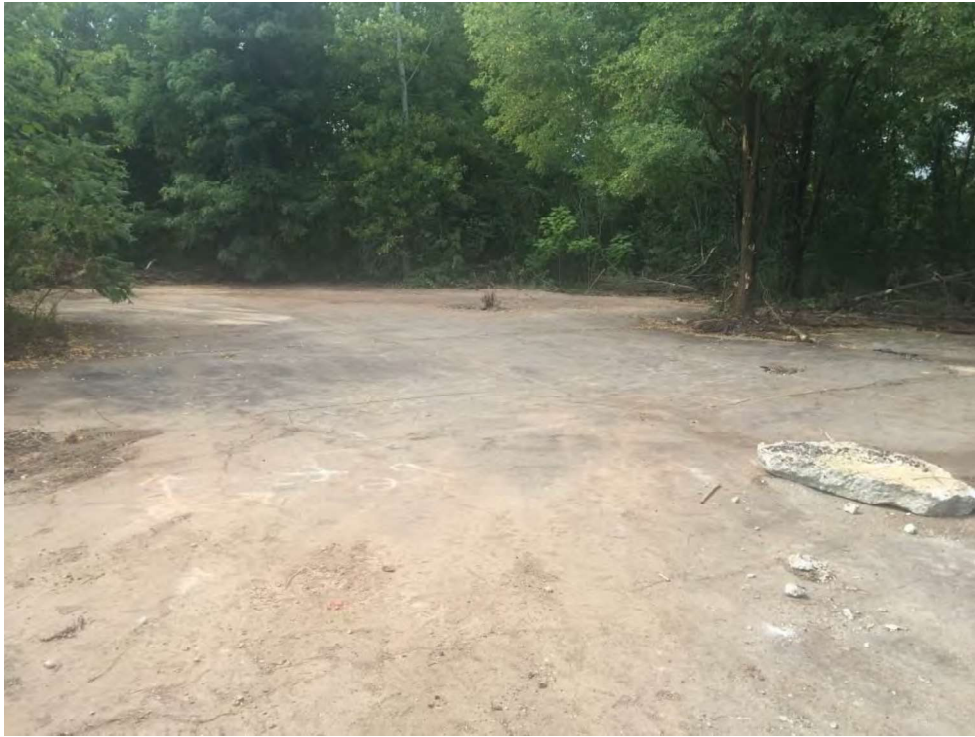
SCENE: View of grid area SS-29 at the completion of excavation activities. Photograph taken facing north.

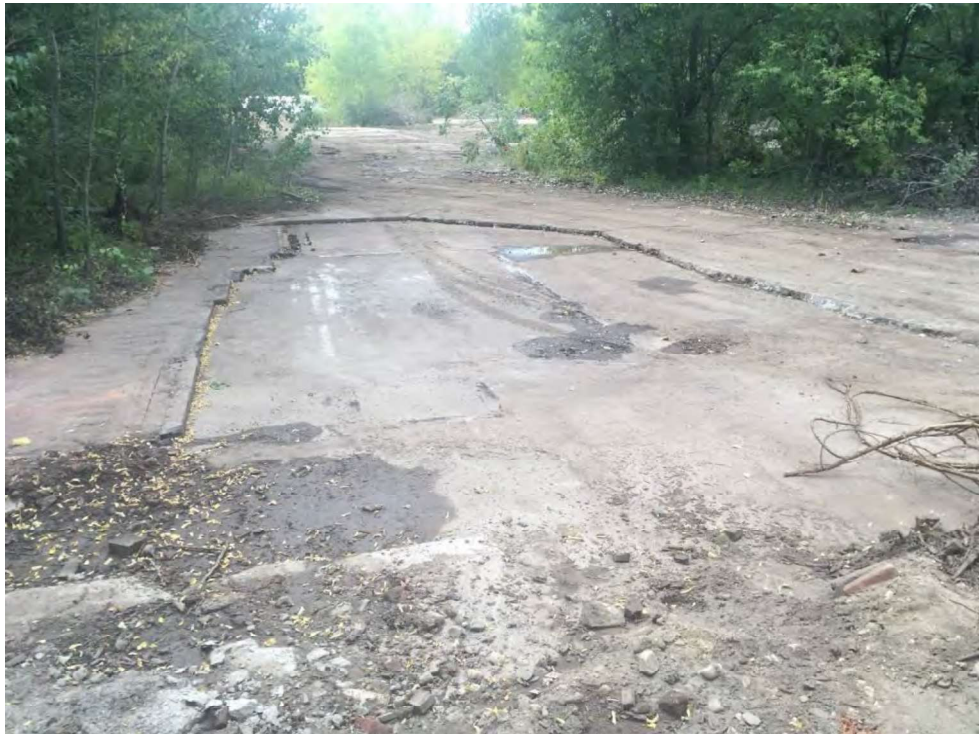
SCENE: View of the Pile 5/ACM-74C area at the completion of excavation and scraping activities. Photograph taken facing west.

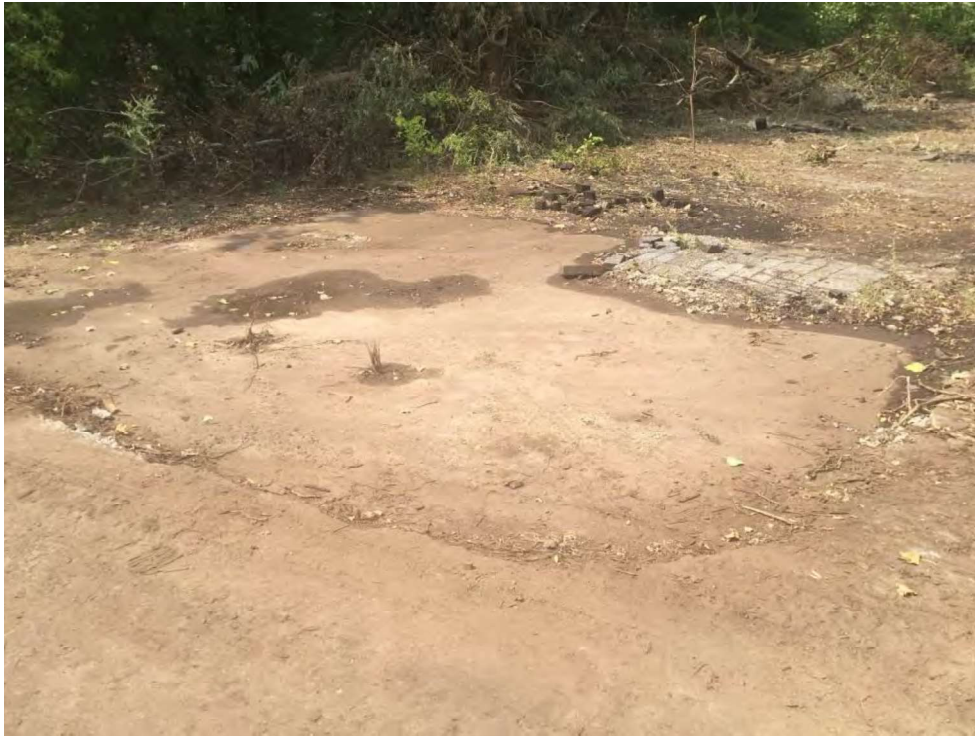
SCENE: View of grid area SS-74/SS-104 at the completion of excavation and scraping activities. Photograph taken facing north.

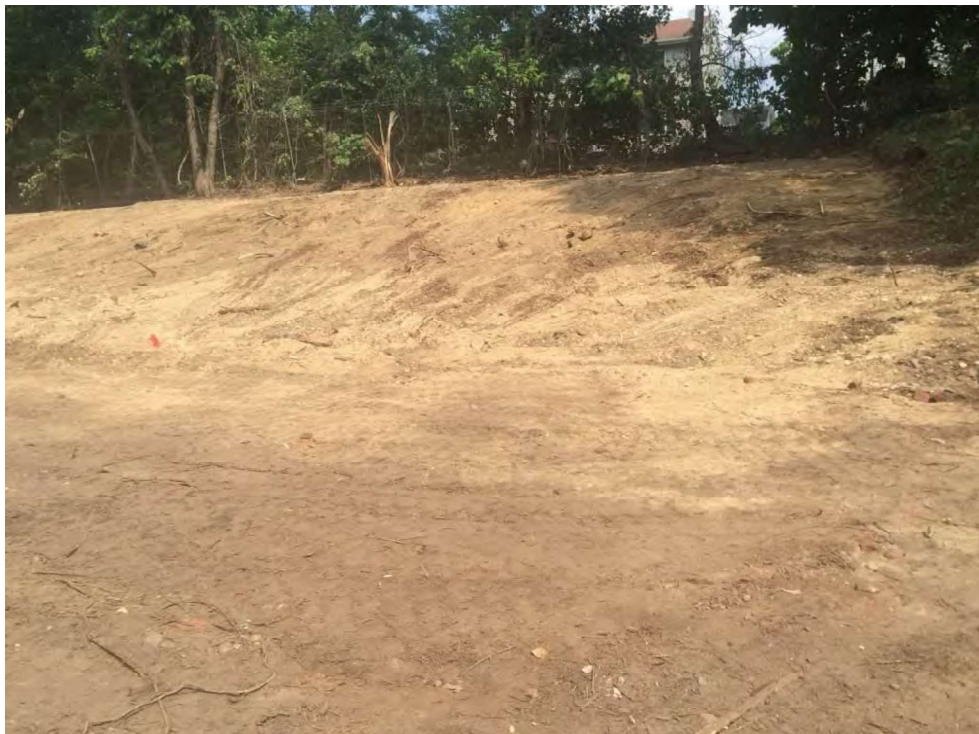
SCENE: View of grid area SS-38 at the completion of excavation activities. Photograph taken facing east.

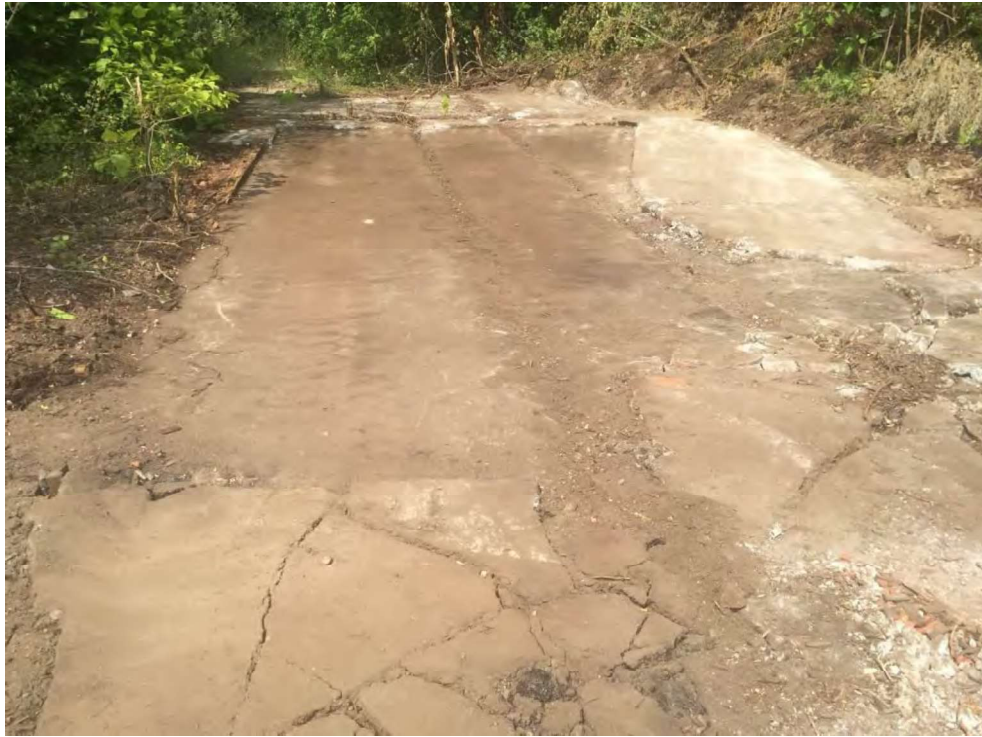
SCENE: View of the Surface 3 area at the completion of excavation and scraping activities. Photograph taken facing north.

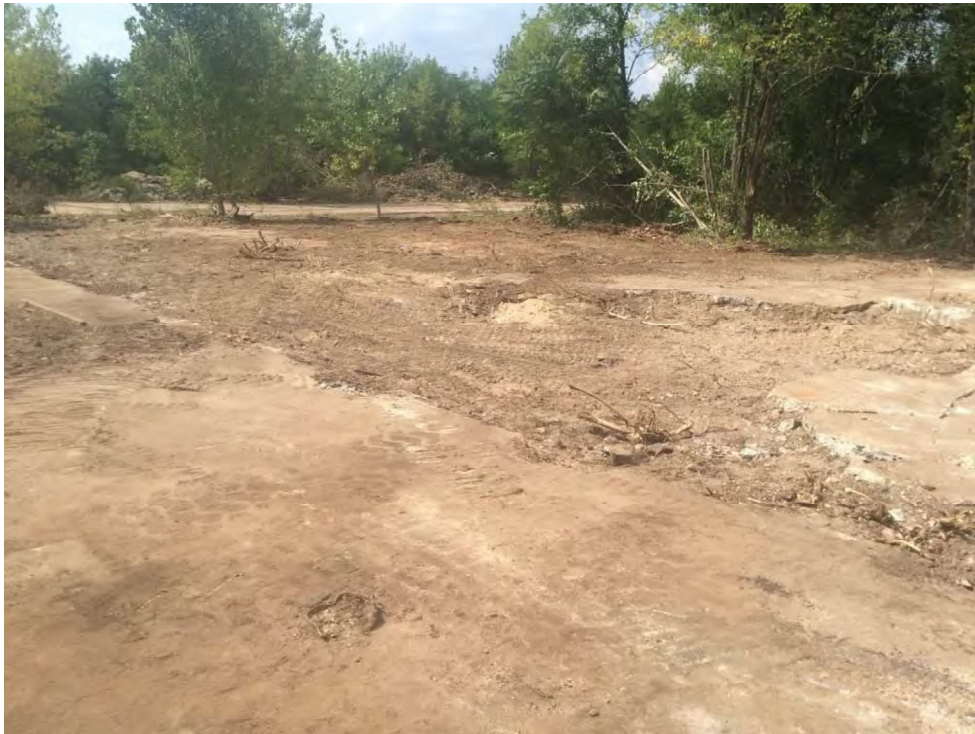
SCENE: View of the Surface 4 area at the completion of excavation and scraping activities. Photograph taken facing northwest.

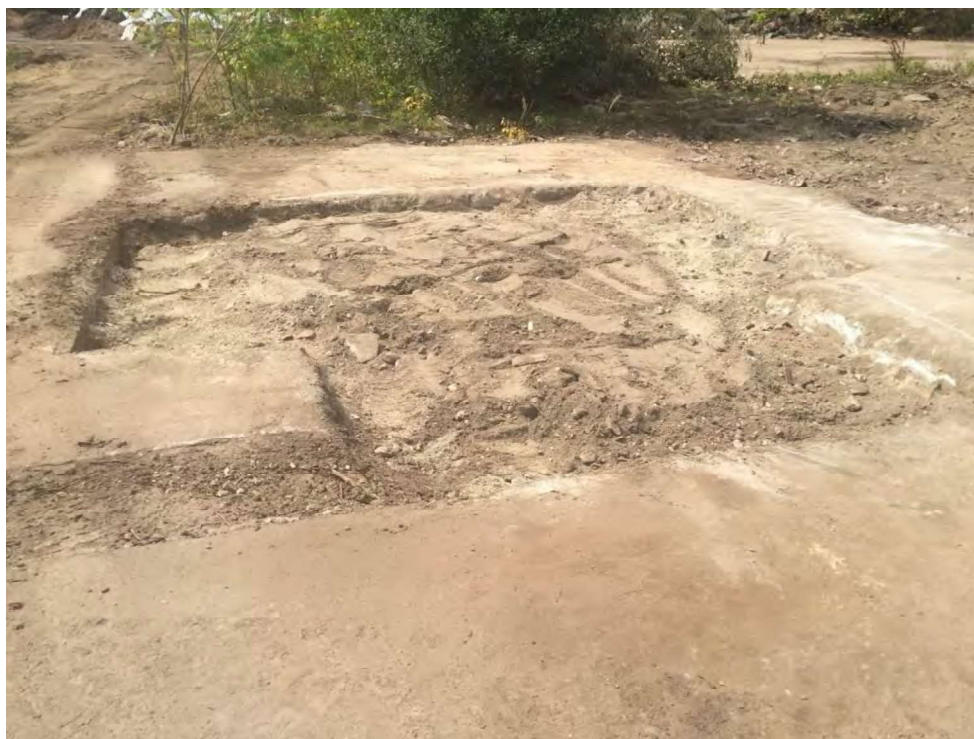
SCENE: View of the southwestern corner of the Surface 4 area at the completion of excavation and scraping activities. Photograph taken facing west.

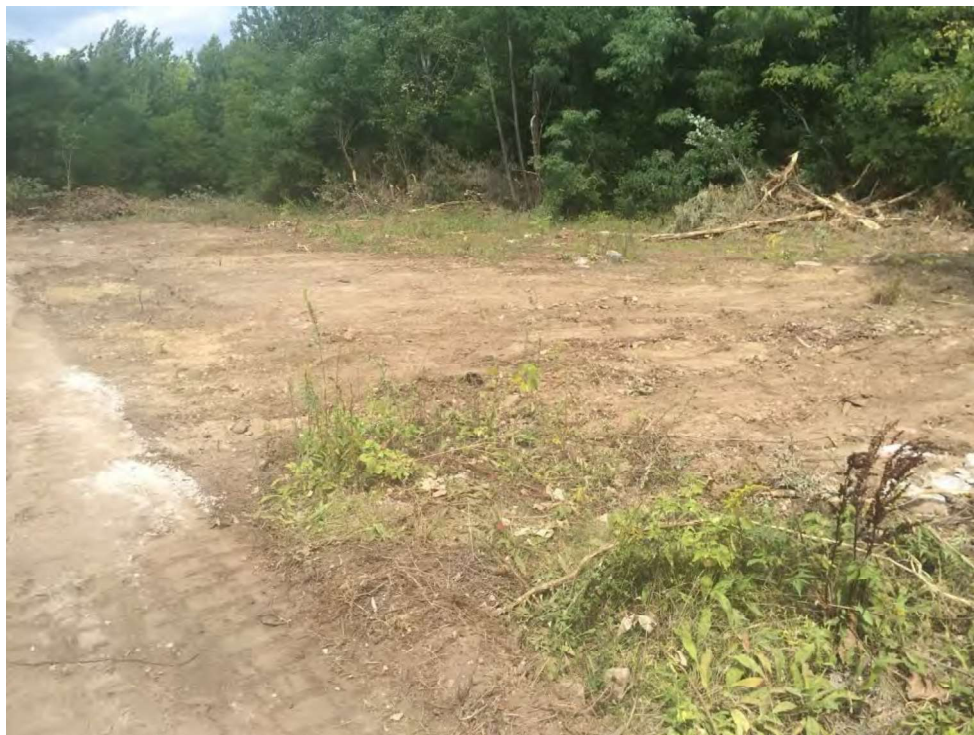
SCENE: View of the Pile 4 area at the completion of excavation and scraping activities. Photograph taken facing northwest.

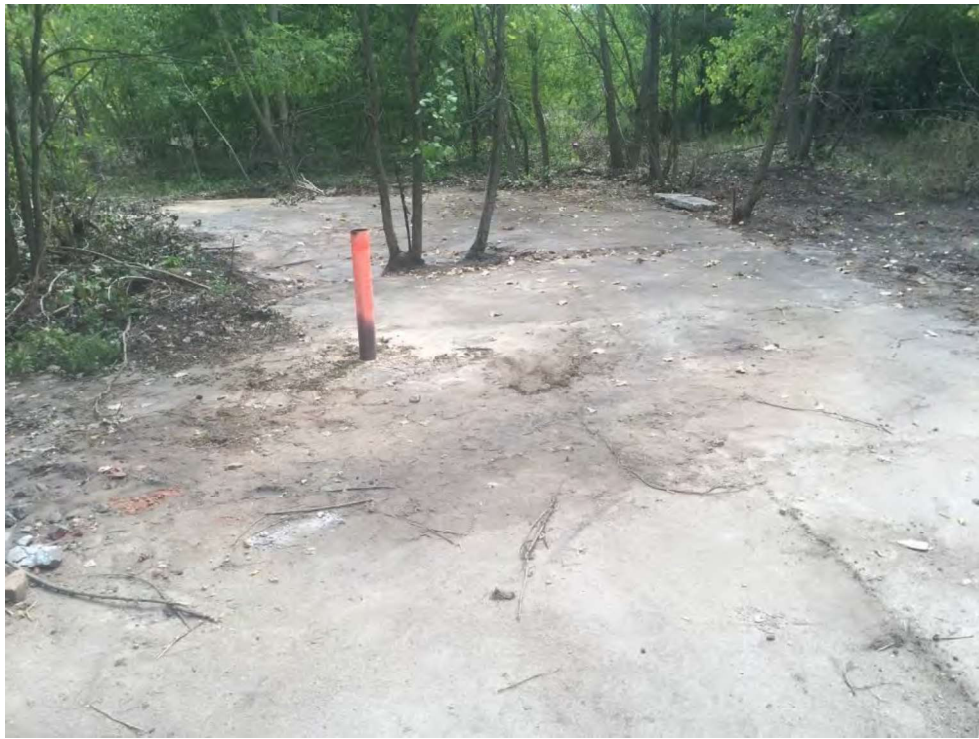
SCENE: View of the Surface 1 area at the completion of excavation and scraping activities. Photograph taken facing west.

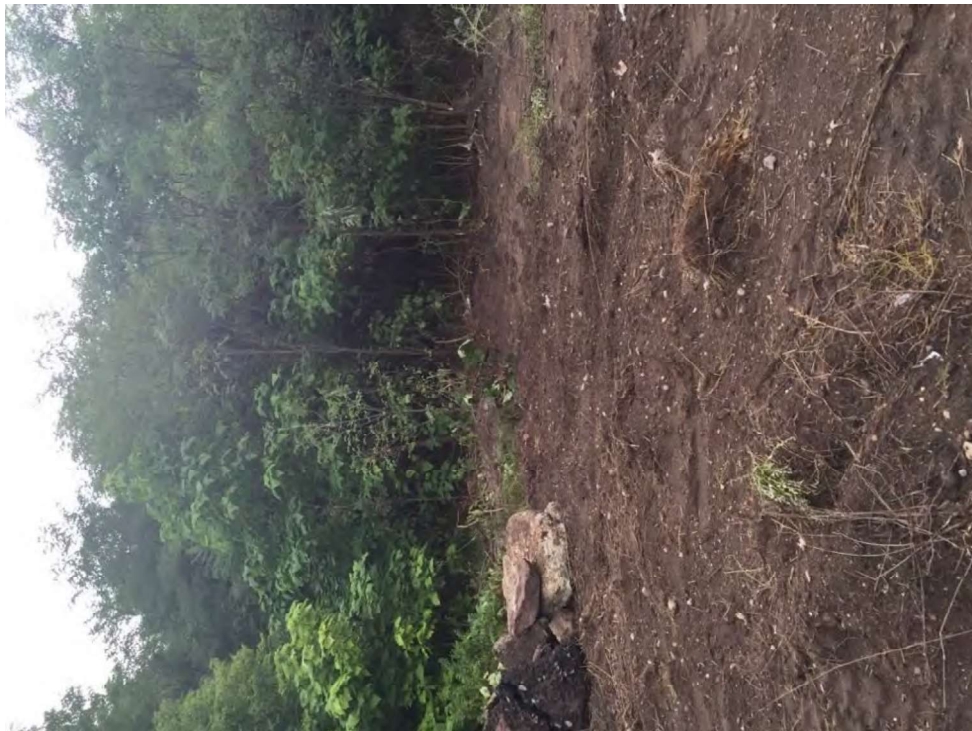
SCENE: View of the Pile 7 area at the completion of excavation activities. Photograph taken facing east.

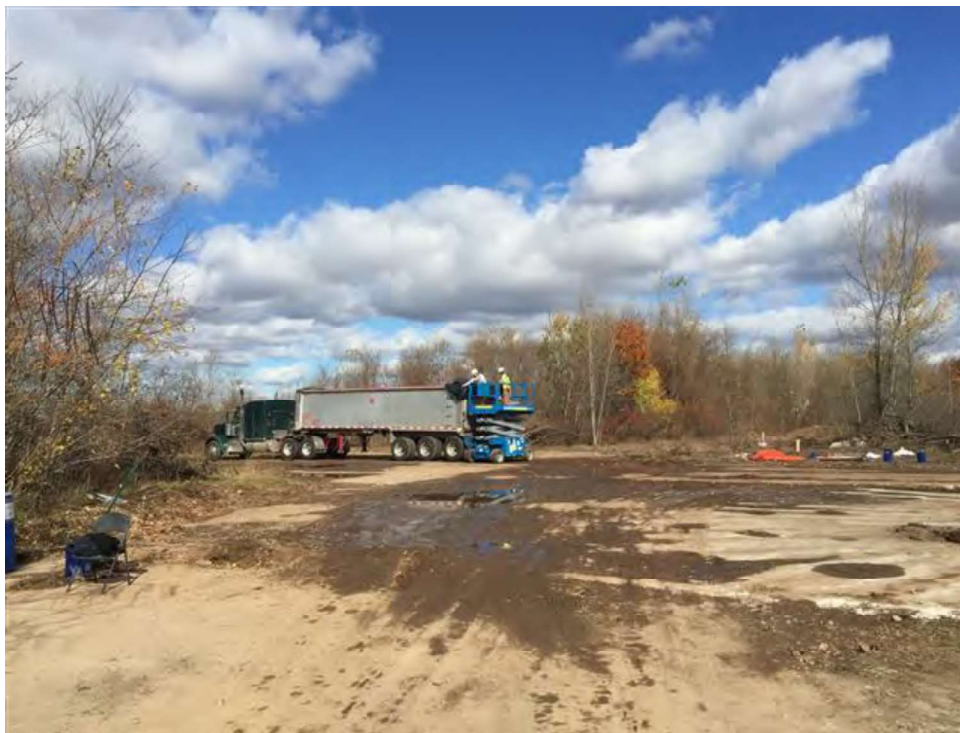
SCENE: View of Emergency Rapid Response Services (ERRS) personnel installing a polyethylene dump trailer liner prior to soil load out. Photograph taken facing east.

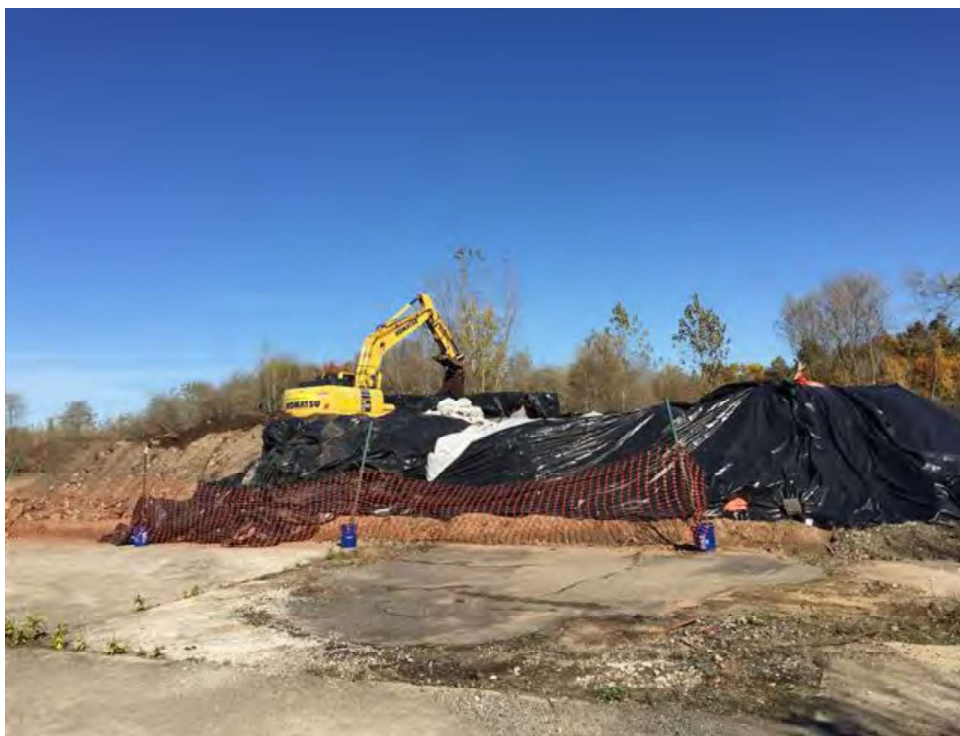
SCENE: View of soil load out activities. Photograph taken facing west.

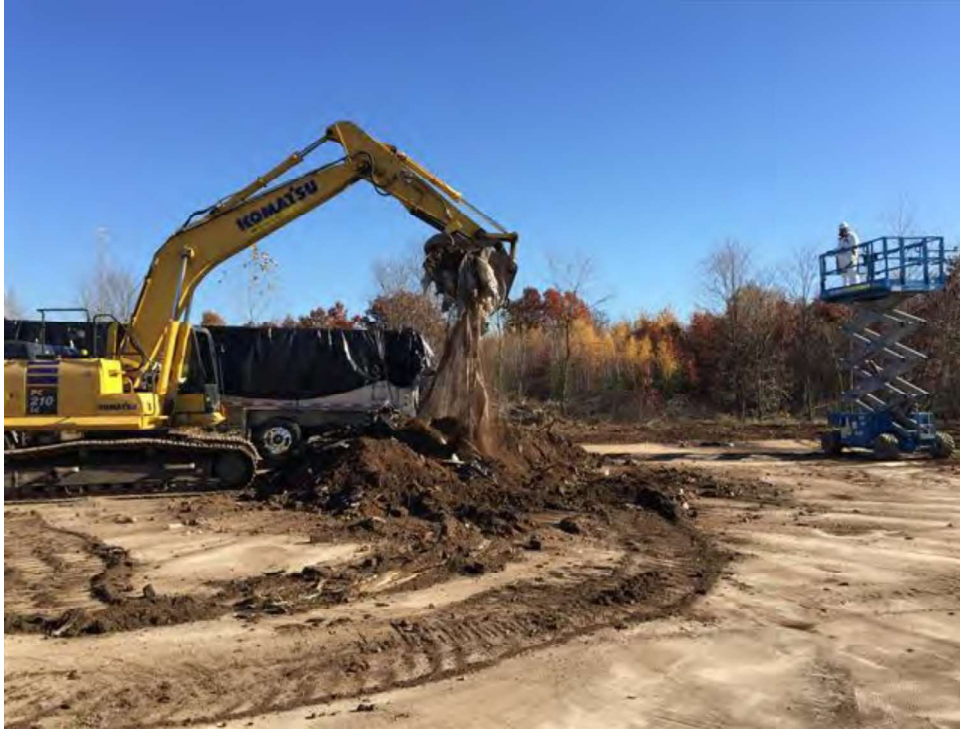
SCENE: View of final soil load out activities. Photograph taken facing west.

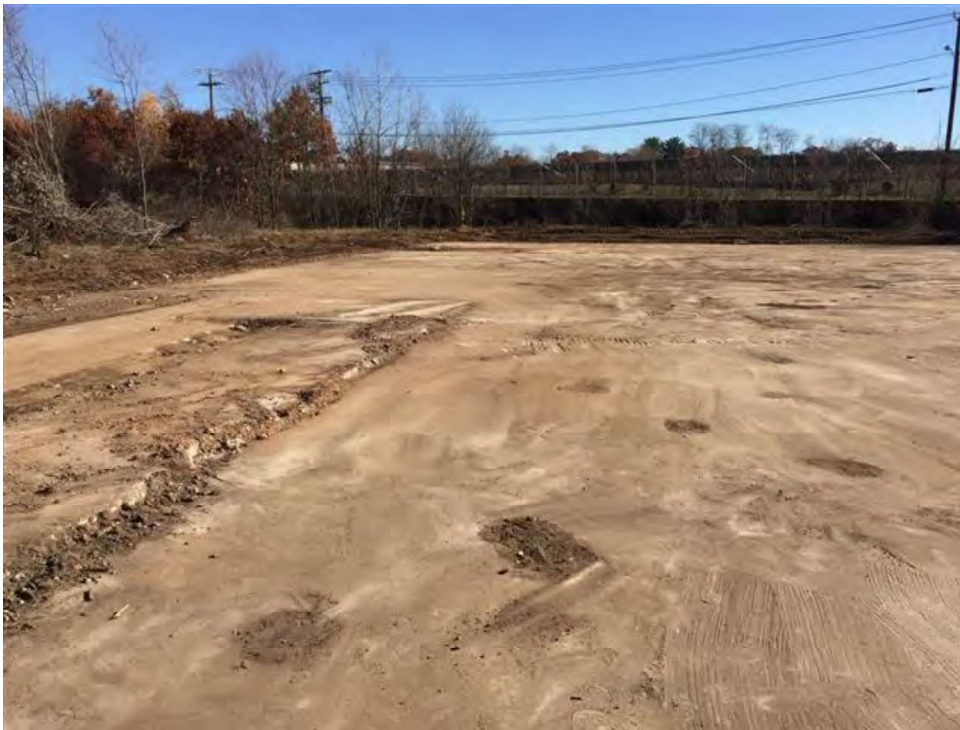
SCENE: View of clean and scraped soil staging area at the completion of disposal activities. Photograph taken facing south.
