Receiver's Rehabilitation Plan

123 Main St
Springfield, MA 01151
99-CV-999
Nov 12, 2015

428 Belmont Ave, Springfield, MA 01108

Summary

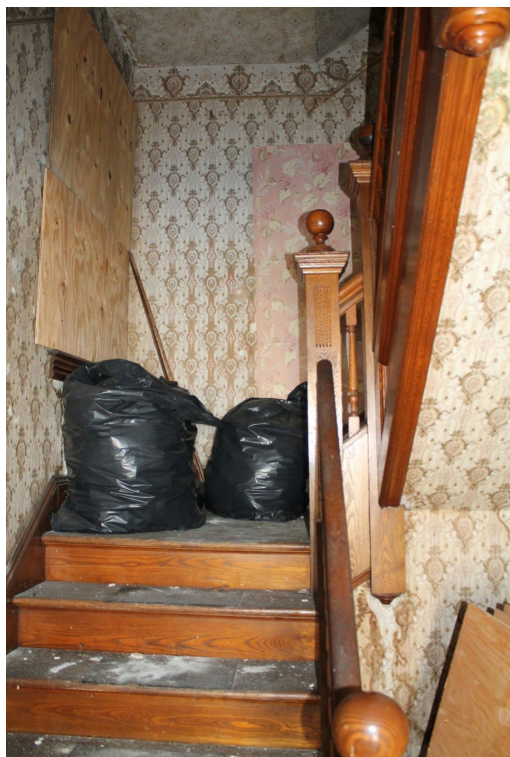
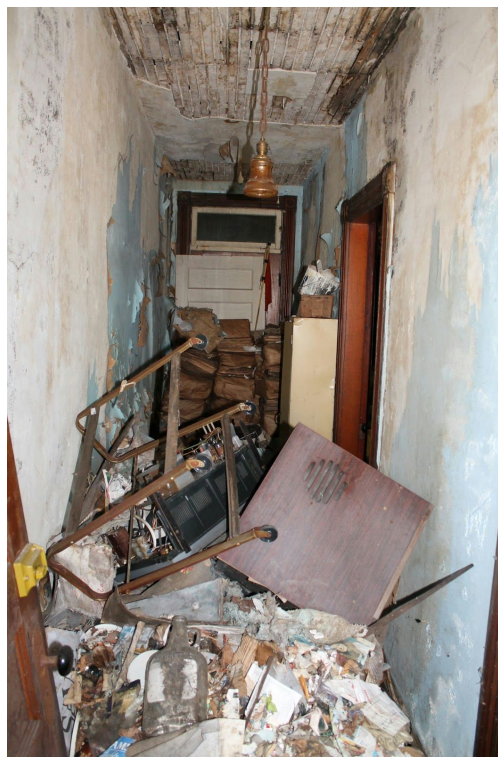
The walls and ceilings are plaster and lath, with approximately 75% of the total surface area being deteriorated past use. Floor coverings are a mixture of hardwood, tile, and carpet. Much of the cabinetry throughout the property, along with doors and trim/casing, has water damage and is rotting.

Interior (1st floor): See fallen plaster, trash/debris
