NARRATIVE APPRAISAL REPORT

FORMER ELIAS BROOKINGS SCHOOL
367 HANCOCK STREET
SPRINGFIELD, MASSACHUSETTS

APRIL 11, 2014

RE: Narrative Appraisal Report:
Former Elias Brookings School
367 Hancock Street
Springfield, MA
Crowley & Associates File #16299

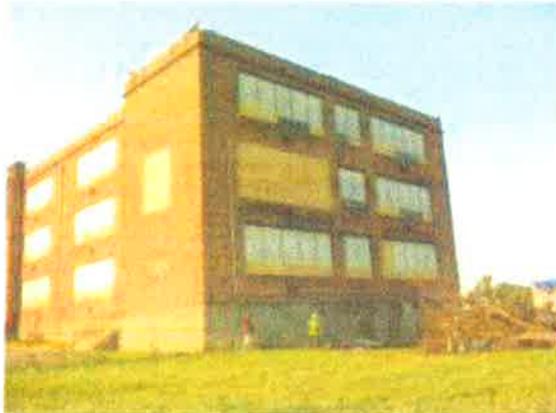
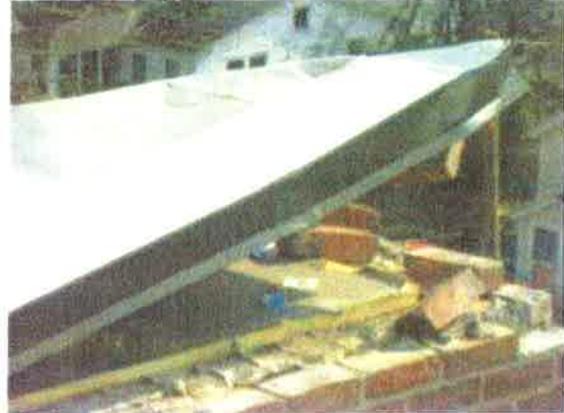
Roof:

Extensive areas of the roof parapet have been dislodged and removed by the tornado with much of the brick falling to the ground below. In areas where the parapet remains, much of the metal coping and blocking has been damaged, often loosening the top courses of brick.

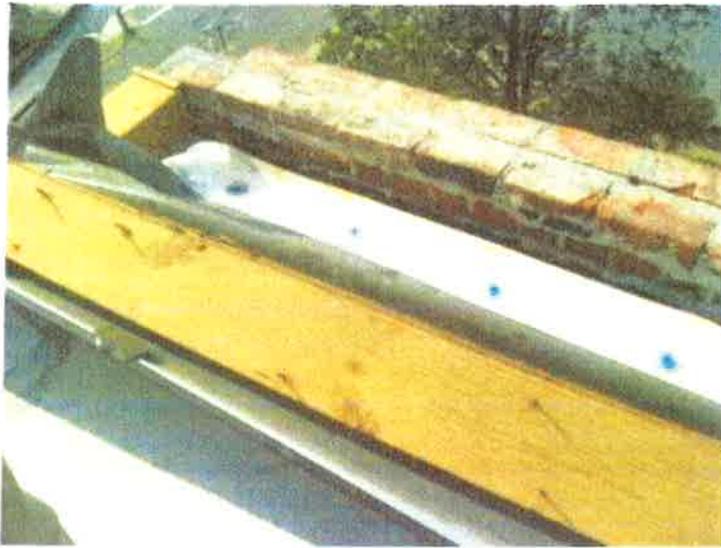
Three large sheet- metal ventilator covers were also blown off by the winds. The City's facilities department has temporarily replaced all but one of them by the time of the study team's visit. The roof access penthouse was also severely displaced by the high winds so that it is no longer plumb, it is now a parallelogram.

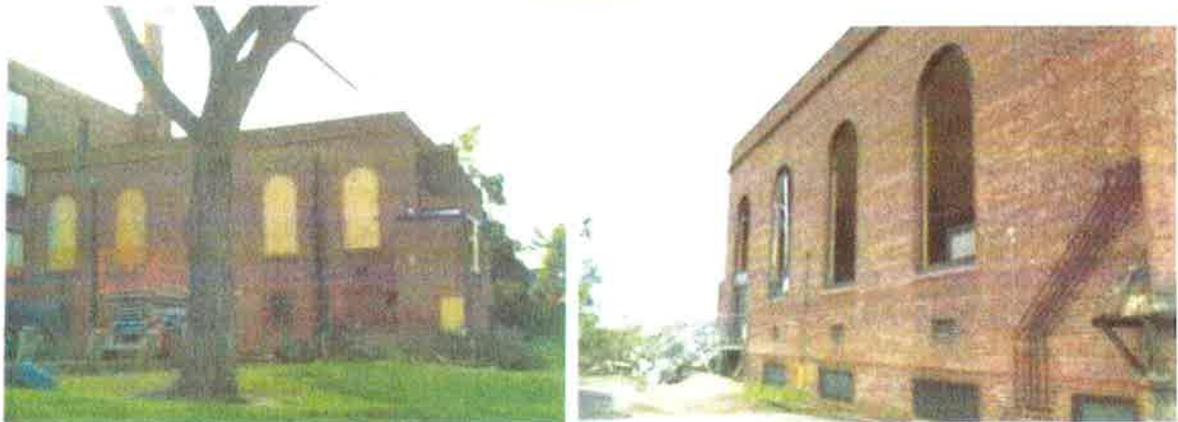
At the gymnasium, virtually all of the fiberglass arched windows and frames were blown out.

The brick parapets were blown off entirely at the south end of the main building and the lower portions of gym building had large sections of brick removed. These lower structures looked to be disconnected (not toothed-in) to the main gym structure and have been displaced.
