Emergency Damage Assessment

Elias Brookings School

Springfield, Mass

June 22, 2011

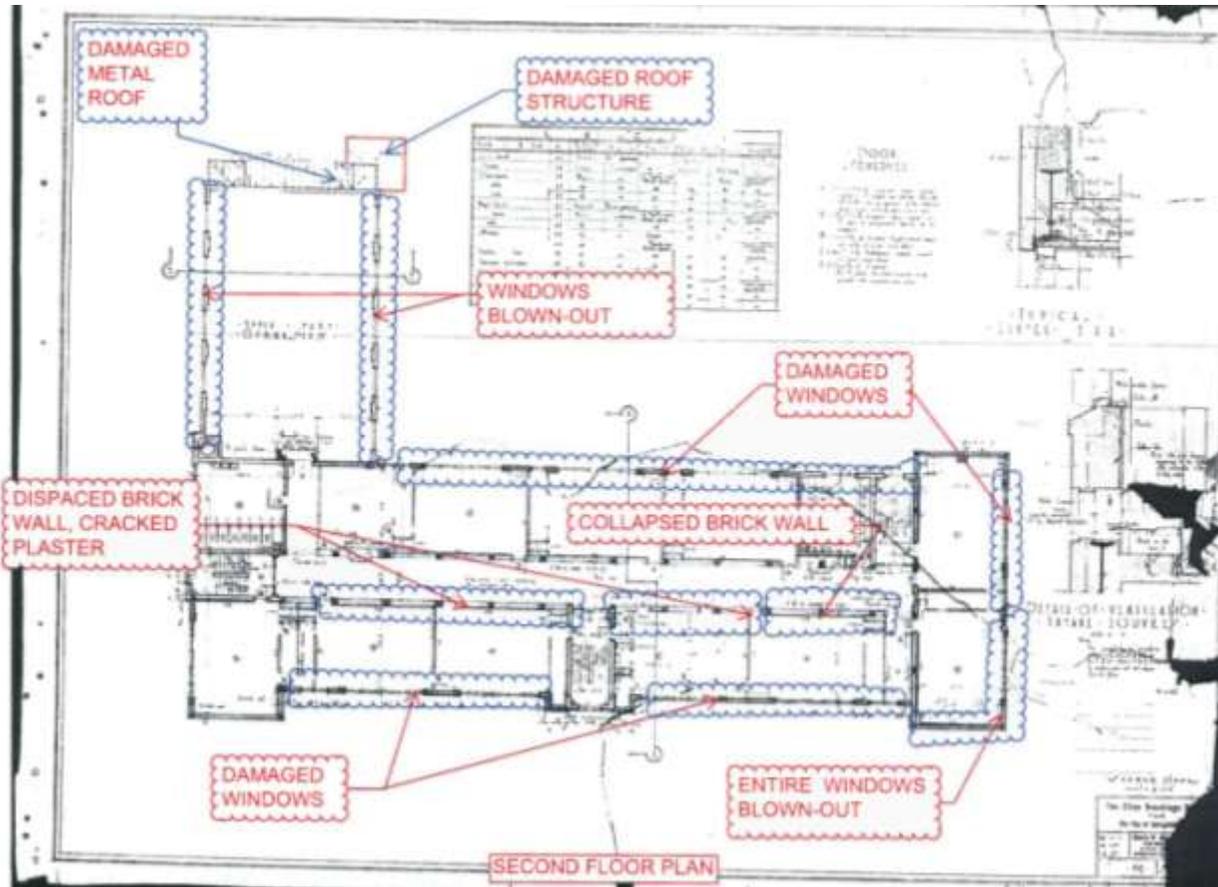
Second Floor Plan (see Appendix for all plans)

The primary damage to the interior is to the corridor walls which were displaced and in some locations, blown over. Portions of the brick walls had collapsed entirely on two floors along the southern end of the classroom corridor. In most all of the remaining East facing classrooms the interior plaster walls had cracked along a line at the top of the masonry corridor walls.

The large classroom at the southern end of the second floor suffered extensive interior damage as this was the classroom that had two corner windows entirely blown out.
