### SPRINGFIELD SS4A

STATE ST & SCHOOL ST / SPRING ST

INTERSECTION NO. 1

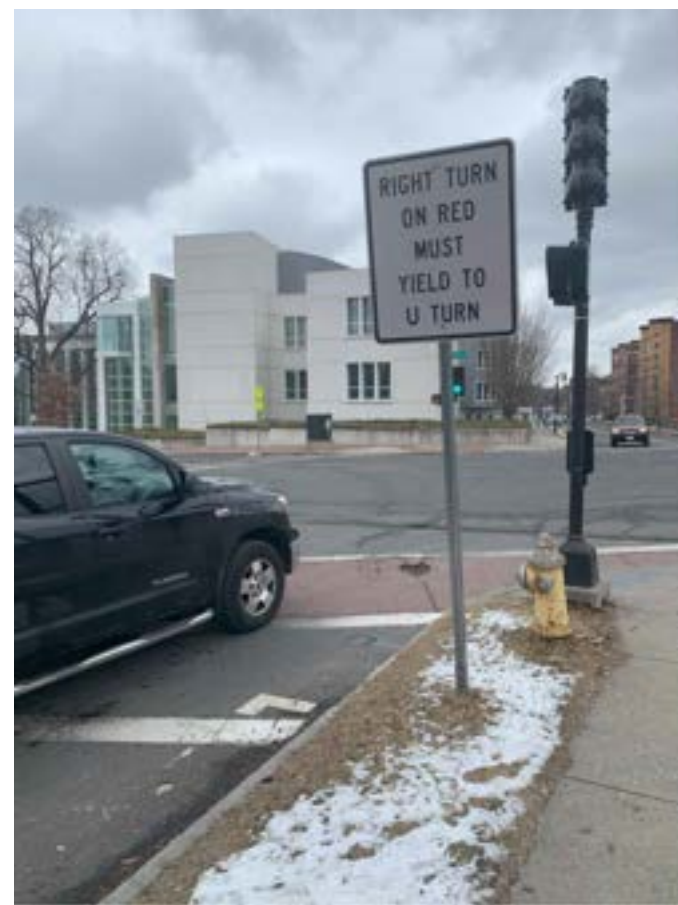
DURING SCHOOL DISMISSAL, THE STATE STREET (NE) RIGHT LANE IS COMPLETELY BLOCKED WITH IDLE VEHICLES FROM 2:10-2:25. THIS MAKES U-TURN MOVEMENTS ON STATE STREET MORE DIFFICULT FOR SUVs, WHICH BACKS UP OTHER DIRECTION OF STATE STREET AS WELL.

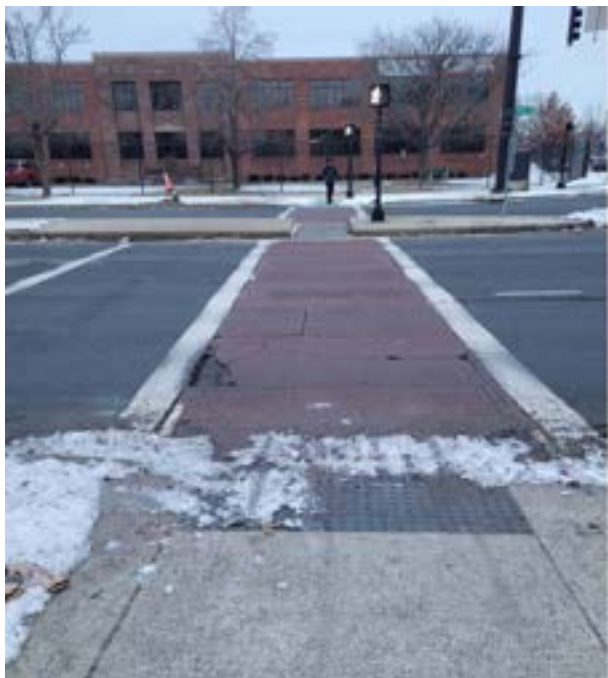
3 STATE STREET CROSSING

3. PAVEMENT MARKINGS ARE FADED.
4. CROSSWALKS EXIST, WITH SOME ASPHALT PATCHING AND MIXED STYLES. CROSSWALK SKEW INCREASES CROSSING DISTANCES.
5. VISIBILITY IS LIMITED AT OAK STREET BY BUILDINGS CLOSE TO ROAD.

1. REALIGN STATE STREET CROSSWALKS
2. TIGHTEN CORNER RADII
3. INSTALL ACCESSIBLE MEDIAN REFUGE ISLAND
4. REDUCE LONG CYCLE LENGTHS
5. ADD CONCURRENT PEDESTRIAN CROSSING PHASE ACROSS OAK STREET AND SAINT JAMES AVENUE
6. SIGN CONSOLIDATION

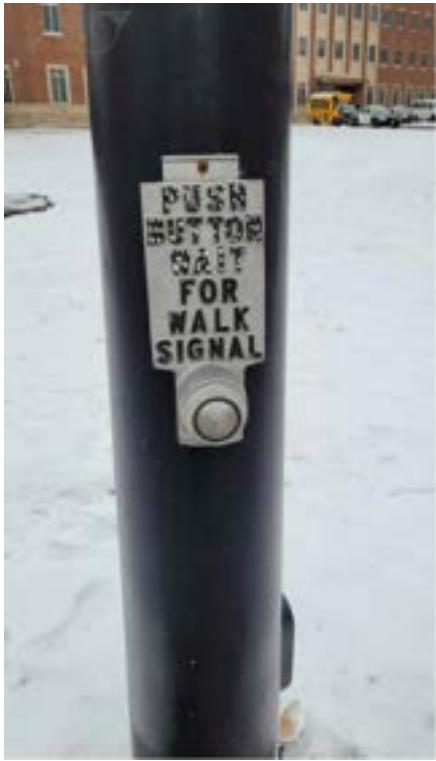
3 GAUCHER STREET PUSH BUTTON

3. MANY STUDENTS TEND TO CROSS DIAGONALLY THROUGH INTERSECTION DURING THE PROTECTED PEDESTRIAN PHASE OR JAYWALK FROM DUNKIN.
4. BOTH CORNERS OF GAUCHER HAVE SINGLE PUSH BUTTON FOR CROSSINGS.

1. MOVE STATE STREET CROSSWALK CLOSER TO INTERSECTION
2. ADD DIAGONAL CROSSING PAVEMENT MARKINGS
3. INSTALL APS PUSHBUTTONS AT ALL CORNERS, RELOCATE WHERE REQUIRED
4. ADD "NO TURN ON RED" RESTRICTIONS AS NEEDED
5. REDUCE CYCLE LENGTHS ON STATE STREET, WITH MORE FREQUENT PEDESTRIAN CYCLES
6. CONSIDER ADDITION OF BUS SHELTER AT STOPS ON STATE STREET

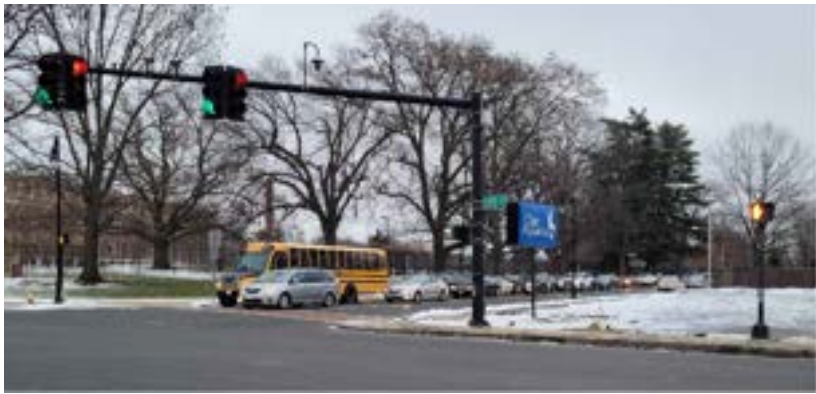
5 BENTON STREET VEHICLE QUEUE

9. A LEFT TURN ARROW FOR STATE STREET (SB) IS PRESENT WITH NO DEDICATED TURN LANE.
10. INTERSECTION IS LARGE, WITH SWEEPING RADII.
11. EXCLUSIVE RIGHT-TURN LANE AND RIGHT ON RED PERMITTED FROM BENTON.

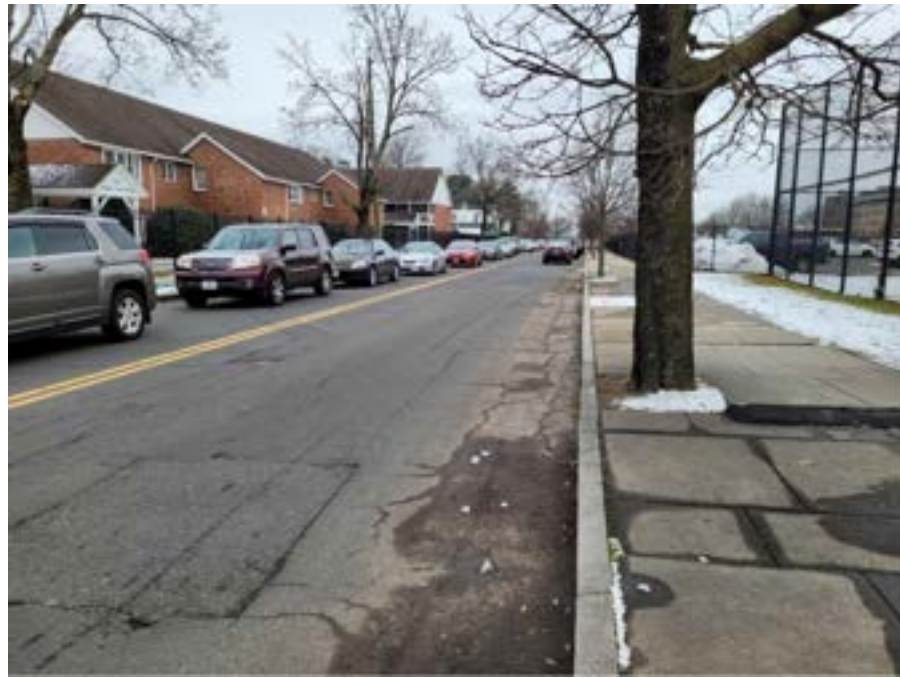
1 UNION STREET TRAFFIC SIGNAL

- 9. SIGNAL EQUIPMENT IS OUTDATED. MISSING SIGNAL VISORS.
- 10. CONTRADICTORY PARKING SIGNS EXIST ON UNION STREET.
- 11. BUS STOPS WERE OBSERVED ON WALNUT STREET.

- 1. POTENTIAL CONVERSION TO ALL-WAY STOP INTERSECTION
- 2. INCREASE CURB RADIUS
- 3. INSTALL INTERSECTION LIGHTING
- 4. IF SIGNAL REMAINS - UPDATE SIGNAL EQUIPMENT AND ADD EXCLUSIVE PEDESTRIAN PHASE

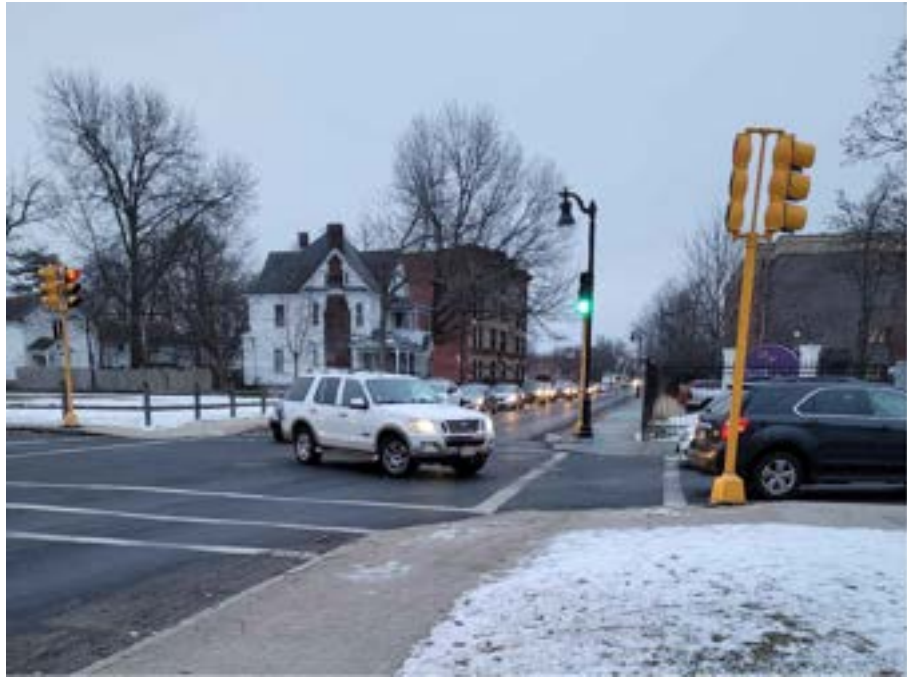
2 UNION STREET VEHICLE QUEUE

- 12. DURING SCHOOL DISMISSAL, BUSES STOP ON UNION STREET, AND THE QUEUE EXTENDS THROUGH AND BLOCKS THE INTERSECTION.

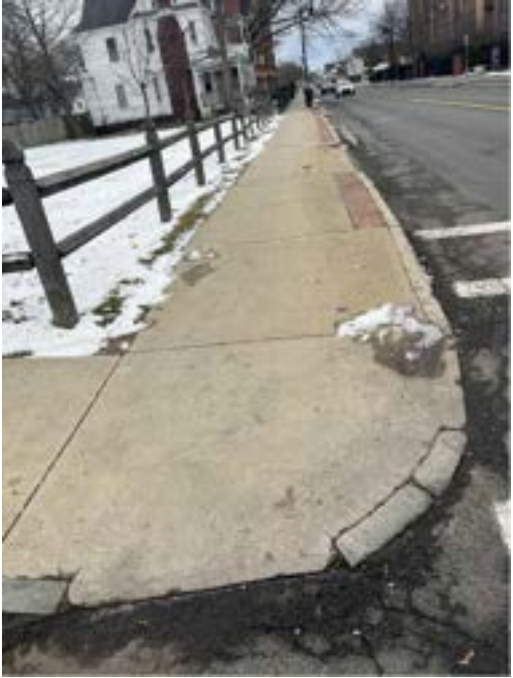
3 WALNUT STREET VEHICLE QUEUE & TURN

- 3. SIDEWALK WIDTHS ARE NARROW, WITH SIGNALS AND LIGHT POSTS IN THE SIDEWALK.
- 4. VEHICLES ARE SPEEDING ON THE WALNUT STREET APPROACHES TO CATCH THE LIGHT OR ARE RUNNING THE RED.

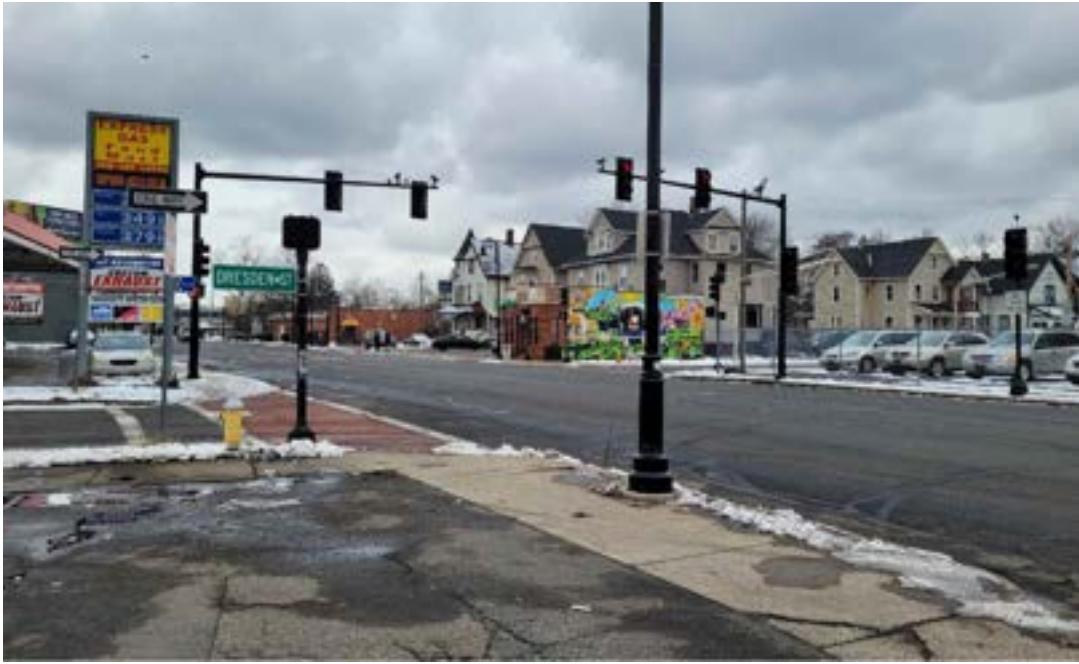
3 STATE STREET FADED SIGN

- CROSSWALKS ARE FADED AND CRACKING, MARKINGS ARE NOT HIGH-VIS.
- CLEAR DESIRE LINE YET NO CROSSWALK ACROSS STATE STREET (EAST).
- THERE IS A PEDESTRIAN SIGNAL PHASE, THOUGH LONG DELAYS.
- PEDESTRIAN EQUIPMENT IS DATED AND NON-COMPLIANT.
- GAS STATION ADDS FIFTH APPROACH, COMPLICATES SIGNAL MOVEMENTS.
- NO "NO TURN ON RED" SIGN POSTED FOR CORTLAND STREET TRAFFIC, DESPITE LIMITED VISIBILITY.
- "NO TURN ON RED" FROM DRESDEN SEEMS UNWARRANTED. AMBIGUITY ABOUT NUMBER OF LANES ON DRESDEN.
- NO BIKE LANES ARE PRESENT, BUT DATED SIGNS REMAIN.
- HIGH SPEEDS WERE OBSERVED FOR THROUGH TRAFFIC ON STATE STREET.
- THERE ARE REDUNDANT PARKING RESTRICTION SIGNS.
- THERE IS POOR DELINEATION BETWEEN THE GAS STATION DRIVEWAY APRON, ACCESSIBLE RAMP, AND THE BACK OF SIDEWALK.

- INSTALL HIGH-VIS PAVEMENT MARKINGS, DELINEATING TWO LANES ON DRESDEN STREET OR TAPER THE APPROACH TO SINGLE LANE
- ADD SECOND PEDESTRIAN CROSSWALK ACROSS STATE STREET EAST OF DRESDEN STREET
- INSTALL APS PUSHBUTTONS AND RELOCATE NON-COMPLIANT PUSHBUTTON LOCATIONS
- ADD "NO TURN ON RED" RESTRICTIONS AS NEEDED
- ADD CONCURRENT PEDESTRIAN PHASE ACROSS DRESDEN STREET AND CORTLAND STREET

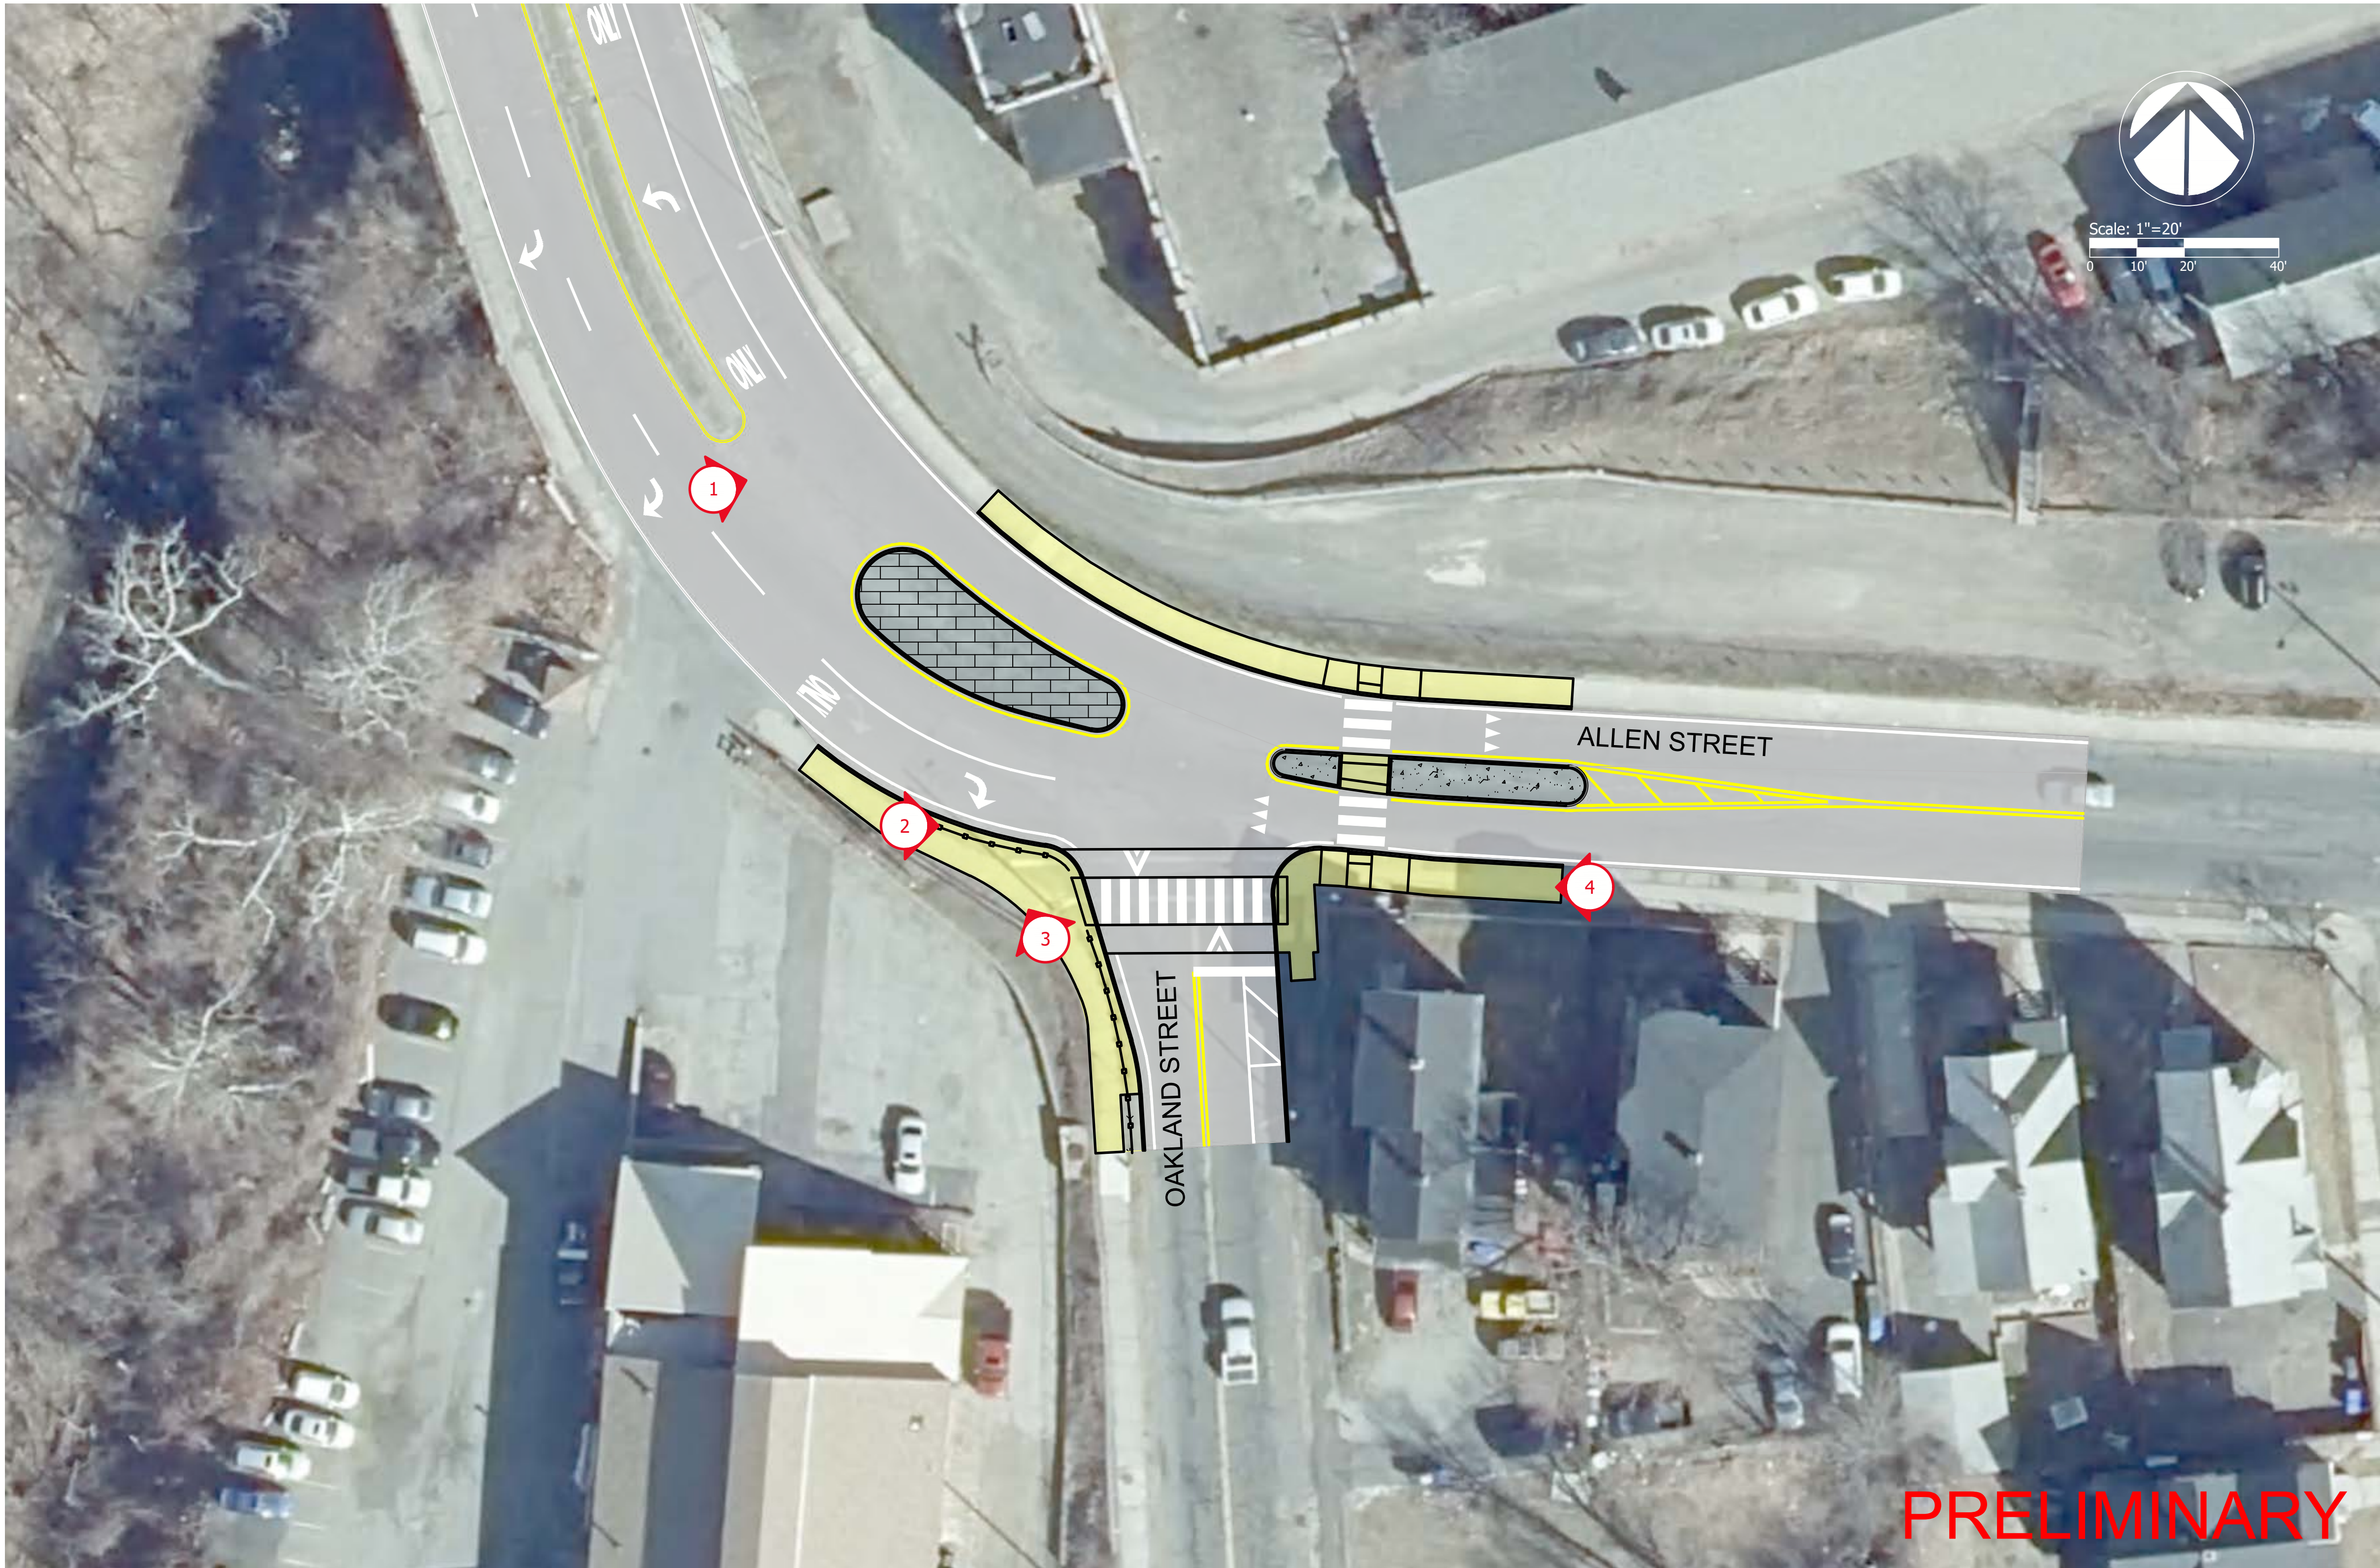
1. THERE ARE NO BICYCLE ACCOMMODATIONS.
2. THERE IS NO MARKED CROSSING FOR ALLEN STREET; ADJACENT INTERSECTIONS HAVE CROSSWALKS ACROSS ALLEN STREET.
3. LANE DELINEATION, INCLUDING LANE LINES AND CENTERLINES, ARE MISSING CREATING AMBIGUITY. STRIPING USED TO BE PRESENT.
4. OAKLAND STREET HAS LIMITED VISIBILITY DUE TO GRADE CHANGES AND A RETAINING WALL. VEHICLES RESORT TO PULLING PAST STOP LINE.
5. GUARDRAIL ON OAKLAND STREET HAS BEEN DOWNED. ISLAND APPEARS TO HAVE BEEN MOUNTED SEVERAL TIMES.
6. INTERSECTION LIGHTING EXISTS ONLY ON ONE SIDE OF CROSSWALK.
7. VERY HIGH SPEEDS WERE OBSERVED ON ALLEN STREET, ESPECIALLY RIGHT TURNS ONTO OAKLAND STREET, WHICH HAS A LARGE RADIUS.
8. LARGE TRUCKS WERE OBSERVED MAKING LEFT TURNS INTO THE COMMERCIAL DRIVEWAY WEST OF THE INTERSECTION.

1. INSTALL CURB EXTENSION TO TIGHTEN RADII
2. INSTALL HIGH-VIS PAVEMENT MARKINGS, EXTENDING AND ADDING LANE DELINEATION PAVEMENT MARKINGS, AND EXTENDING MEDIAN
3. ADD OBJECT MARKER TO MEDIAN
4. POTENTIAL RAISED CROSSWALK ON OAKLAND STREET
5. POTENTIAL CROSSWALK WITH REFUGE ISLAND ACROSS ALLEN STREET
6. MOVE LANE DELINEATION SIGN FROM UTILITY POLE TO ITS OWN POST

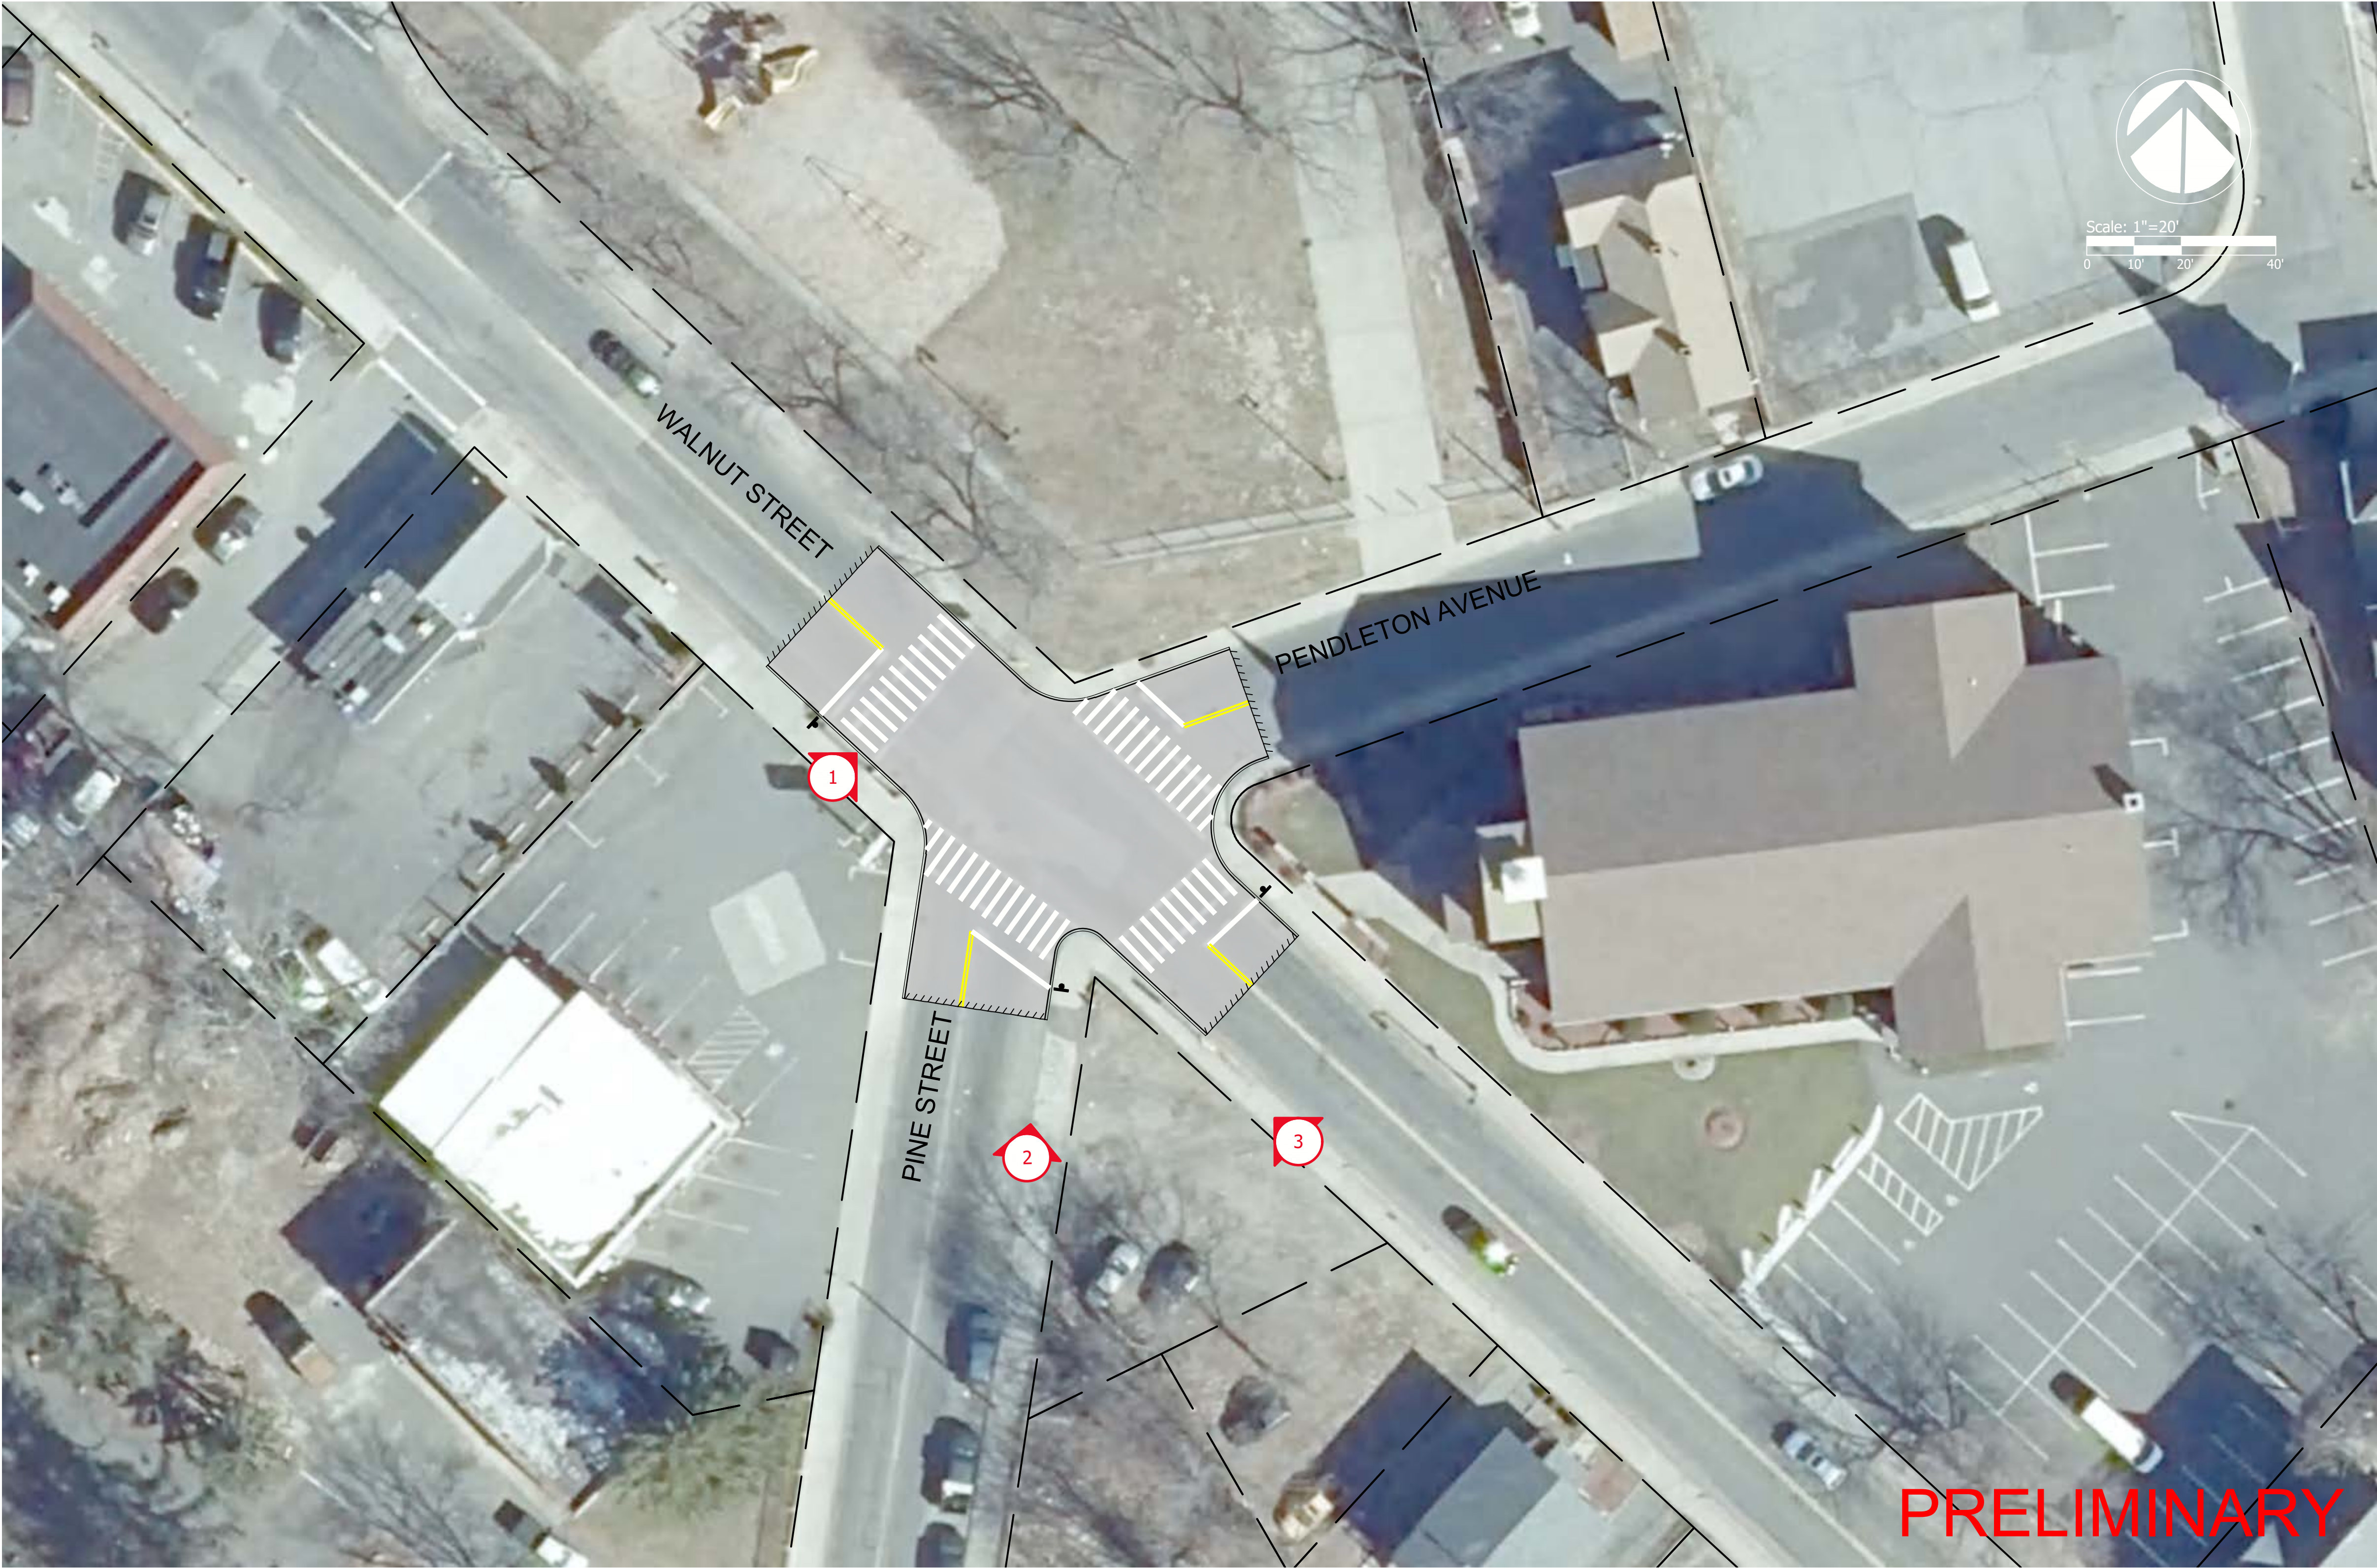
- 1. THERE ARE NO PEDESTRIAN SIGNALS, AND NO DWPS AT RAMPS. CROSSWALKS ARE FADED, AND OF DIFFERENT STYLES.
- 2. THERE IS ONLY ONE TRAFFIC SIGNAL HEAD FOR VEHICLES APPROACHING FROM PINE STREET AND PENDLETON AVE. ALL EXISTING SIGNALS GROUND MOUNTED.
- 3. TRAFFIC OBSERVED FROM PINE AND PENDLETON IS MAINLY TURNING ONTO WALNUT, WITH CARS STOPPING PAST STOP BAR.
- 4. BRICK WALL IN FRONT OF THE CHURCH LIMITS VISIBILITY FOR TURNING MOVEMENTS.
- 5. ALL APPROACHES ARE SINGLE LANE WITH NO BICYCLE ACCOMMODATIONS.
- 6. THERE ARE NO "NO TURN ON RED" RESTRICTIONS.
- 7. HIGH SPEEDS WERE OBSERVED FOR THROUGH TRAFFIC ON WALNUT.
- 8. ON-STREET PARKING WAS OBSERVED ON PINE STREET WITH NO RESTRICTION AT INTERSECTION.
- 9. DIFFICULT PULLING OUT OF PARKING LOT INTO PINE STREET QUEUE.
- 10. THERE IS INADEQUATE SITE LIGHTING.

- 1. PROPOSED ALL-WAY STOP CONVERSION
- 2. POTENTIAL RAISED CROSSWALK AND INTERSECTION
- 3. INSTALL ADA COMPLIANT RAMPS AND HIGH-VIS CROSSWALKS
- 4. INSTALL INTERSECTION LIGHTING
- 5. CREATE DELINEATION BETWEEN SIDEWALK AND PARKING LOT

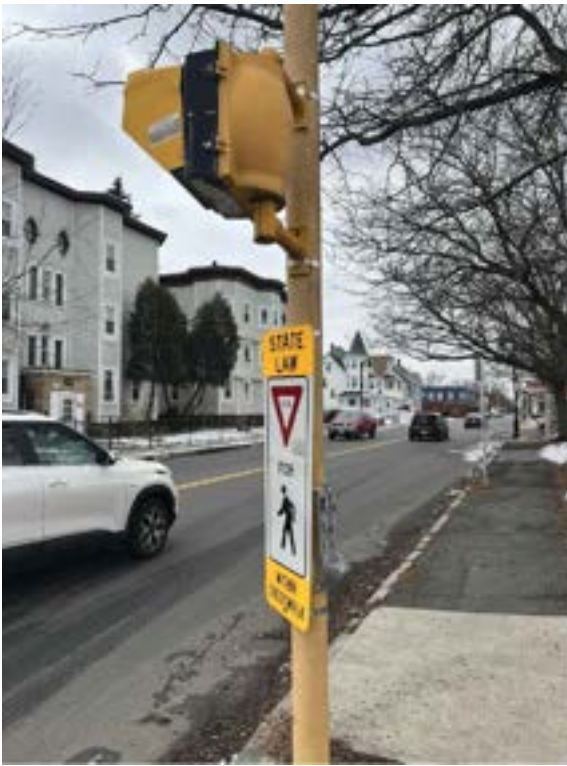
1 PEDESTRIAN SIGNAL

- 1. THERE IS A DEDICATED PEDESTRIAN PHASE, BUT NO COUNTDOWN TIMERS.
- 2. THERE IS A MEDIAN ON OAKLAND STREET, BUT THE REFUGE ISLAND IS NOT ADA COMPLIANT, AND THERE IS NO PUSH BUTTON ON THE REFUGE ISLAND.

- 1. TIGHTEN CORNER RADII AND ADD CURB EXTENSION, REDUCING CROSSING DISTANCES
- 2. NARROW EXISTING LANES AND REMOVE RIGHT-TURN LANE
- 3. INSTALL BUS PULL-OFF AREAS
- 4. INSTALL HIGH-VIS CROSSWALKS AND ADA RAMPS
- 5. INSTALL NEW EQUIPMENT WITH RETROREFLECTIVE BACKPLATES AND PEDESTRIAN COUNTDOWN TIMERS
