RESILIENCY IMPROVEMENTS AT WATERSHOPS POND DAM DRAWDOWN PERIOD MONITORING REPORT #3

MARCH 23, 2021

RESILIENCY IMPROVEMENTS AT WATERSHOPS POND DAM
1 ALLEN STREET
SPRINGFIELD, MASSACHUSETTS

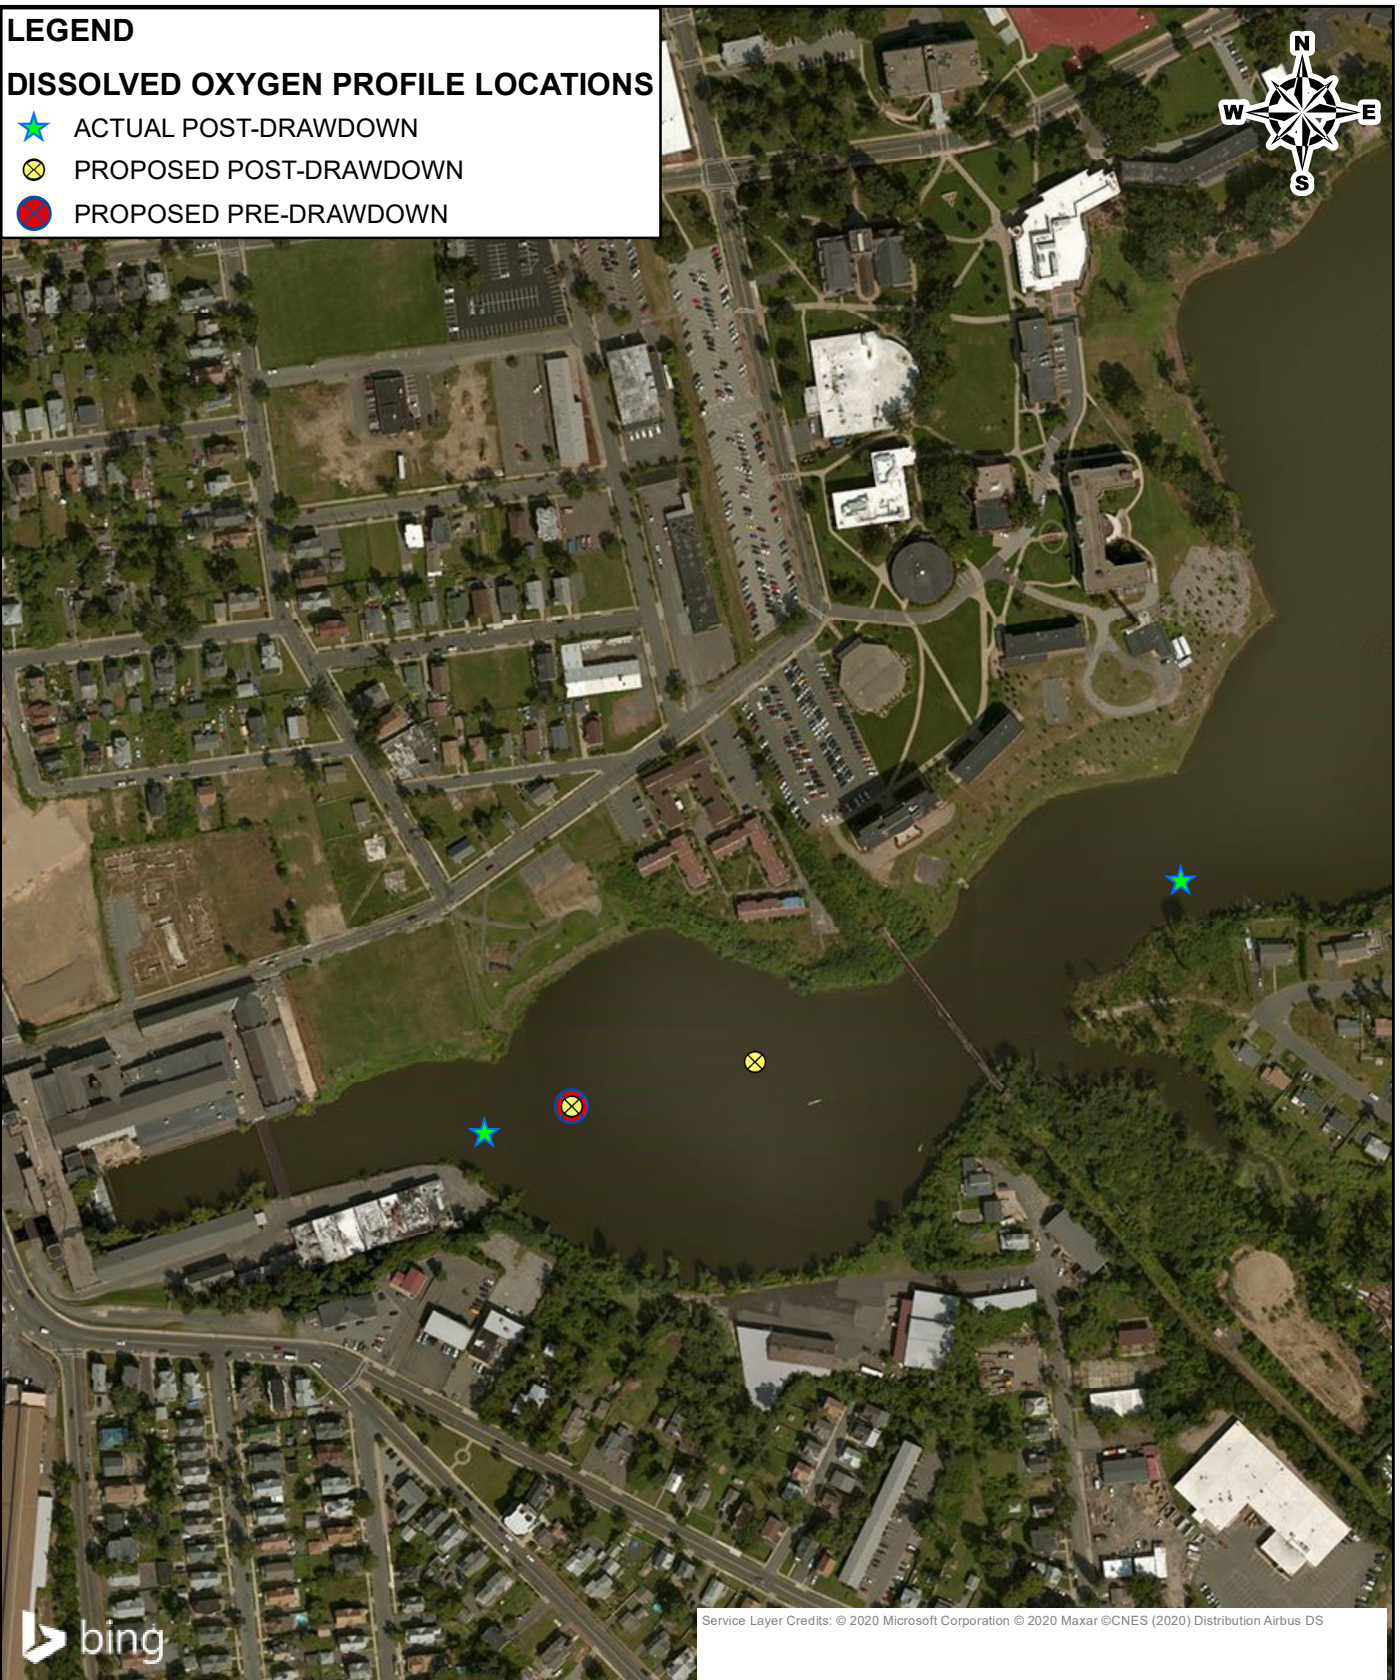
PROJ MGR: JRB	REVIEWED BY: TEJ	CHECKED BY: SLL	FIG. 1
DESIGNED BY: ARD	DRAWN BY: ARD	SCALE: 1 in = 350 ft	
DATE: 12/21/2020	PROJECT NO: 15.0166625.20	REVISION NO:

DISSOLVED OXYGEN PROFILE MONITORING LOCATIONS

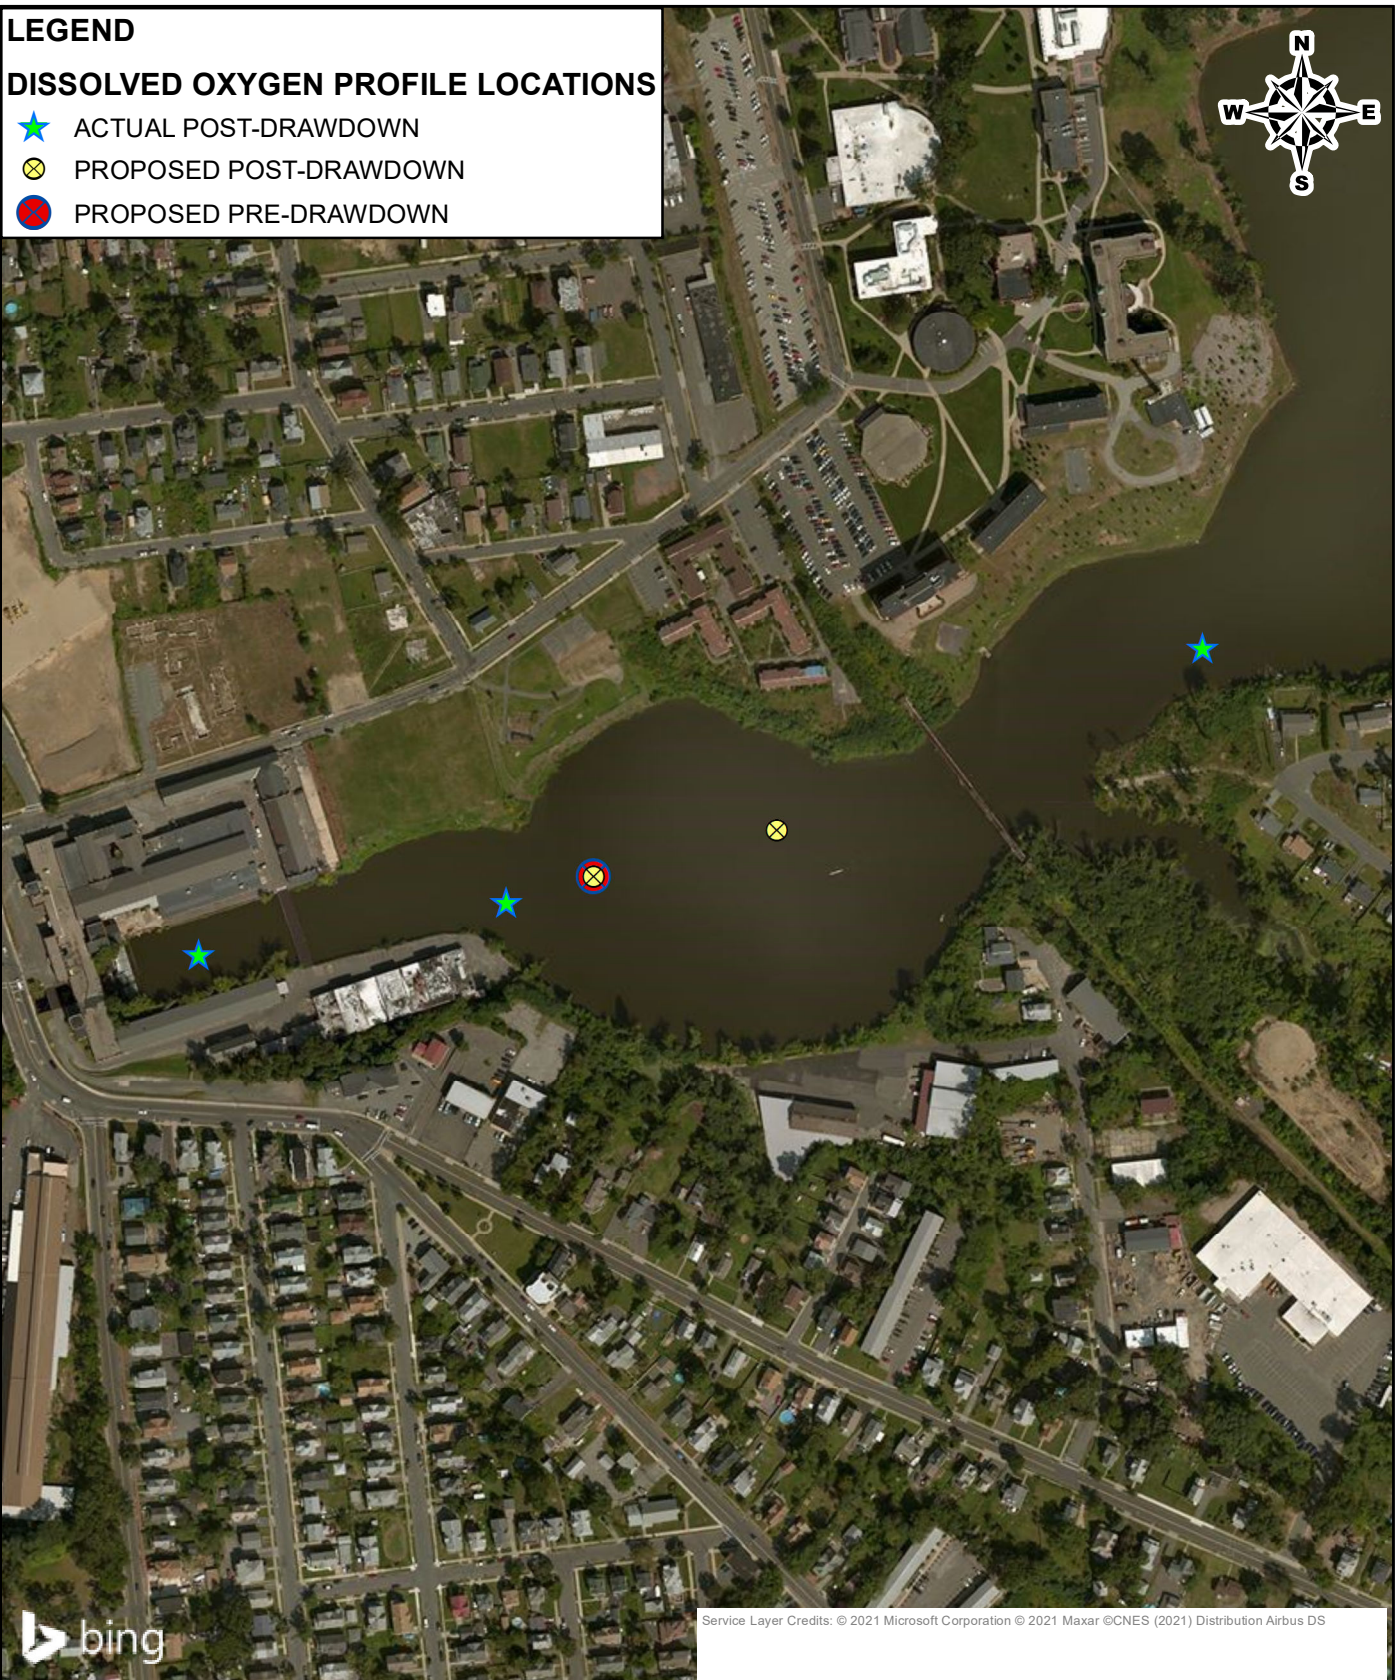
FIG.
1A

The current monitoring event was conducted on March 23, 2021. Monitoring was repeated at the two locations selected during the first sampling event, conducted December 15, 2020. A new, third sampling location nearer the dam was added to take advantage of deeper residual pool depth at this location for monitoring (see **Figure 1A** for data collection locations).

**DISSOLVED OXYGEN PROFILE
MONITORING LOCATIONS**
