RESILIENCY IMPROVEMENTS AT WATERSHOPS POND DAM DRAWDOWN PERIOD MONITORING REPORT #8

August 9, 2021

RESILIENCY IMPROVEMENTS AT WATERSHOPS POND DAM
 1 ALLEN STREET
 SPRINGFIELD, MASSACHUSETTS

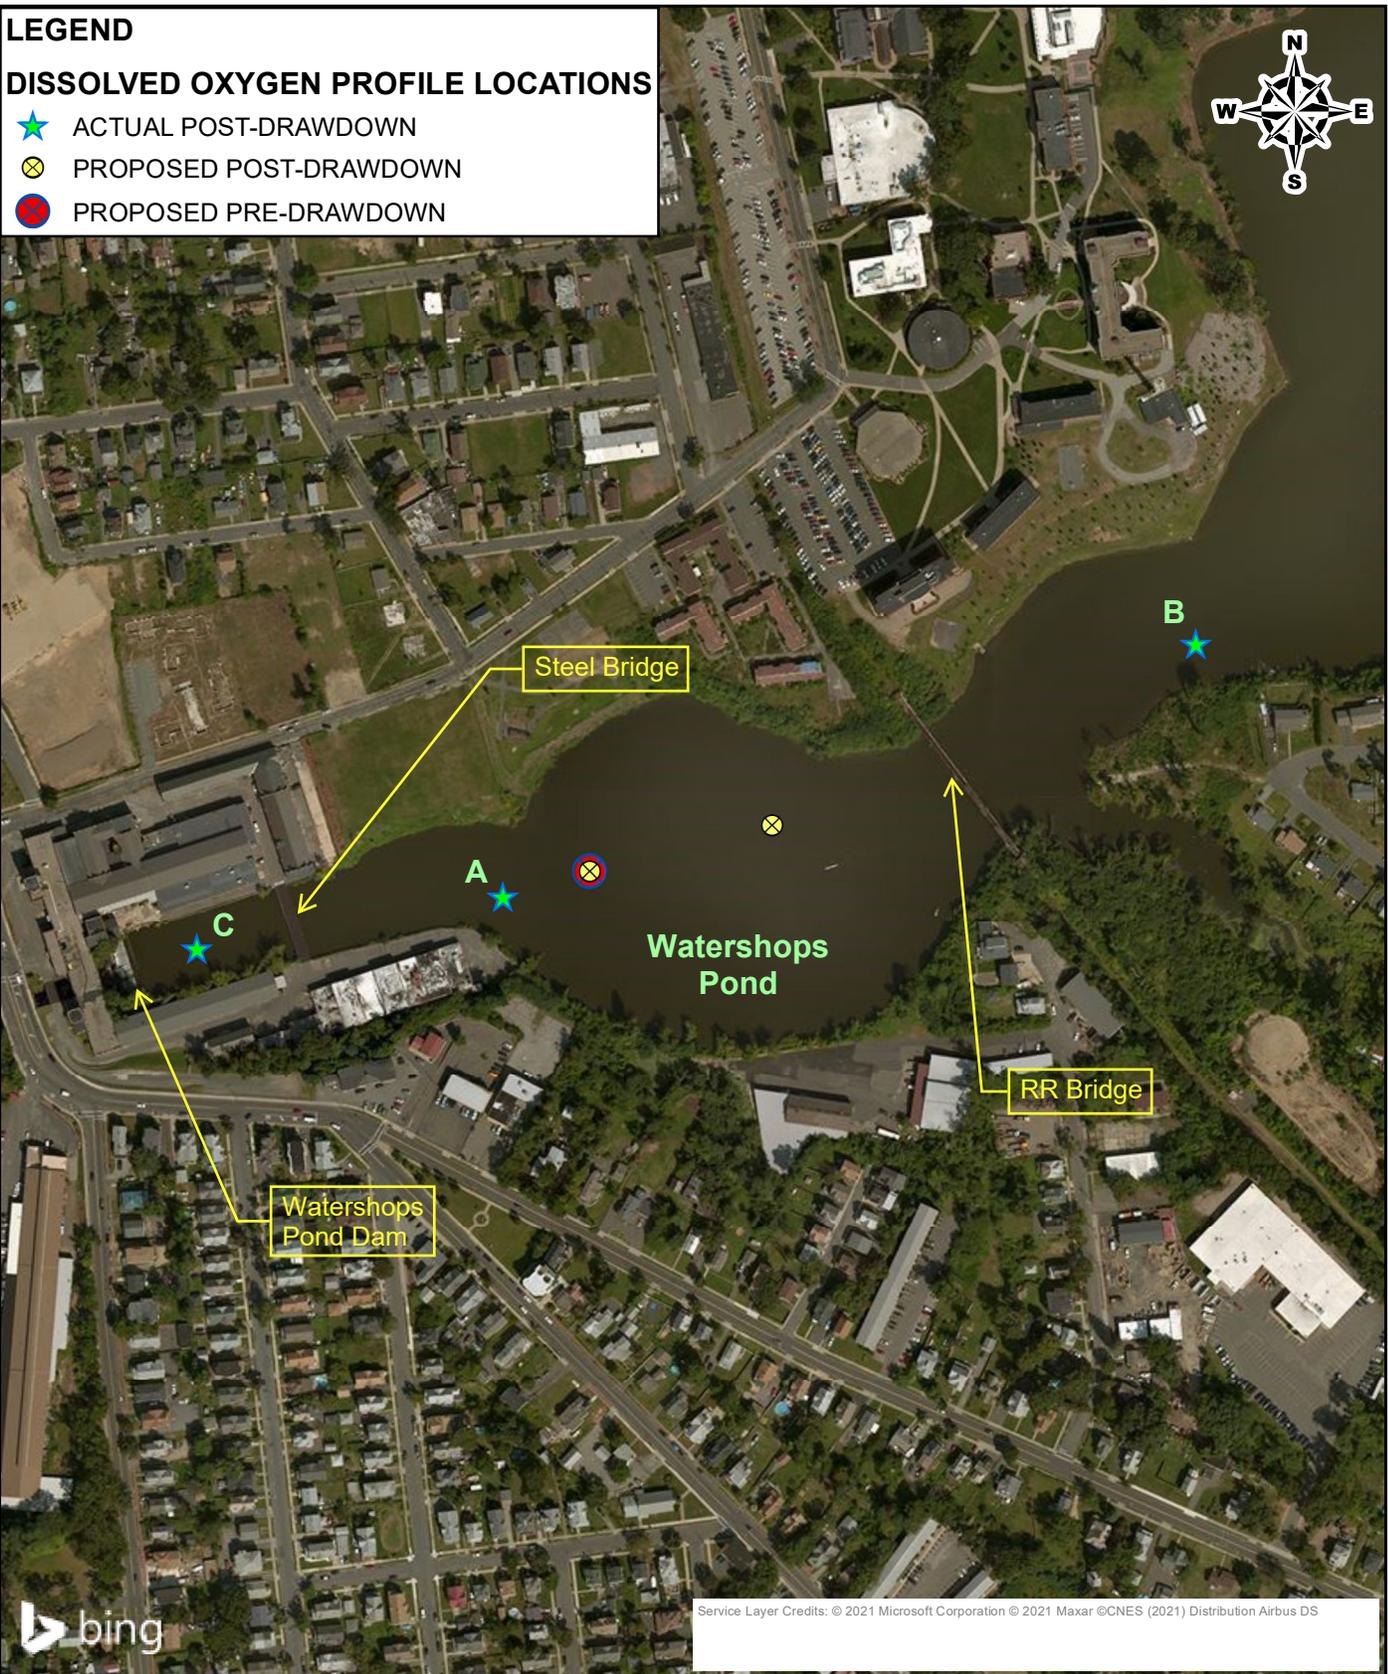
FIG.
1A

The current monitoring event was conducted on August 9, 2021. Monitoring was repeated at the two locations selected during the first sampling event, conducted December 15, 2020 and a third sampling location near the dam which was added on March 23, 2021 to take advantage of deeper residual pool depth for monitoring (see **Figure 1A** for data collection locations).

**DISSOLVED OXYGEN PROFILE
 MONITORING LOCATIONS**

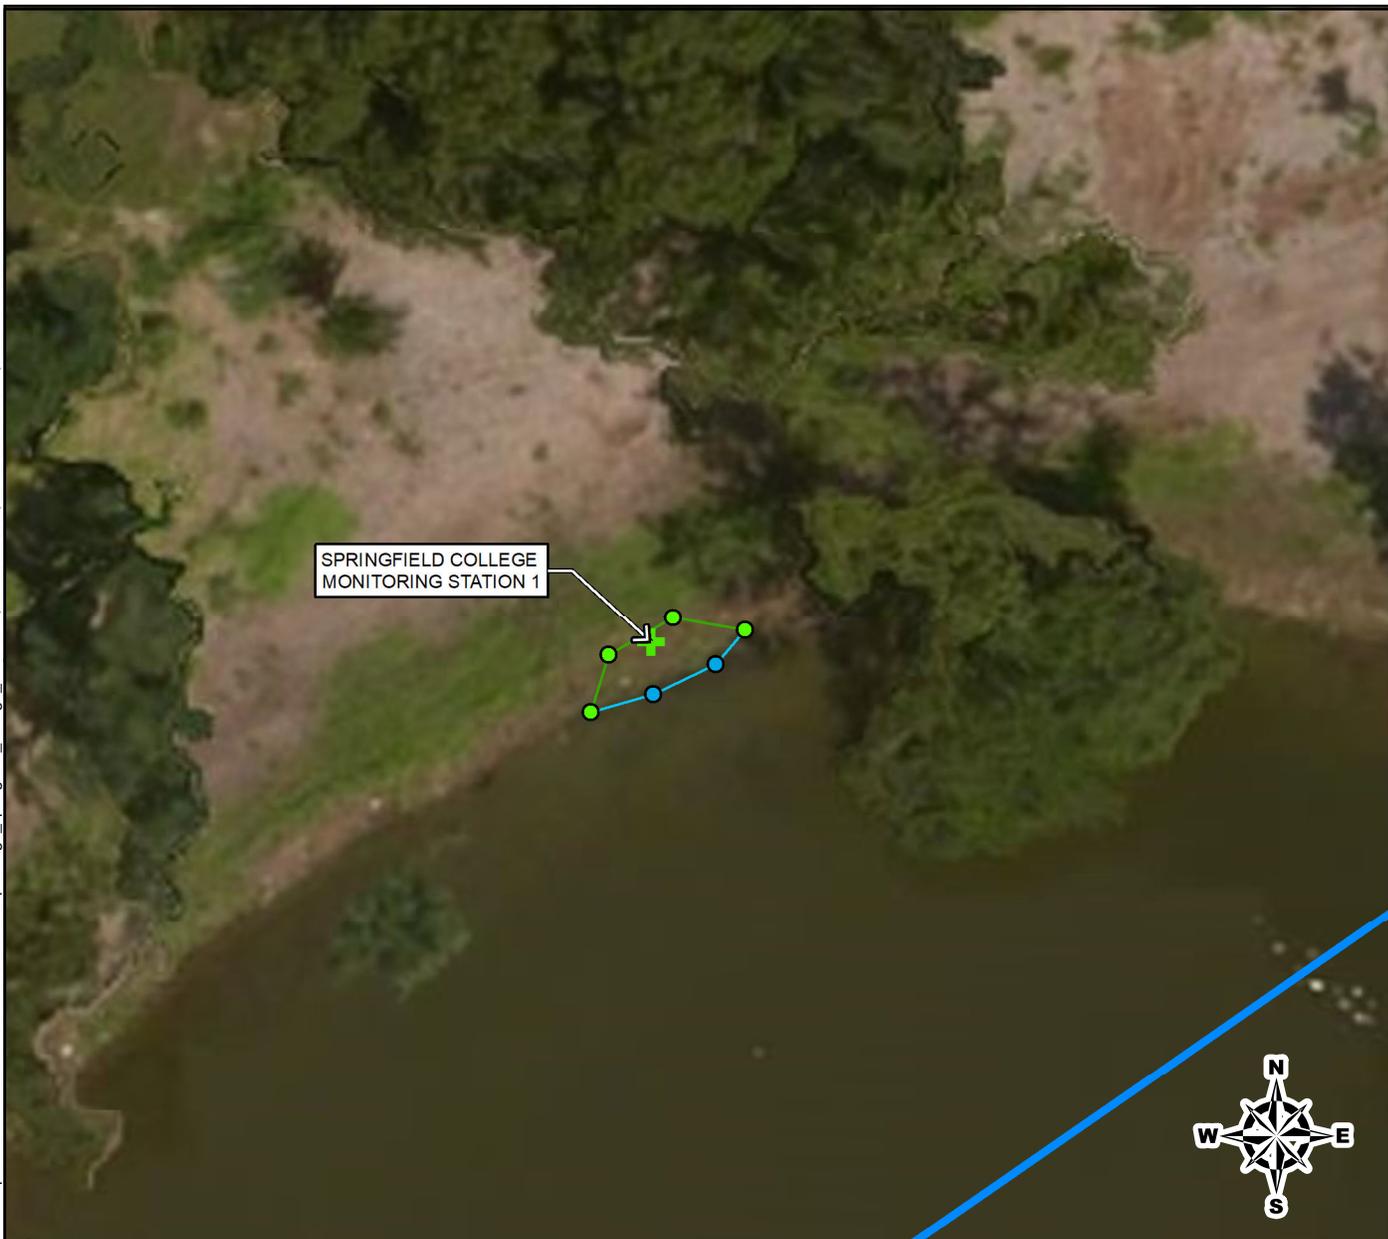
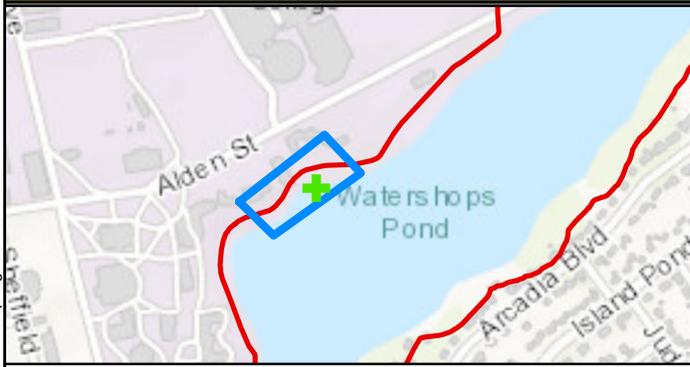
PROJ MGR: TEJ	REVIEWED BY: TEJ	CHECKED BY: SLL	FIG. 2
DESIGNED BY: JRB	DRAWN BY: ARD	SCALE: 1 in = 20 ft	
DATE: 11/24/2020	PROJECT NO: 15.0166625.20	REVISION NO:

SPRINGFIELD COLLEGE BVW

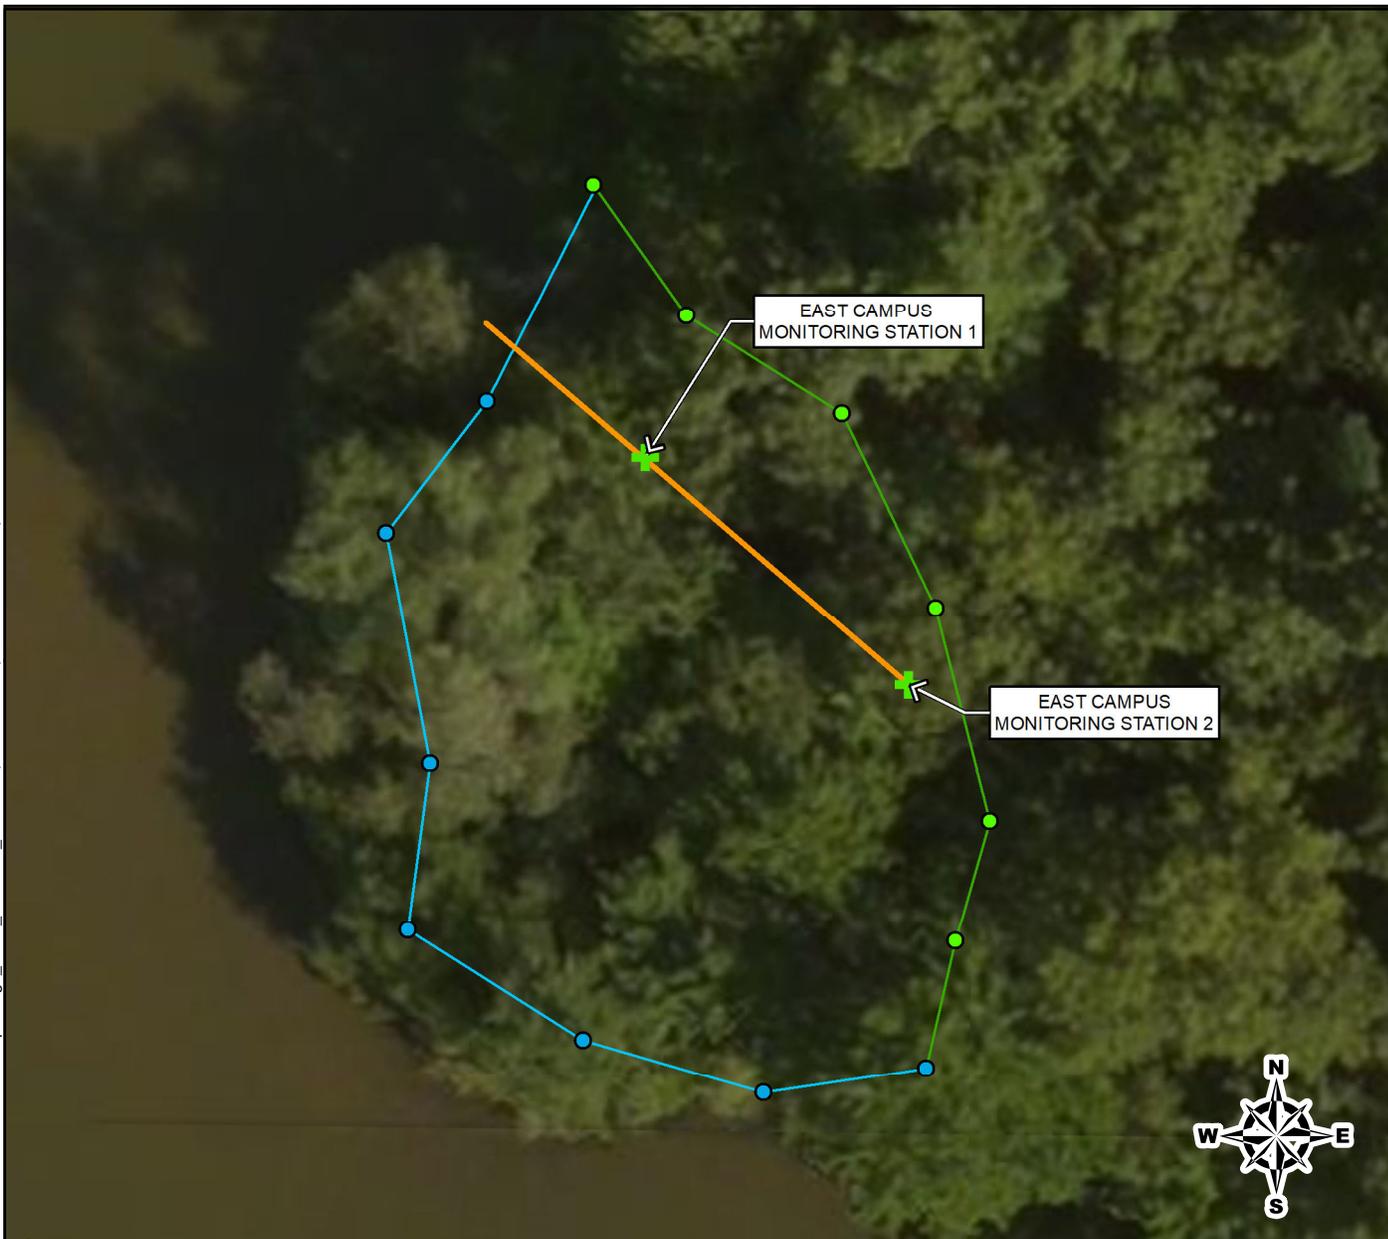
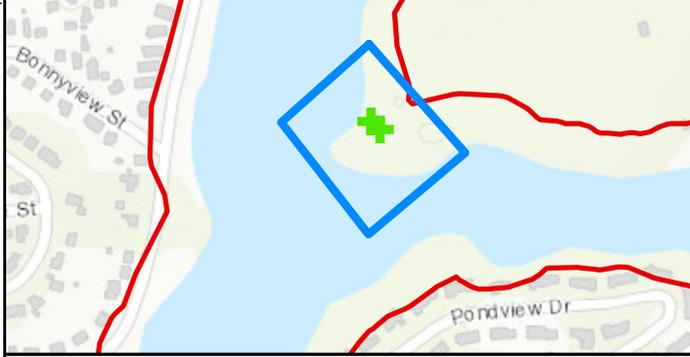
PROJ MGR: TEJ	REVIEWED BY: TEJ	CHECKED BY: SLL	FIG. 3
DESIGNED BY: JRB	DRAWN BY: ARD	SCALE: 1 in = 20 ft	
DATE: 11/25/2020	PROJECT NO: 15.0166625.20	REVISION NO:

SPRINGFIELD COLLEGE
EAST CAMPUS BVW

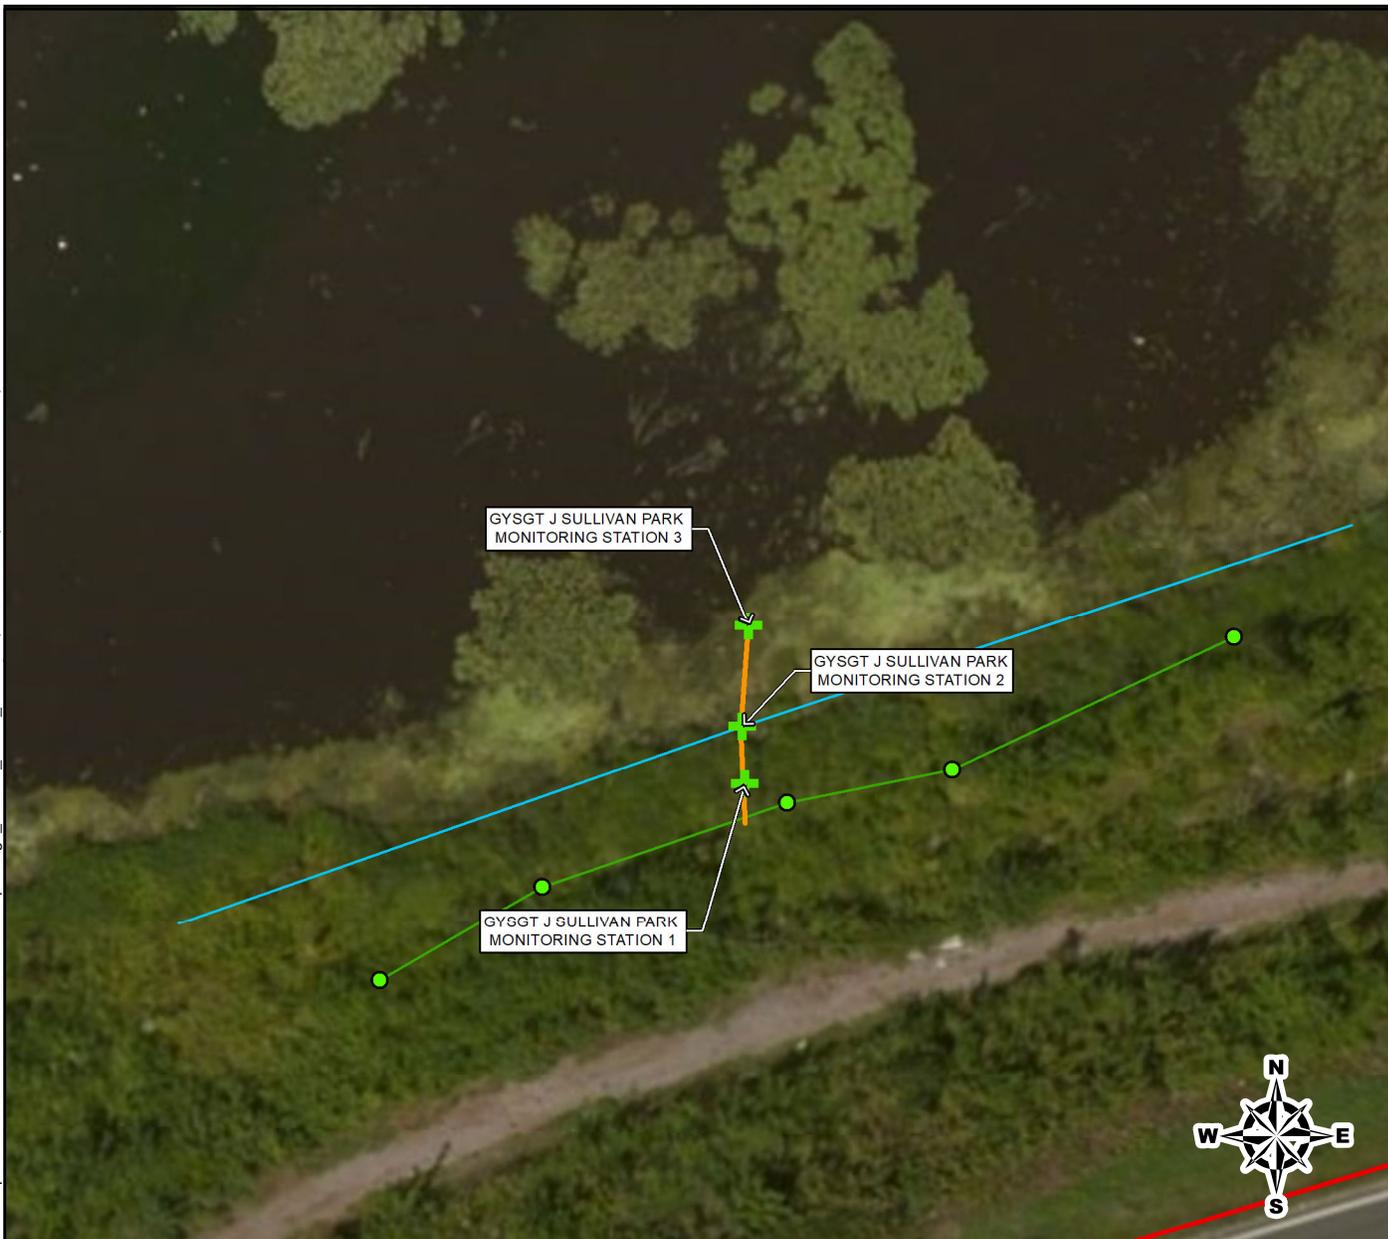
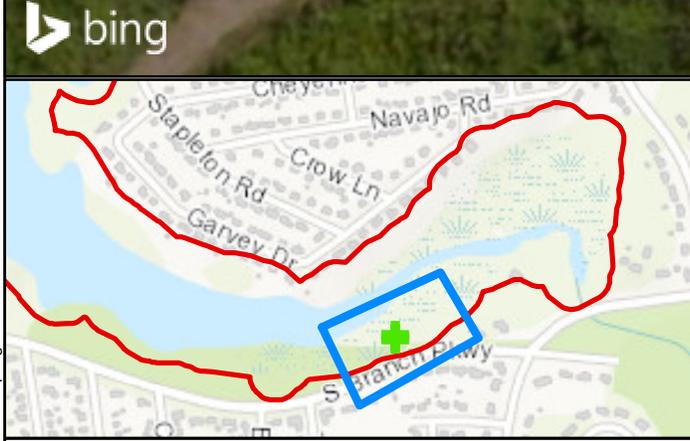
PROJ MGR: TEJ	REVIEWED BY: TEJ	CHECKED BY: SLL	FIG. 4
DESIGNED BY: JRB	DRAWN BY: ARD	SCALE: 1 in = 30 ft	
DATE: 11/24/2020	PROJECT NO: 15.0166625.20	REVISION NO:

GYSGT. J. SULLIVAN PARK BVW
